District of North Vancouver Fromme Mountain Trails Environmental Assessment

February 21, 2015

DIAMOND HEAD
CONSULTING LTD.

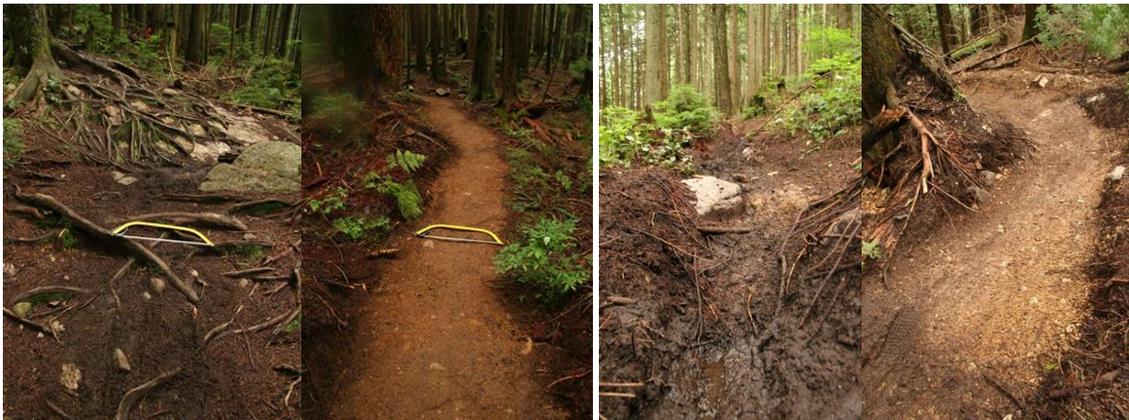
Before and after photos of upgrades to Espresso (left) and Executioner (right).

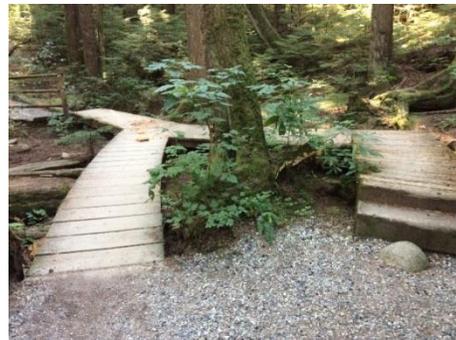
The Trails Study BMPs require that all creek crossings comply with the BC Riparian Assessment Regulation and that an assessment report be completed by a Qualified Environmental. The newer and pre-existing creek crossings assessed generally do not comply with the BMPs which would require larger protection zones. Most have been constructed to the top of bank with little protection through the riparian zone. Steep slopes leading down to creeks cause surface water flow which along with skidding of bikes causes sedimentation into the creeks.

Creek crossings on the lower Baden Powell Trail

It has been recommended that all creek crossing structures extend to a sufficient distance beyond the creek banks. Also they should be designed to prevent people and dogs from accessing the creek bed. Trails within 30m from significant creeks should be made a priority for upgrading. These measures will greatly reduce the risk to water quality and better protect riparian habitat.

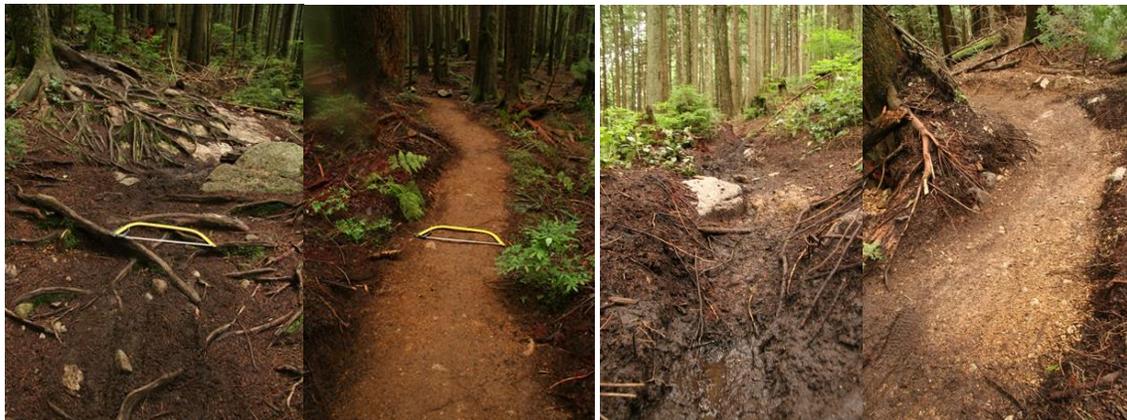
Figure 1. Photos of before and after upgrades in sections of Executioner (left) and Espresso (right).

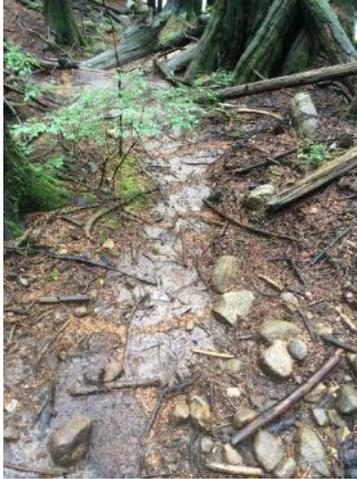
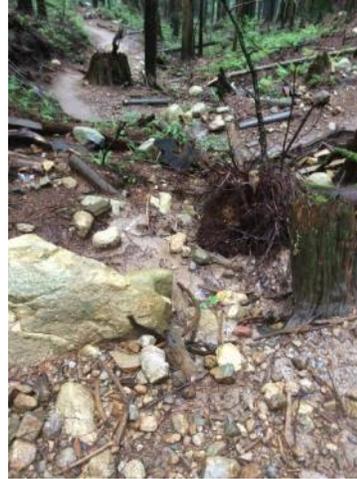
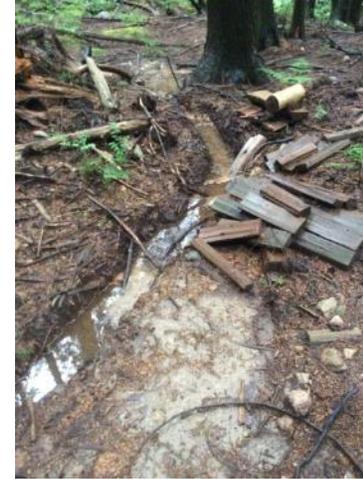
New and upgraded trails tend to have less off-trail impacts related to water. Strategic trail alignments built at gentler slopes and with reverse grades have proven to effectively manage surface water flow. Upgraded trails also have strategically placed ditches to help manage water flow onto the trail. Trails with the least impact are built up on grade without digging down into the soil profile. This helps preserve natural surface water flows.

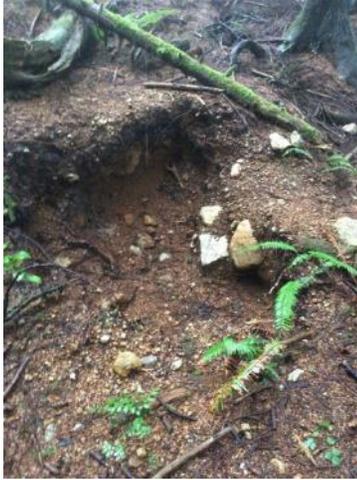
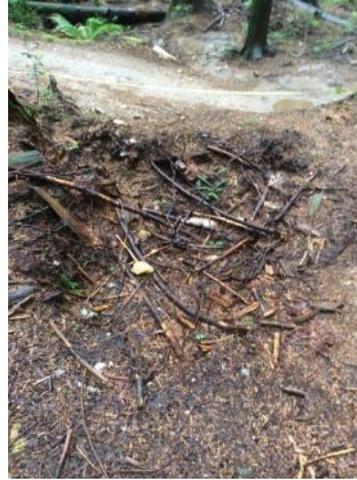
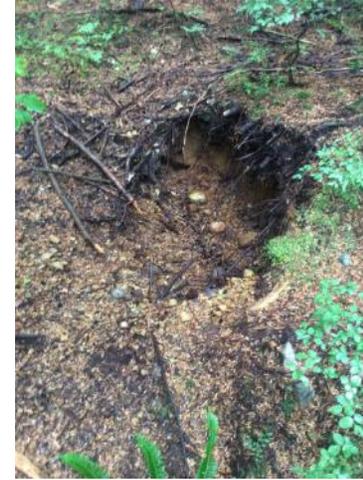
New and upgraded trails have more off trail impacts related to construction and high traffic. On newly constructed trails, there is mineral soil present on the fill slope where vegetation has not yet established. These trails require a large amount of mineral soil. This is taken from areas adjacent to the trail called borrow pits. Most of these are within 5m of the trail. These cause localized impacts to understory vegetation and some damage to the structural roots of nearby trees. No signs of slope instability or water damage was observed related to these borrow pits.

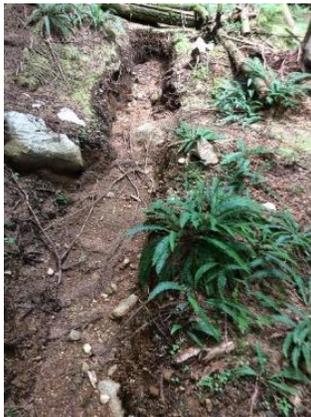
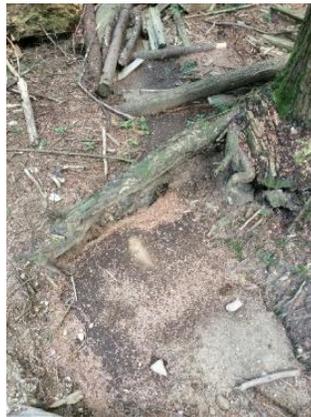
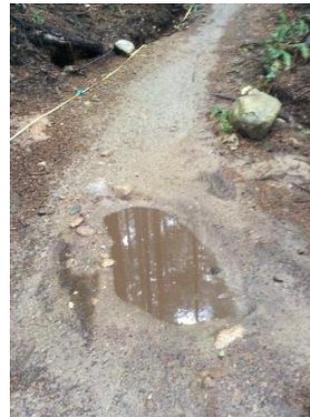
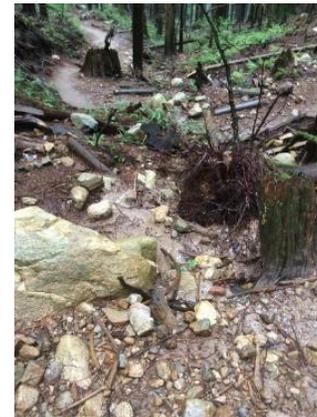
As previously discussed, newer and upgraded trails have gentler grades and are constructed to manage water flow. Surface water flow was greater on trails with a deep cut slope. This intercepts surface water flows increasing the amount of water flowing onto the trail. Construction of trails above grade allows for more natural ground flows to continue below the trails surface.

- Upgrade older trails to new trail design standards that manage surface water flow.
- Avoid or minimize the depth of cut slopes during construction.
- Prioritise the upgrading and maintenance of trail sections that are within 30m of any creeks.

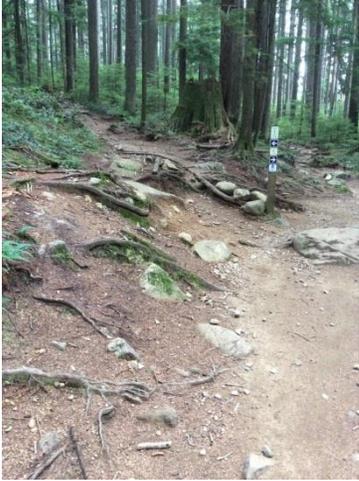
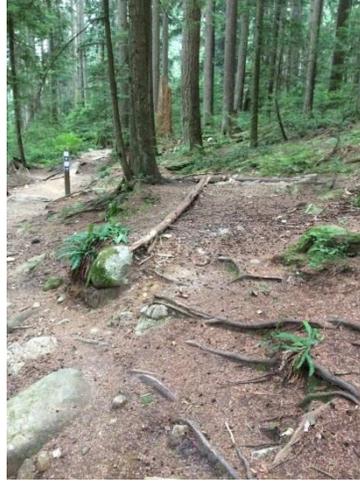
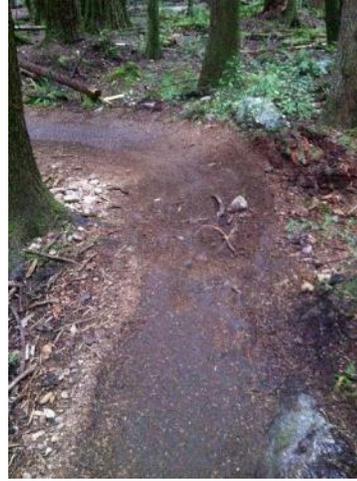
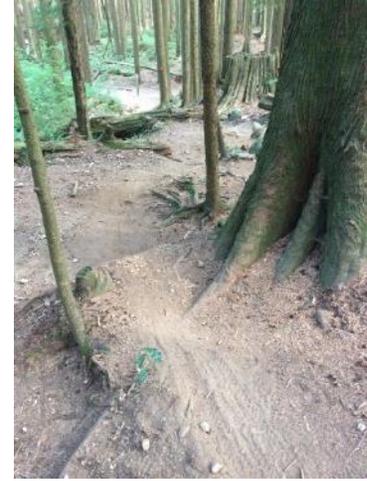
Newer trails tend to have a gentler grade and subsequently bikes do not skid as frequently and the tread wear was lower. The areas that do show signs of tread wear on newer trails include the sections before TTFs and steep corners. Placing obstacles strategically before these areas has been effective at slowing riders to prevent them from skidding.

- Continue to promote new trail design standards that control and reduce bike skidding.
- Increase resources for maintenance of trails that experience high wear and tear.

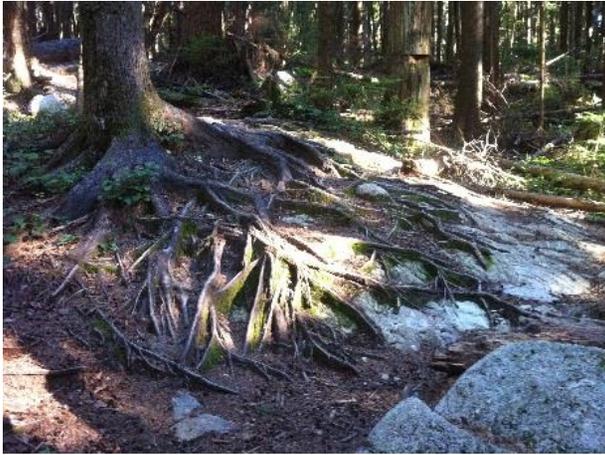
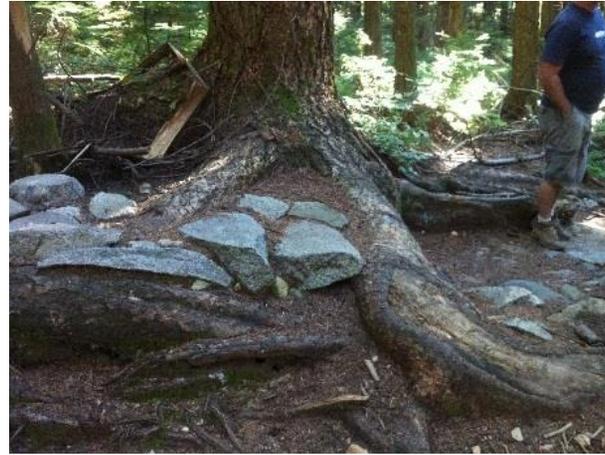
Generally trail construction requires no direct cutting of mature trees. Subsequently, the trails have caused very little impact on the overall canopy of Fromme Mountain. Hazard tree mitigation can cause significant impacts to the ecology of a forest. Some of the most valuable habitat features include large dead and dying trees (wildlife trees). They provide forage and nesting sites for birds and roosting areas for bats. The removal of numerous large trees was evident along the lower Baden Powell Trail in Mountain View Park.

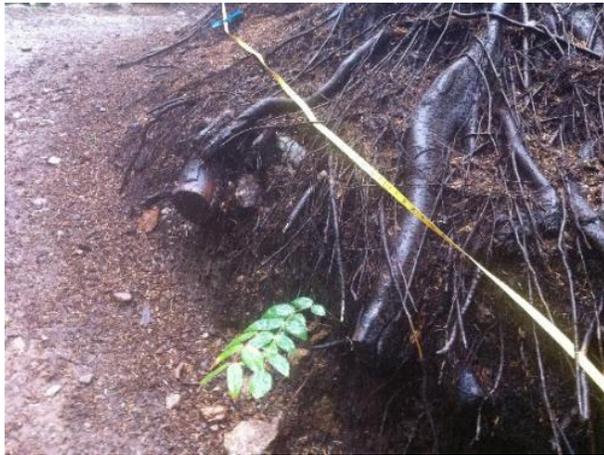
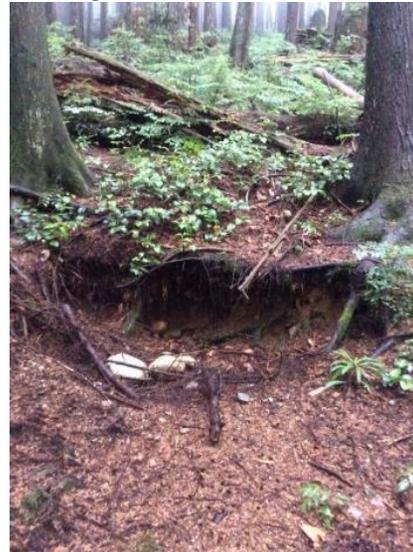
On trails that are constructed with deep cut slopes (such as Bobsled), tree roots are difficult to avoid. The extent of roots cut depends on the depth of the cut slope. Bobsled is an example of a trail that was cut deeper into the soil profile. This caused high impacts to tree roots. The cutting and exposing of tree roots was the most significant impact recorded to vegetation.

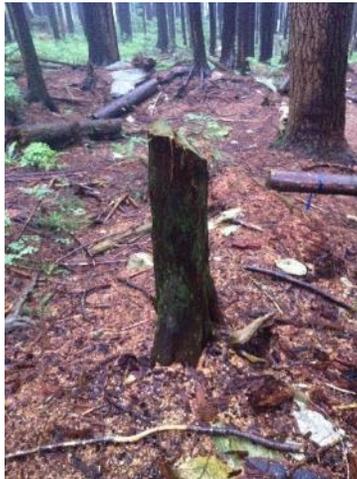
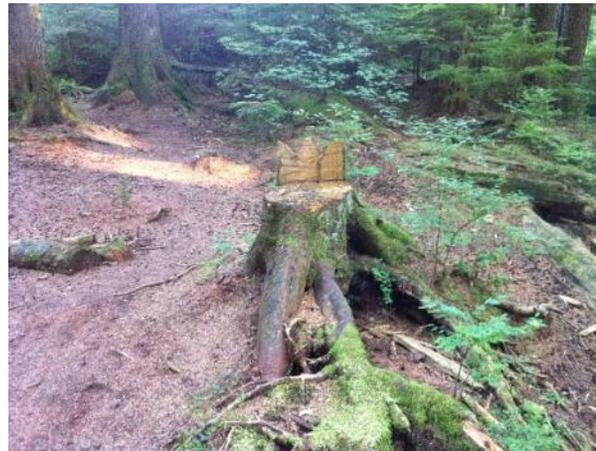
Along other trails, there was evidence of cutting of understory cedar trees to be used for construction of TTFs. It was difficult to quantify how many of these have been cut for trail construction and when this took place in relation to the adoption of the Trails Study.

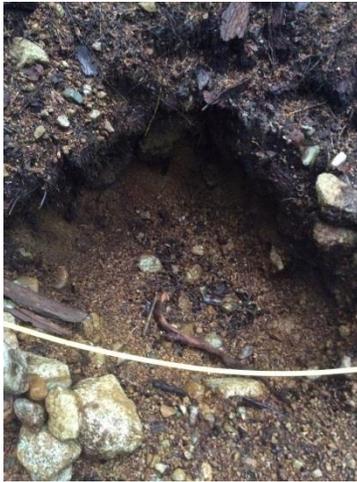
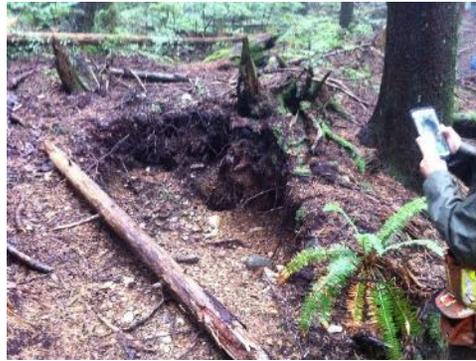
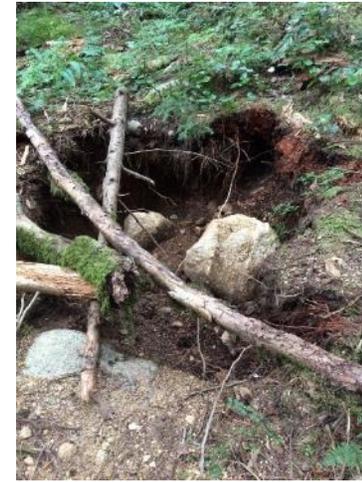
Building trails to the standards of the Trails Study requires high volumes of mineral soil sourced from “borrow pits.” These are holes in the ground that are 1 to 3m in diameter and up to 1.5m deep. These remove immediate ground vegetation and create permanent depressions in the forest floor. Most are restored and covered with logs and organic debris. Due to the density of trees, most pits are within the drip line of trees. Also due to difficulty of transportation, most are within 5m of trails.

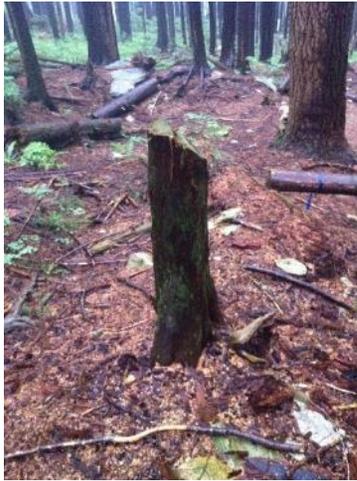
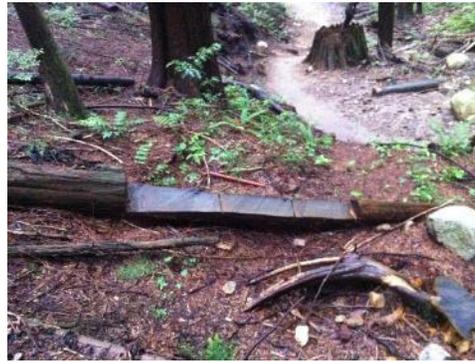
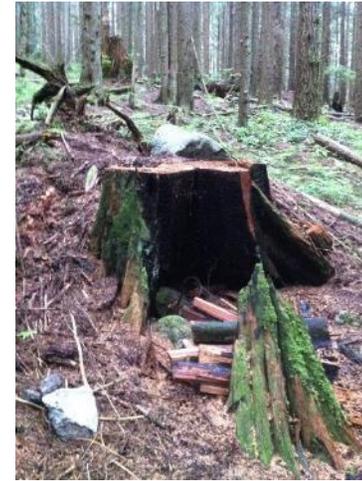
Trail construction and maintenance requires the use of wood for boardwalks and retaining features. Western redcedar is used primarily as it is most resistant to rot. This has been sourced from dead standing trees, recently fallen trees, understory trees and heritage stumps. Live trees that are impacted include mostly smaller cedar trees that are growing under the canopy of the mature forest. These trees represent the next generation of trees that will replace the existing trees as they die. There are remaining dead standing cedar trees that remained from the old growth stand. These range in height from 2 to 8m. Most have hollow centers and are burnt on the inside. These are being cut for the construction of boardwalks and bridges.

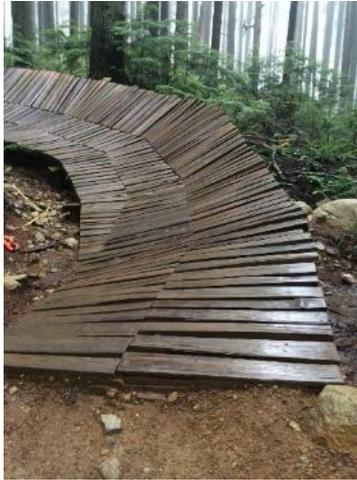
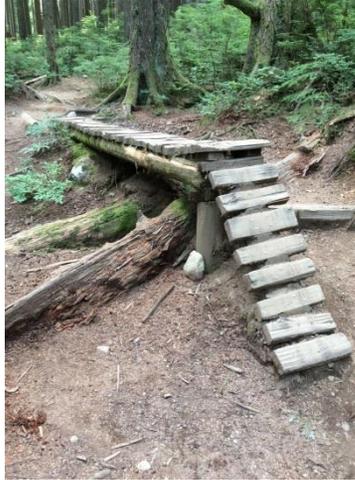
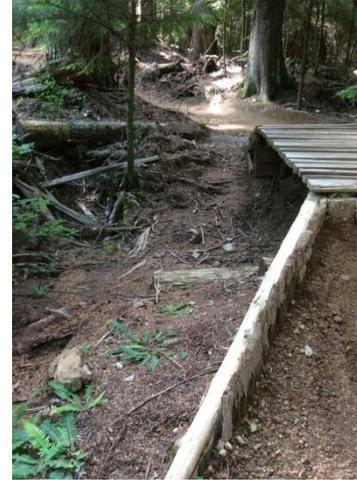
Most TTFs are found on trails that are designed to be moderate or difficult. New trails that have been constructed have fewer TTFs and were built to include easily accessible ride-arounds. Where no alternative routes are provided, off trail impacts were observed. Viewing areas for high use TTFs on busier trails have caused off trail impacts due to users leaving the trail.
