**NORTH VANCOUVER
DISTRICT**

2019 ANNUAL DRINKING WATER QUALITY REPORT

August 24, 2020.

District of North Vancouver Utilities Department

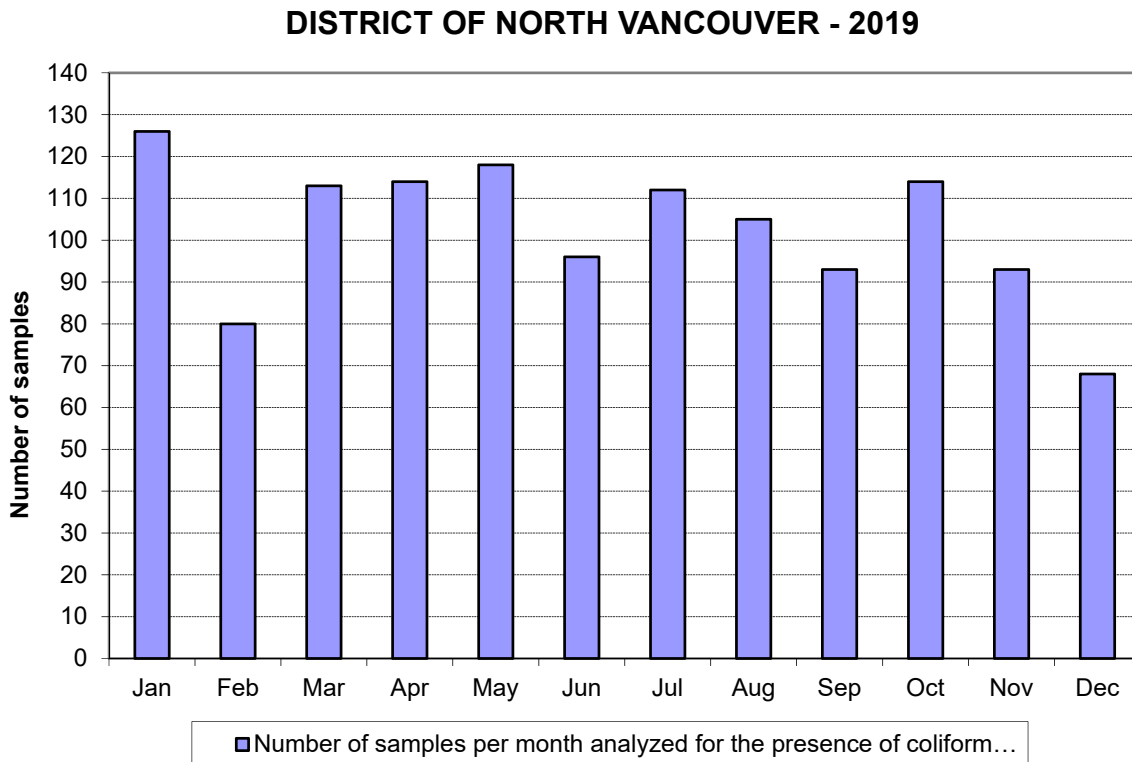
Figure 1 below shows the number of scheduled weekly sample collected and analysed in 2019 on a monthly basis.

Figure 1. Number of Scheduled Weekly Samples Collected

In 2019 DNV staff collected a total of 1,232 regular scheduled samples from 39 sample sites or an average of 103 samples per month. This exceeds the Regulations population based sample requirement for DNV of 34 sites and 86 samples per month. Three (3) of the thirty-nine (39) sites were removed in July 2019 to improve the efficiency of the sampling program. Sample collection is scheduled weekly on a rotating basis using strategic grouping of sample sites distributed across the system. Generally 13 samples are collected twice weekly for a total of 26 samples per week.
