NORTH VANCOUVER
DISTRICT

DRINKING WATER QUALITY ANNUAL REPORT 2016

May 15, 2017. District of North Vancouver Utilities Department

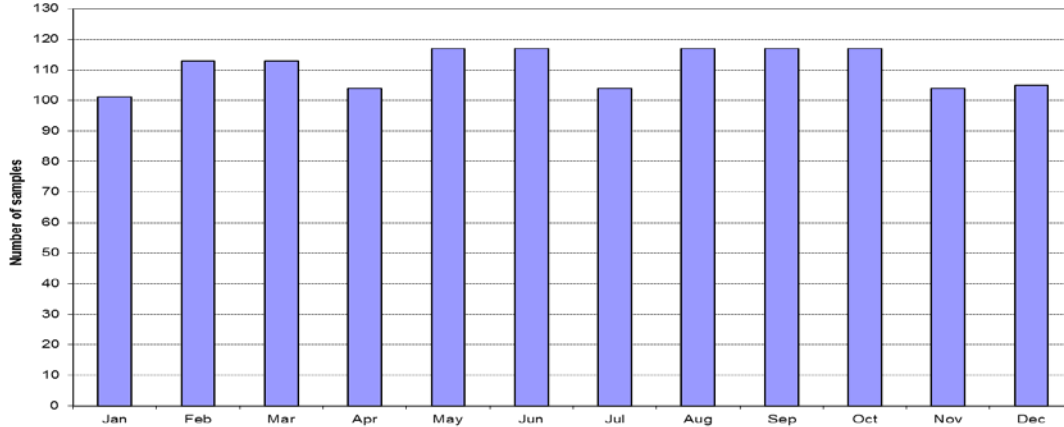
Figure 1. Number of Scheduled Weekly Samples Collected

In 2016 DNV staff collected a total of 1330 regular scheduled samples from 39 sample sites or an average of 111 samples per month. This exceeds the Regulations population based sample requirement for DNV of 34 sites and 86 samples per month. Sample collection is scheduled weekly on a rotating basis using strategic grouping of sample sites distributed across the district. Typically 13 samples are collected twice each week for a total of 26 samples per week.

Figure 1 below shows the number of sample collection on a monthly basis.

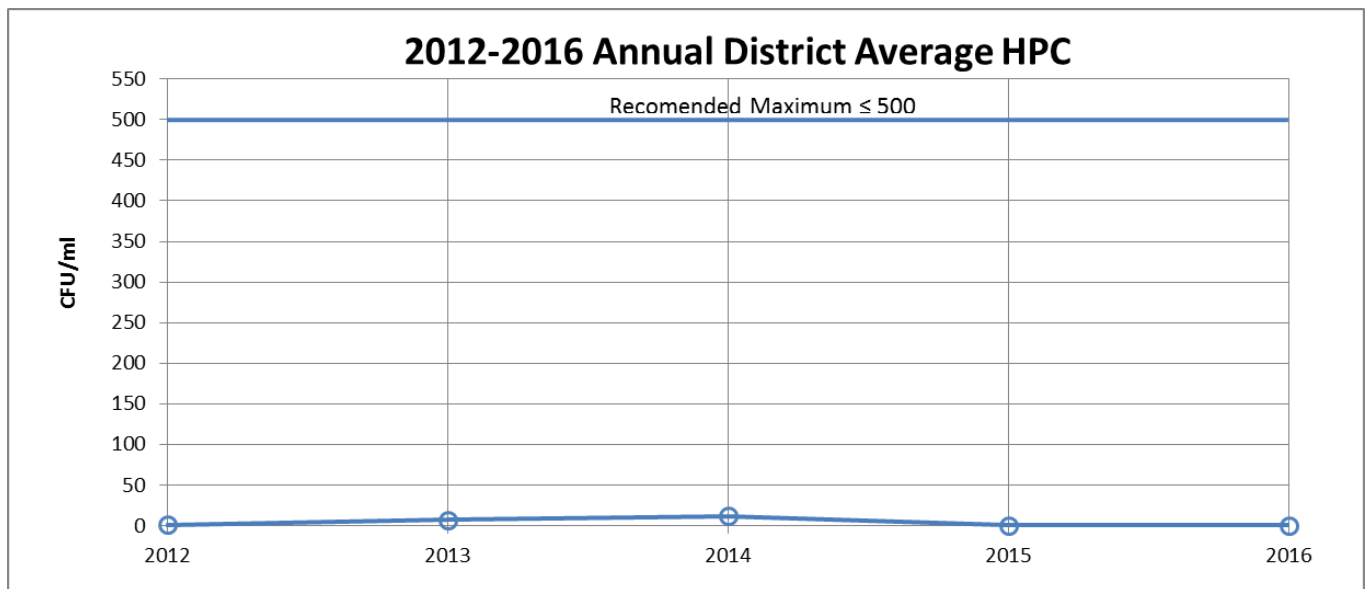
Figure 2. HPC Five Year Annual Averages

All samples collected in 2016 met the guidelines for safe drinking water. There were zero occurrences of detectable E-coli or Total Coliform. All samples collected in 2016 were below the recommended maximum HPC. The annual DNV average HPC for the last five years is presented below.

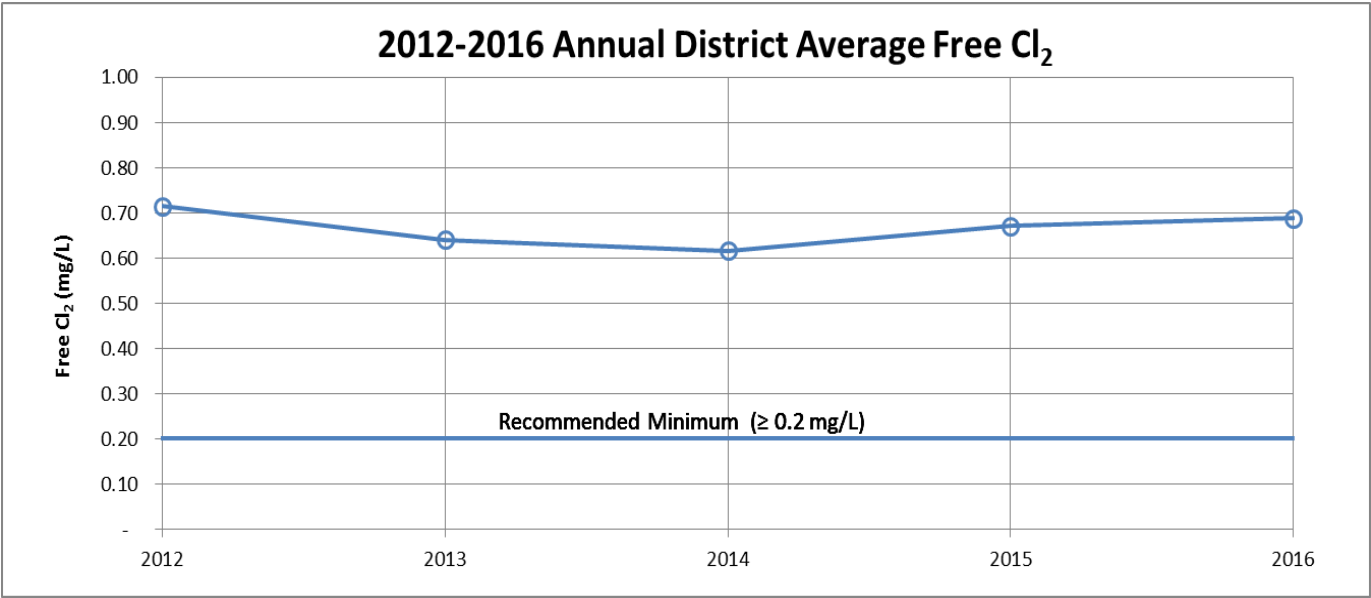
Figure 3. Free Cl₂ Five Year Annual Averages.

In 2016 there were zero samples that had less free chorine than the recommended minimum of 0.20 mg/L. The 2016 average chlorine residual was 0.69 mg/L. The annual DNV average free chlorine for the past 5 years is presented below.

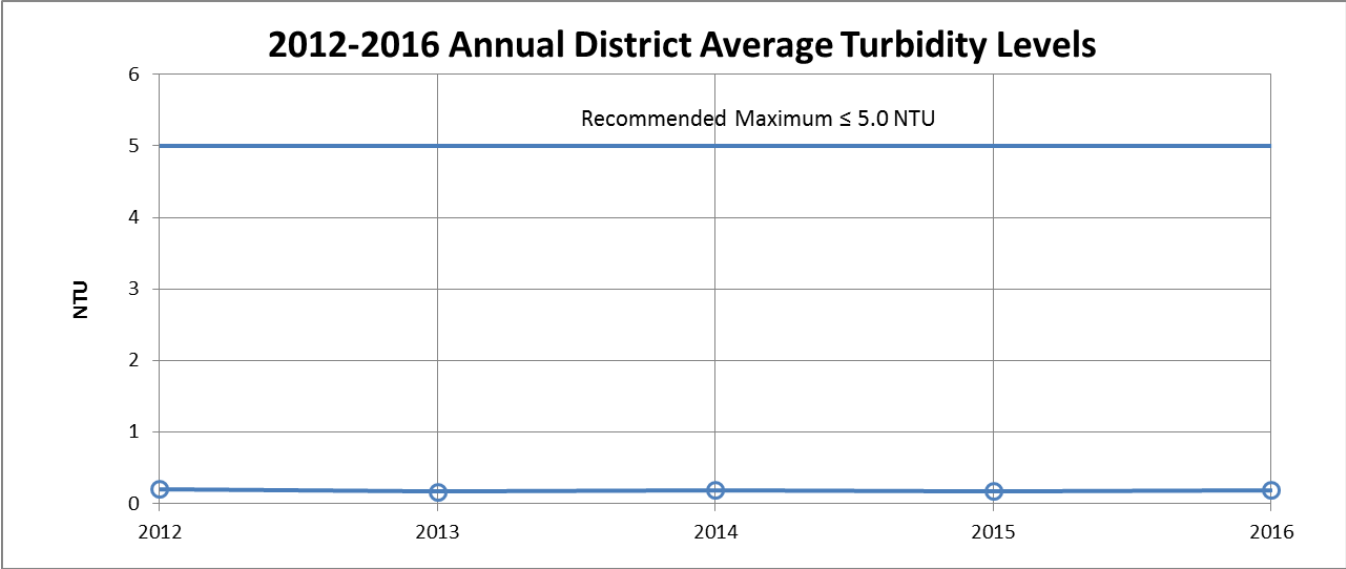
Figure 4. Turbidity Five Year Annual Averages.

The Nephelometric Turbidity Unit (NTU) is used to test and record the turbidity in water. The target NTU is < 1 or “best possible” and should not exceed 5.0 in distribution systems according to the guideline. The average annual turbidity for 2016 was 0.2 NTU. In 2016 six samples, or 0.5%, from six different locations tested above 1 NTU, two samples tested above 5.0 NTU. All other parameters were within acceptable ranges for all six samples. The next sample for all six locations tested below the target NTU.
