**NORTH VANCOUVER
DISTRICT**

2021 ANNUAL DRINKING WATER QUALITY REPORT

August 4, 2022.

District of North Vancouver Utilities Department

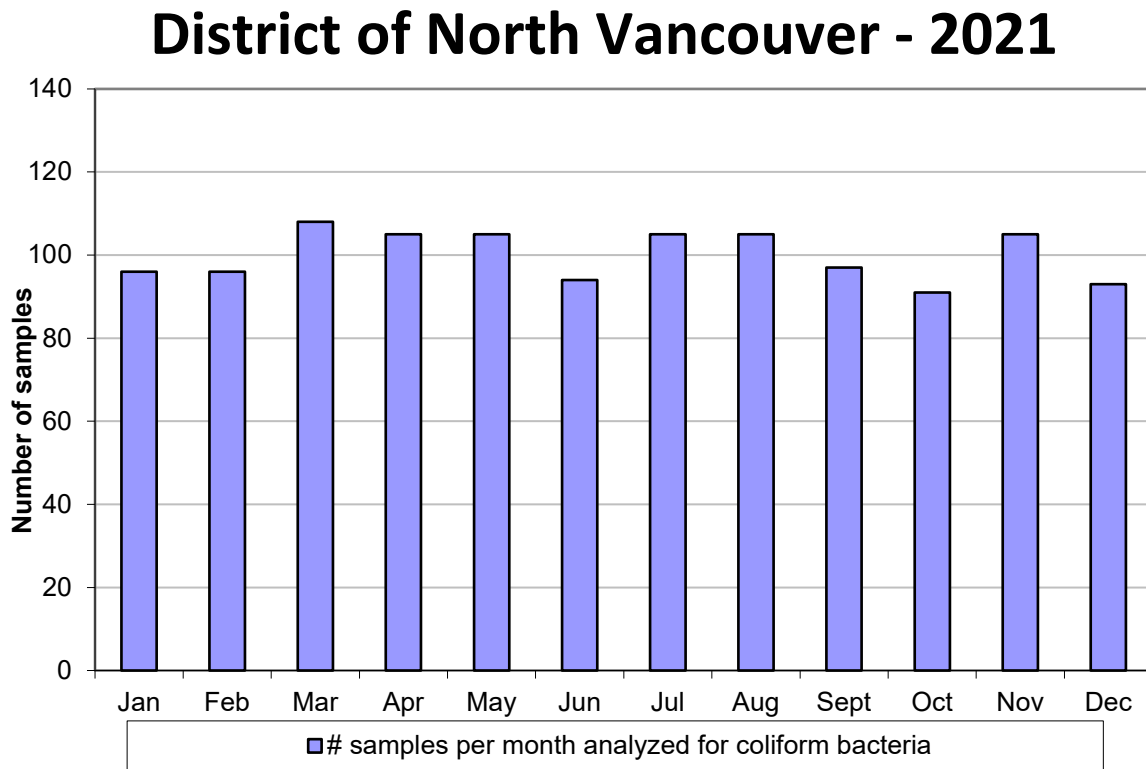
Figure 1 below shows the number of scheduled weekly samples collected and analysed in 2021 on a monthly basis

Figure 1. Number of Scheduled Weekly Samples Collected

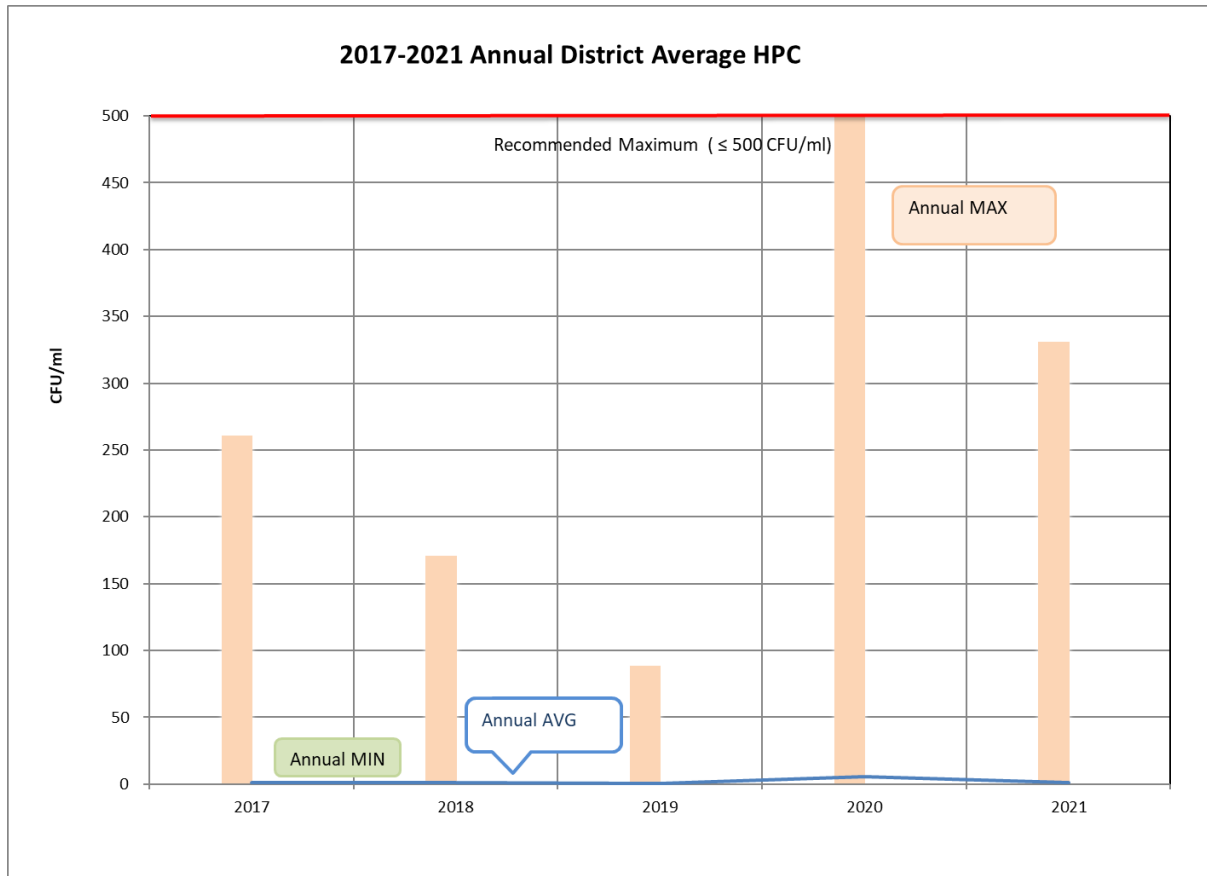
- **HPC:** Heterotrophic plate count is used to monitor general bacteriological quality. The Guideline does not provide an allowable level but instead offers the OG that increases in HPC concentrations above a baseline level of 500 CFU/mL s are undesirable.

Figure 2. HPC Five Year Annual Average and Maximum Values.

The scheduled samples collected in 2021 met the guidelines for safe potable water. There were no occurrences of detectable E. coli nor Total Coliform. One sample was collected in 2021 with turbidity over 5 NTU, which was the result of fire fighting efforts in response to a structure fire. The site was resampled the following day and was back to acceptable levels. The HPC and turbidity levels are stable over time. The annual DNV average HPC and turbidity for the last five years are presented below.

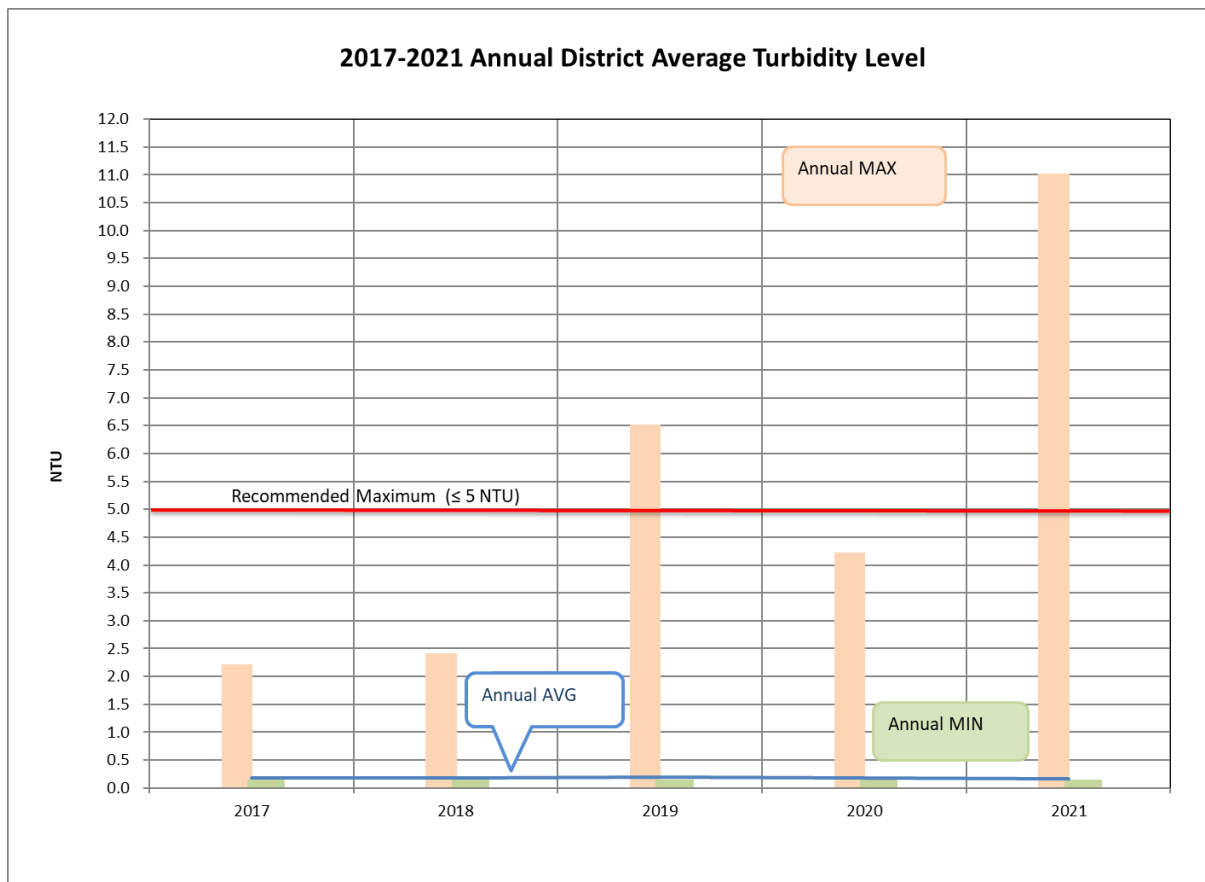
- **Turbidity:** Particles in drinking water can inhibit treatment and indicate potential quality concerns. The Guideline suggest an OG of supply water turbidity target of < 1 Nephelometric Turbidity Unit (NTU) or "best possible" and should not exceed 5.0 in distribution systems.

Figure 3. Turbidity Five Year Annual Average and Maximum Values.

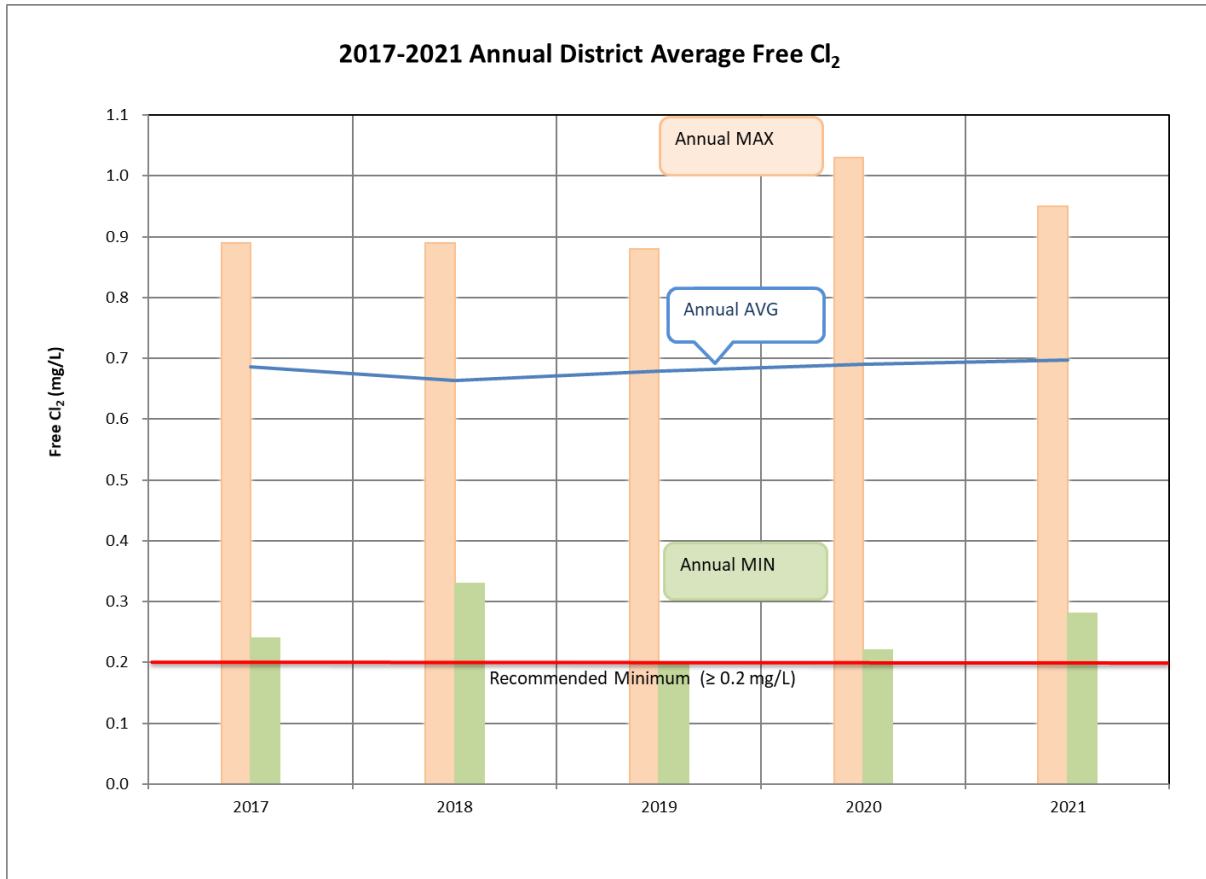
- Chlorine:** Chlorine is used in the disinfection process, and a residual amount in the distribution system is desirable to maintain potable water quality. In 2021, all samples were within the OG range for residual chlorine, 0.04-2.0 mg/L and above the OG of 0.2 mg/L. The average system-wide chlorine residual was 0.70 mg/L. The minimum recorded chlorine residual was 0.28 mg/L. The maximum recorded chlorine residual was 0.95 mg/L. The annual DNV average free chlorine for the past five years is presented below in Figure 4.

Figure 4. Free Cl₂ Five Year Annual Minimum, Average and Maximum Values.

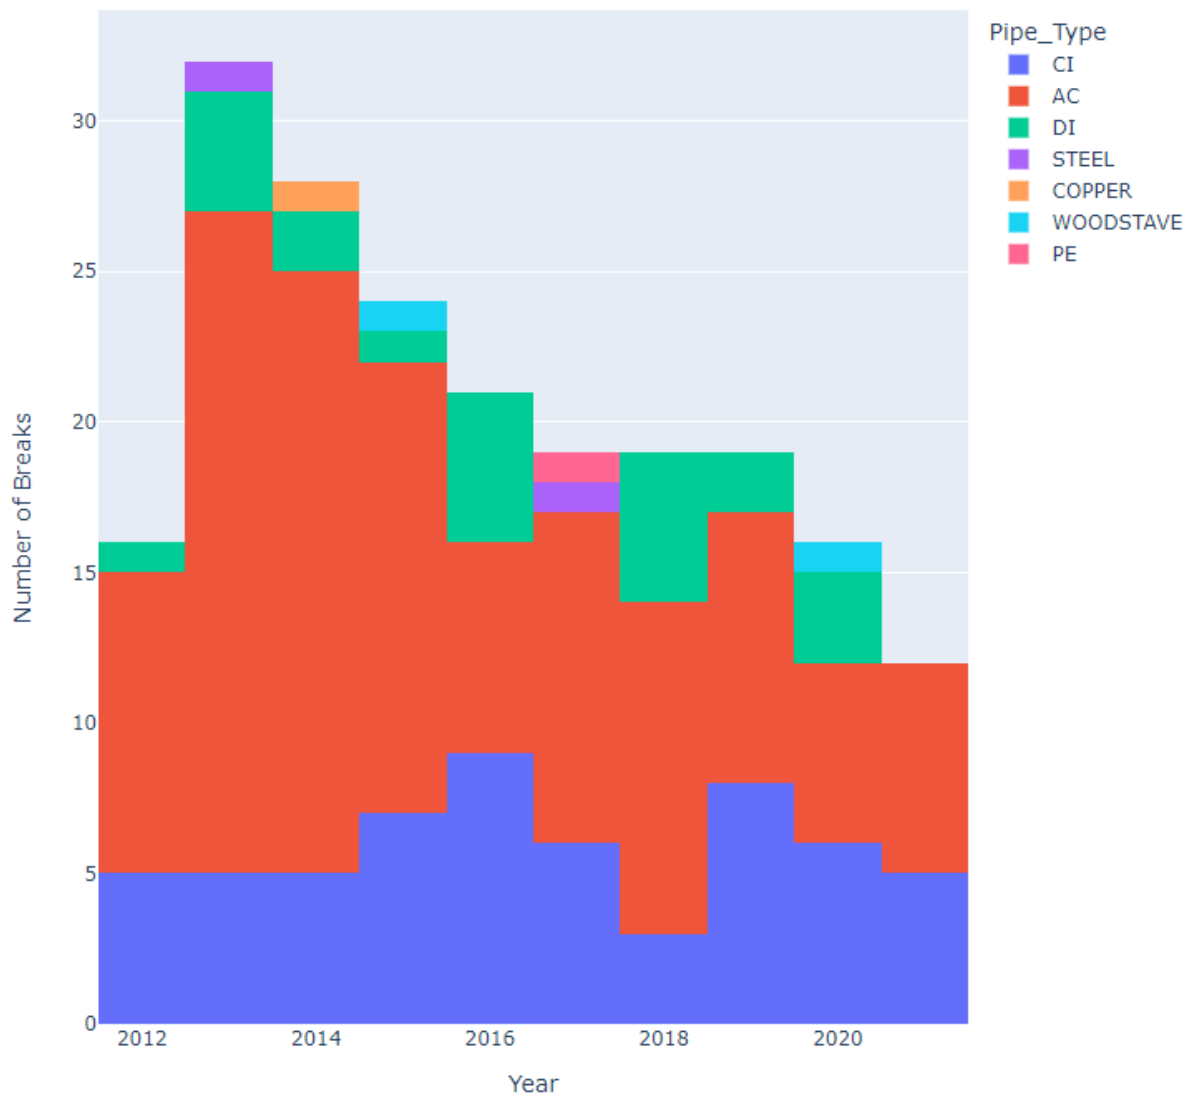
We responded to 12 emergency water main breaks in 2021. Water main break response protocol includes maintaining positive pressure to protect the water system from potential contamination.

Figure 5. 10-Year Water Main Break Summary

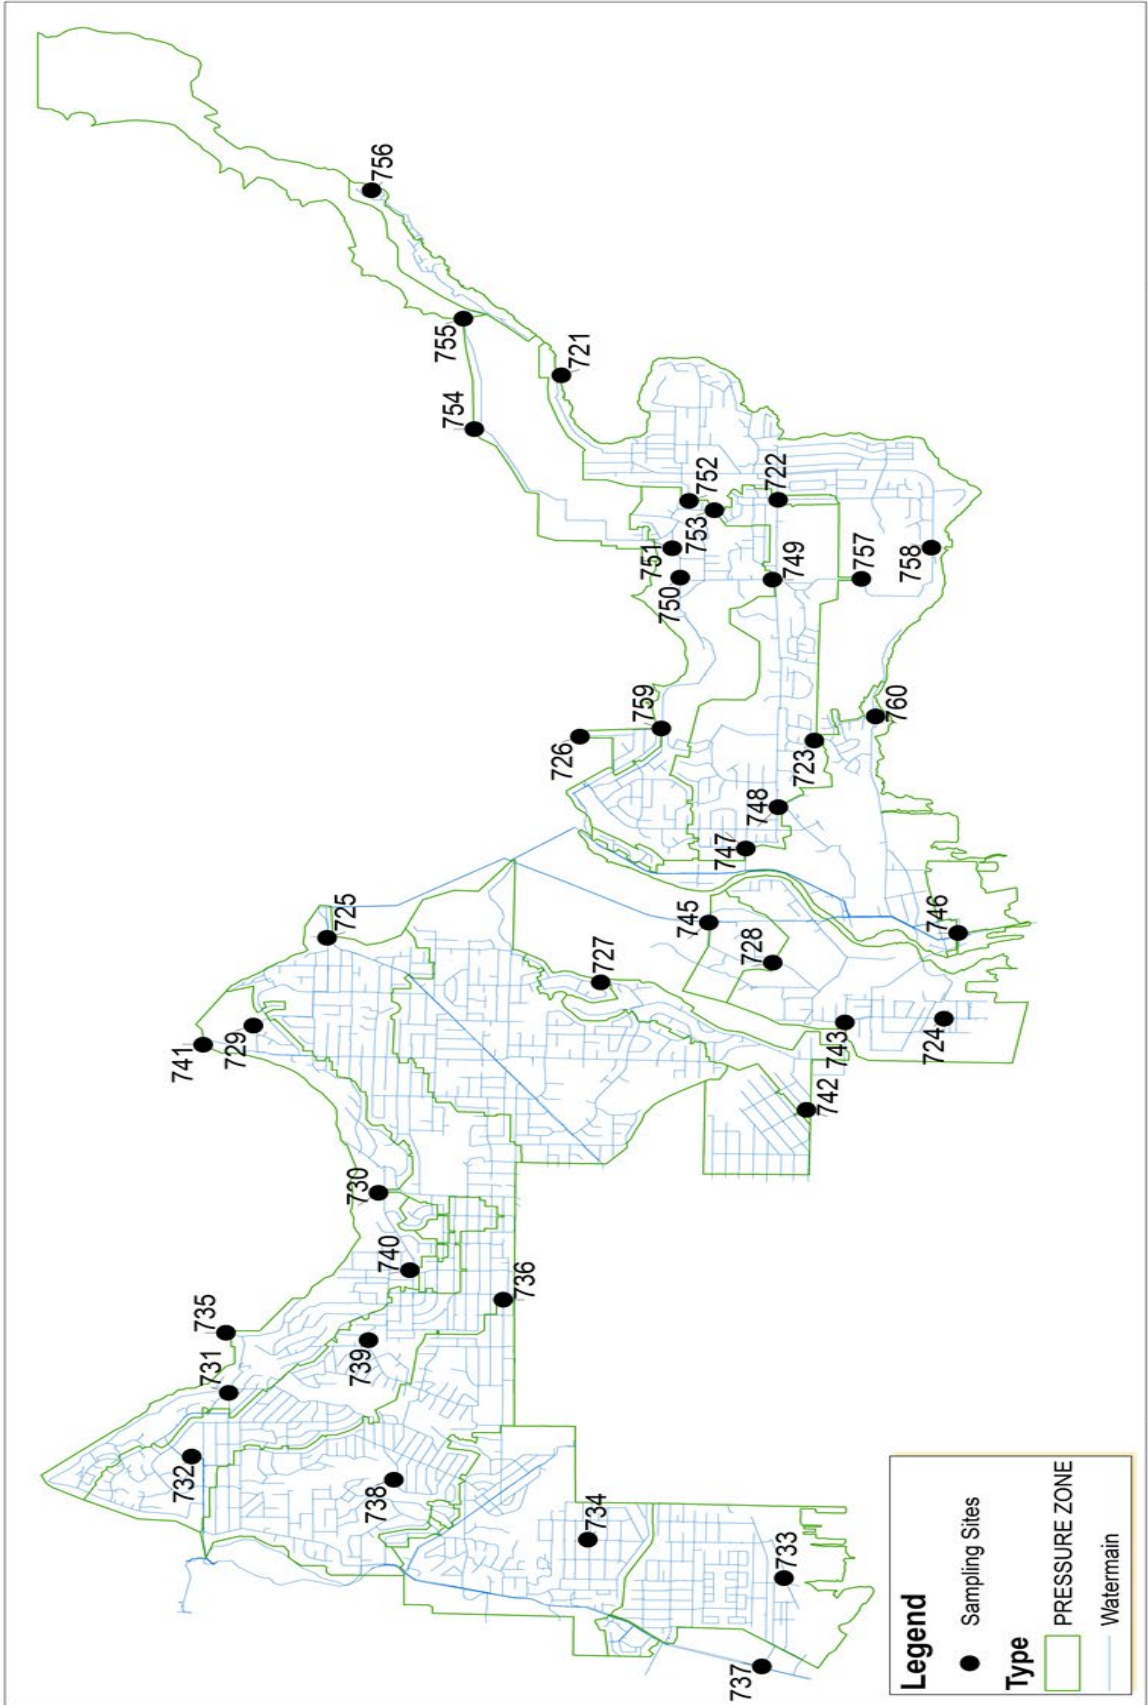
District of North Vancouver Water Quality Sampling Sites
