Maplewood Lands Environmental and Hydrogeological Assessment Report

Executive Summary

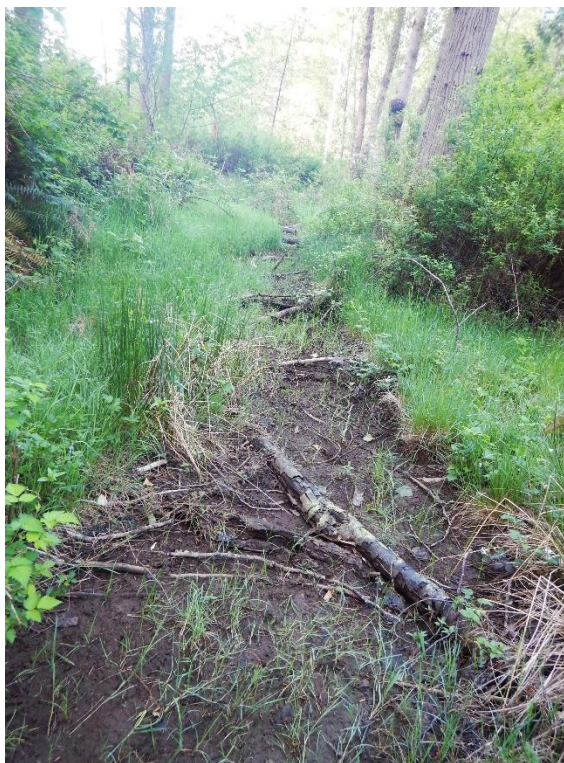
Photo 1. Wetland 4 (remnant of a gravel pit road) conveys water from Watercourses CR1, CR2, CR3 and CR4 to fish bearing habitat on the southside of Dollarton Highway during the winter and is an active wildlife corridor other times of the year.

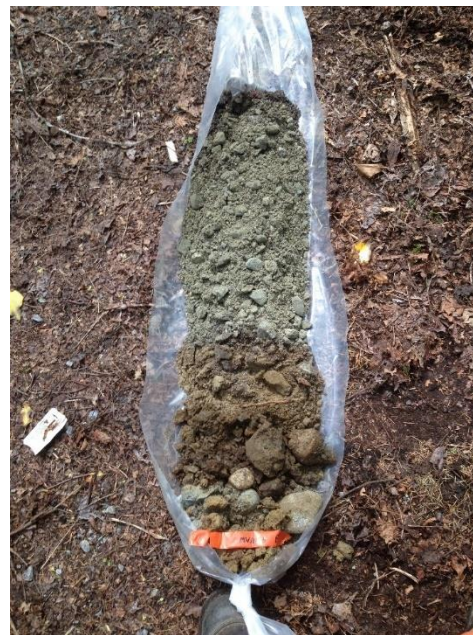
Photo 2. Coarse sand and gravel encountered in the borehole at MW16-06.

Subsurface investigations by Piteau and others (Hardy, 1991; Keystone 2015b, Agra 1999) have confirmed the presence of loose coarse sand and gravel sediments beneath the plain in the western portion of the Study Area to a depth of more than 10m (*Photo 2*). Occasional interbeds of dense silty sand and gravel (glacial till) or silty sediment are present, but since these constitute a minor component of the sediments, groundwater seepage beneath the plain is generally rapid.

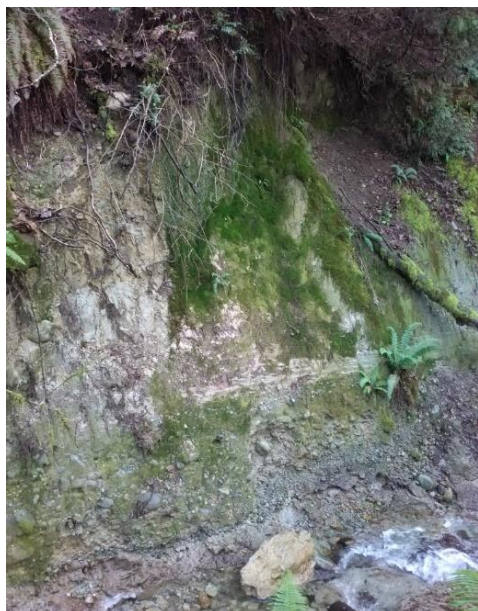
Photo 3. Dense till layer north of the Study Area observed in the Blueridge Creek ravine.

The upland area lying northeast of the Study Area consists of thick till deposits (Salish) and glacio-marine sediments (Capilano) consisting of sand and silt strata. Till is exposed in the incised Blueridge Creek valley immediately east of the Study Area (*Photo 3*).

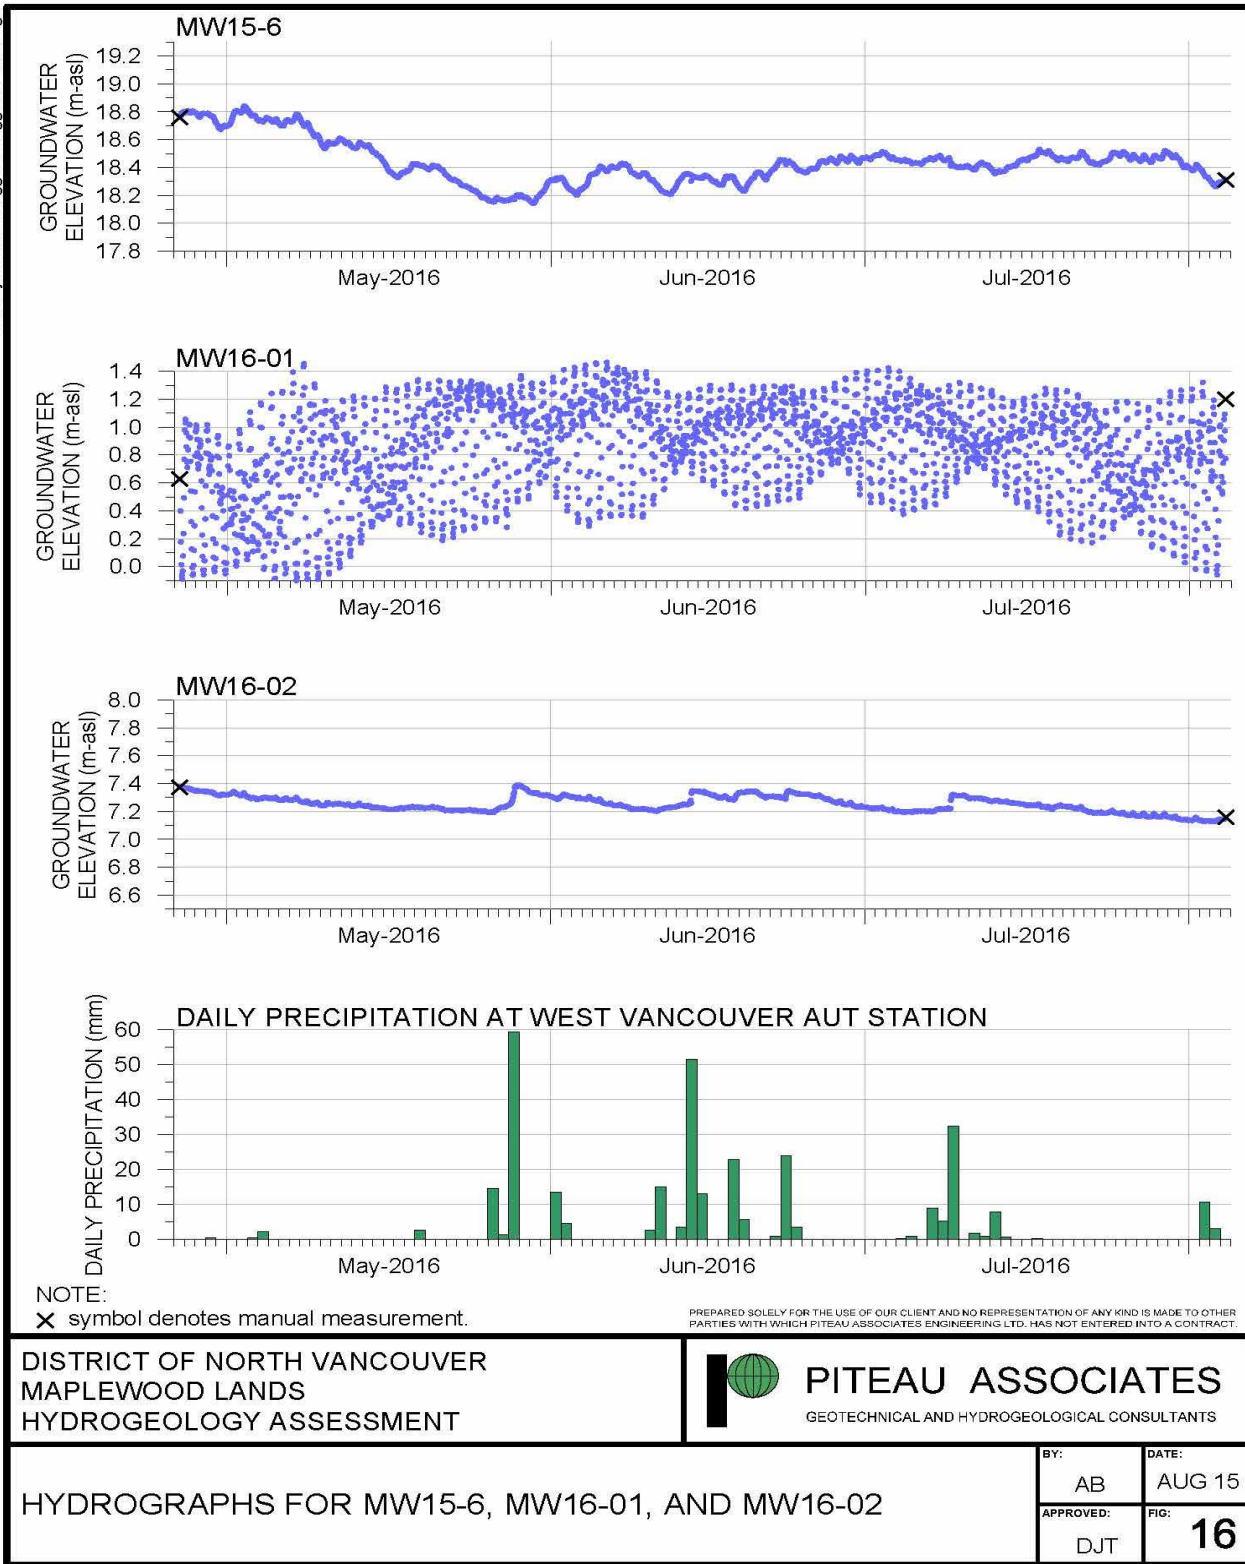
Figure 16. Hydrograph data (water levels) for three monitoring wells located in the MCA and northward in and around the District owned lands.

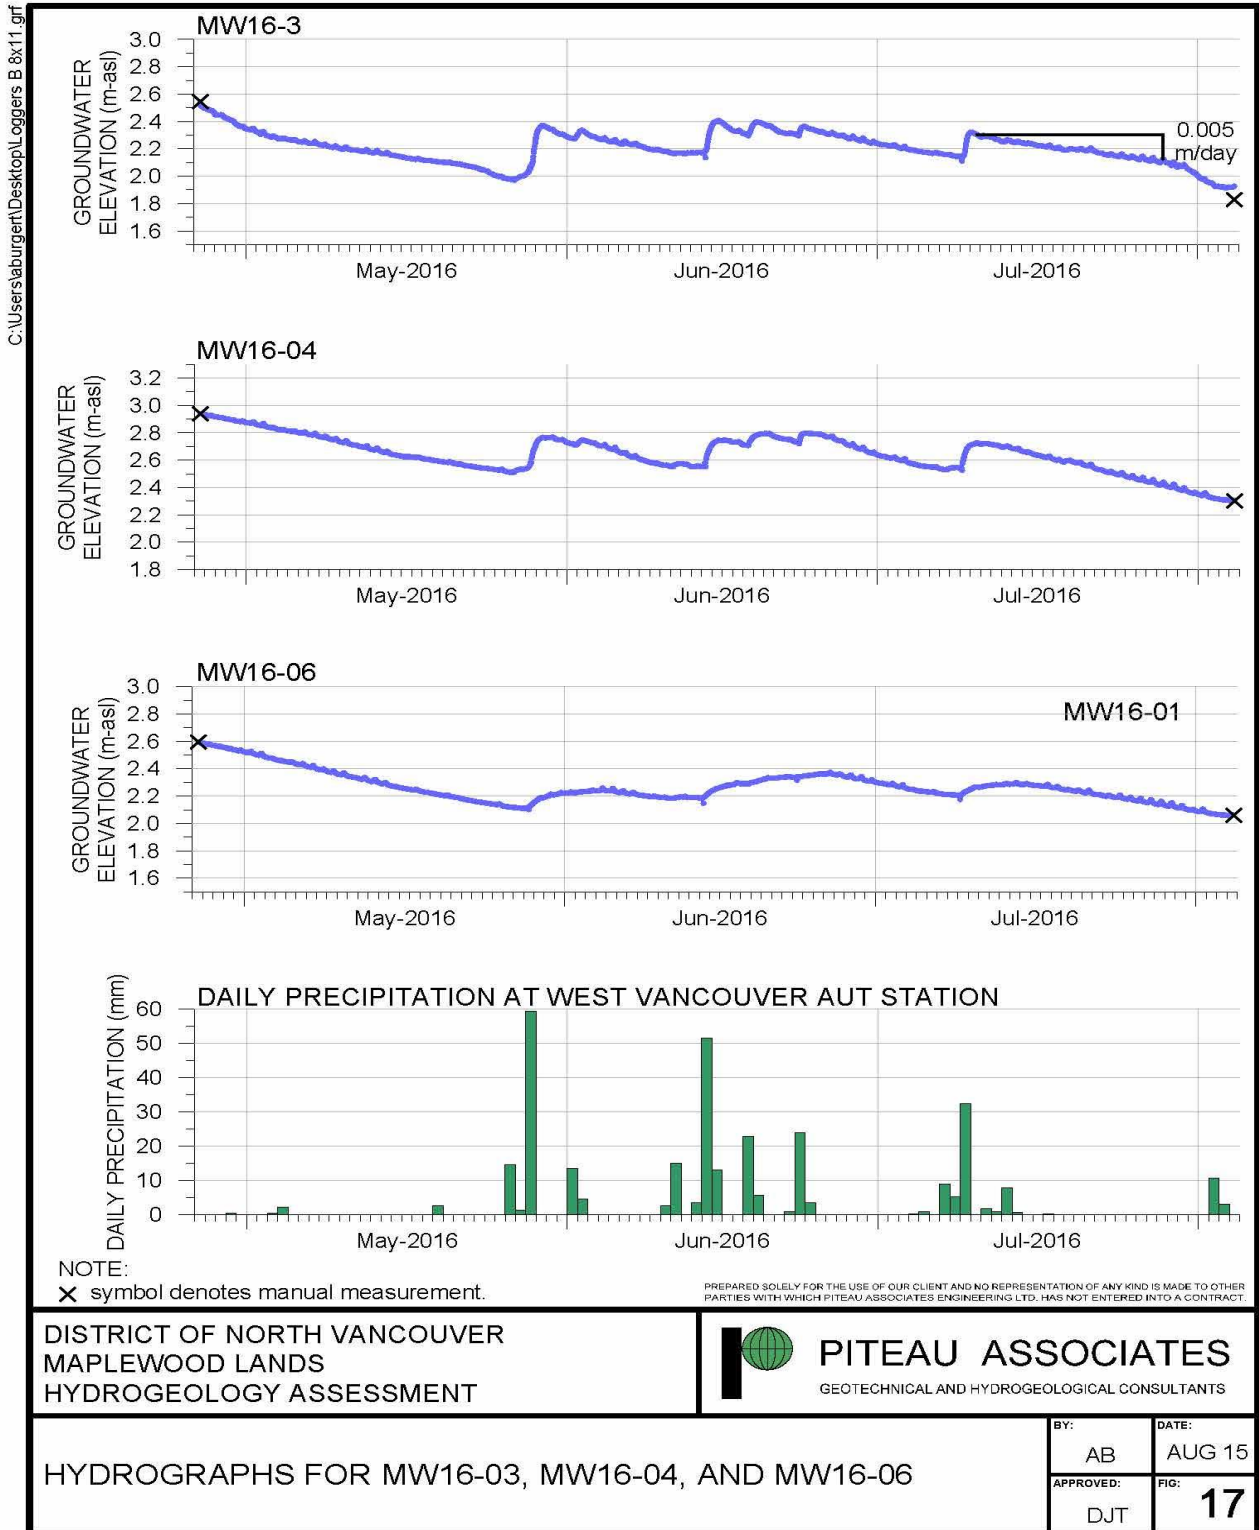
Figure 17. Hydrograph data (water levels) for three monitoring wells located in and around the west side of the Study Area in the Maplewood Village East.

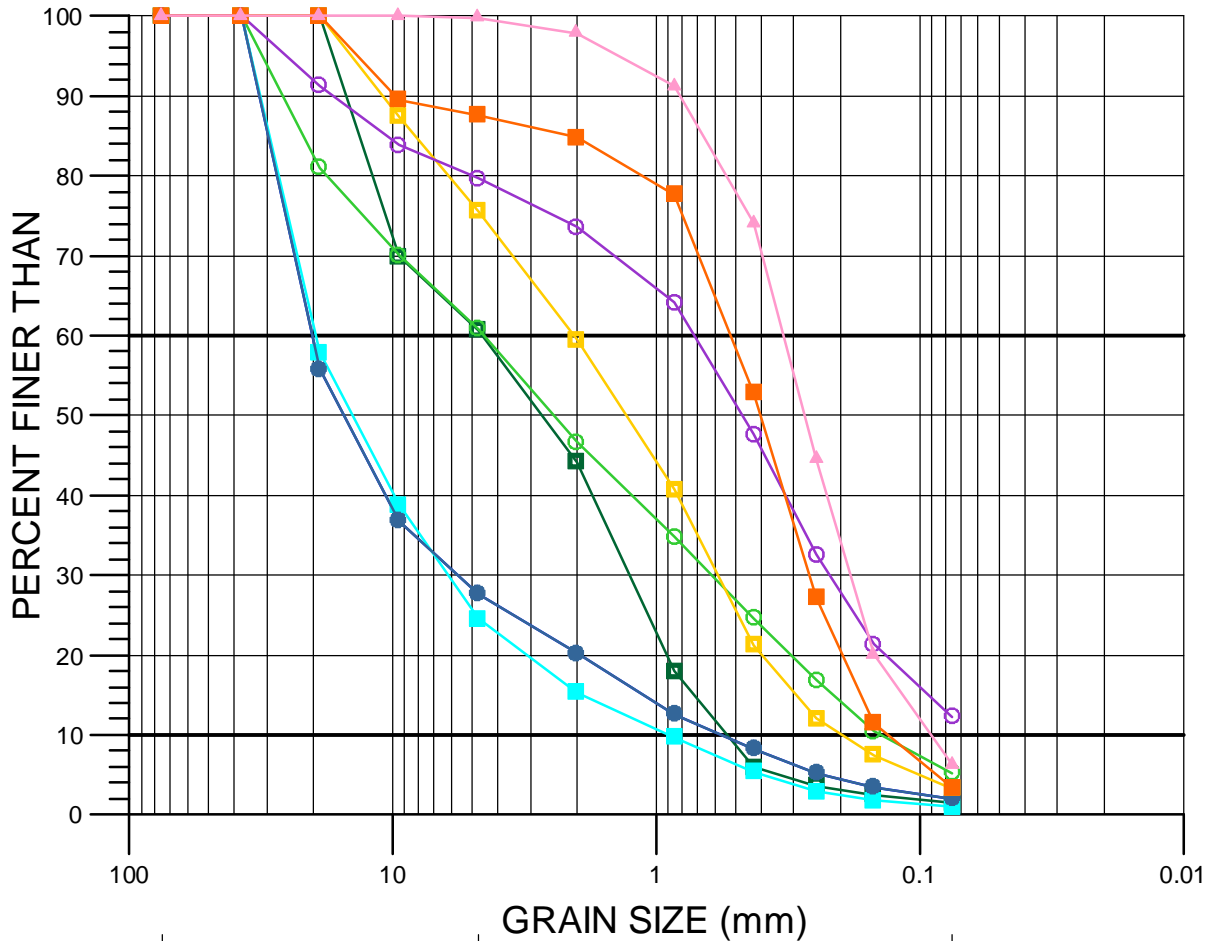
Appendix B: Hydrogeological Study - Grain Size Analysis

USCS	Coarse	Fine	Coarse	Medium	Fine	
COBBLE SIZE	GRAVEL SIZE		SAND SIZE			SILT or CLAY SIZE

- MW16-6 16-18 ft
- MW16-6 8-10 ft
- ▲ MW16-5 15-17 ft
- MW16-5 12-14 ft
- MW16-4 25-27 ft
- MW16-4 20-22 ft
- MW16-2 16-17 ft
- MW16-1 19-20 ft
- ▲ MW16-1 13-15 ft
