NORTH VANCOUVER
DISTRICT

DRAFT DRINKING WATER QUALITY ANNUAL REPORT 2017

May 31, 2018.

District of North Vancouver Utilities Department

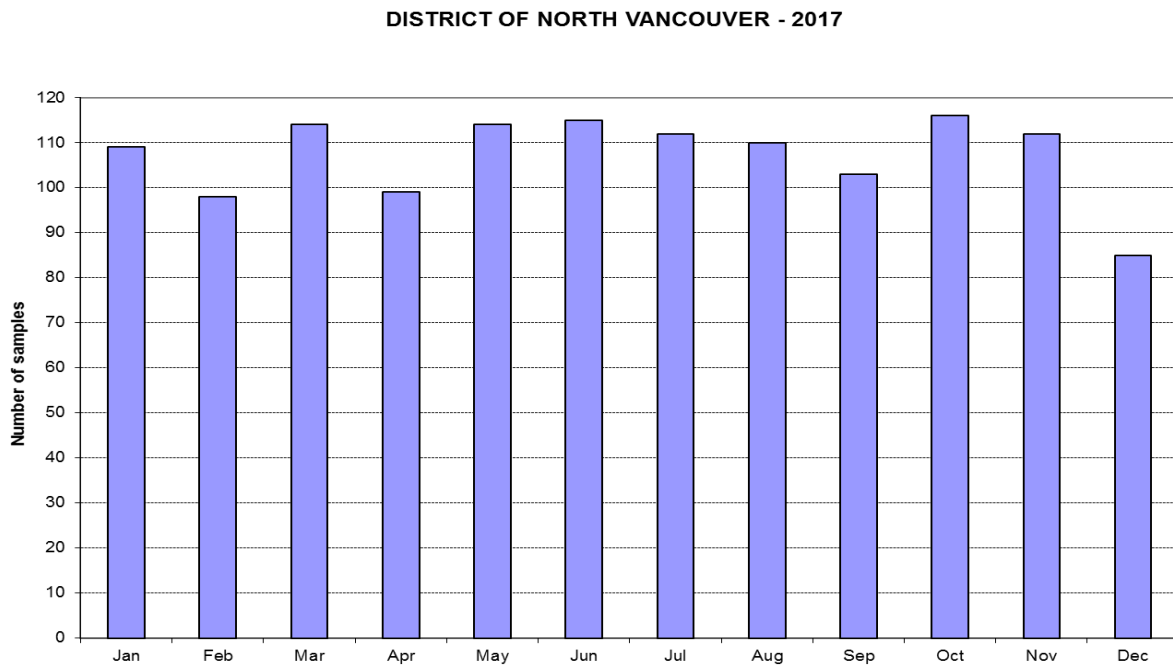
Figure 1. Number of Scheduled Weekly Samples Collected

Figure 1 below shows the number of scheduled weekly sample collected and analysed in 2017 on a monthly basis.

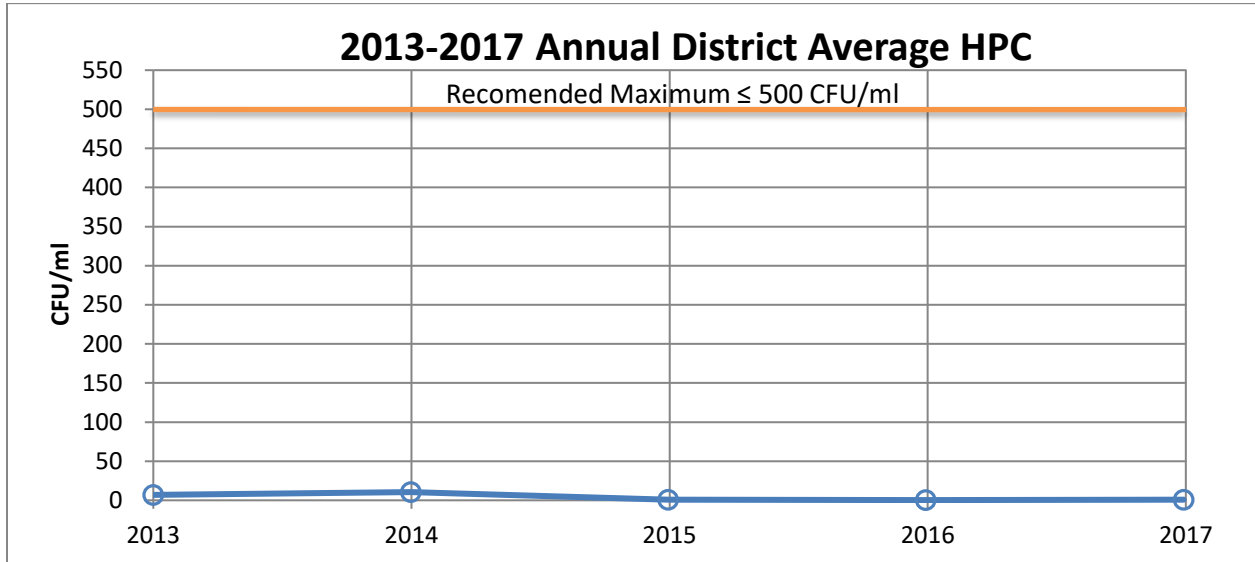
Figure 2. HPC Five Year Annual Averages

All samples collected in 2017 met all guidelines for safe potable water. There were no occurrences of detectable E-coli nor Total Coliform. All samples were below the recommended maximum HPC and turbidity level and are stable over time. The annual DNV average HPC and turbidity for the last five years are presented below.

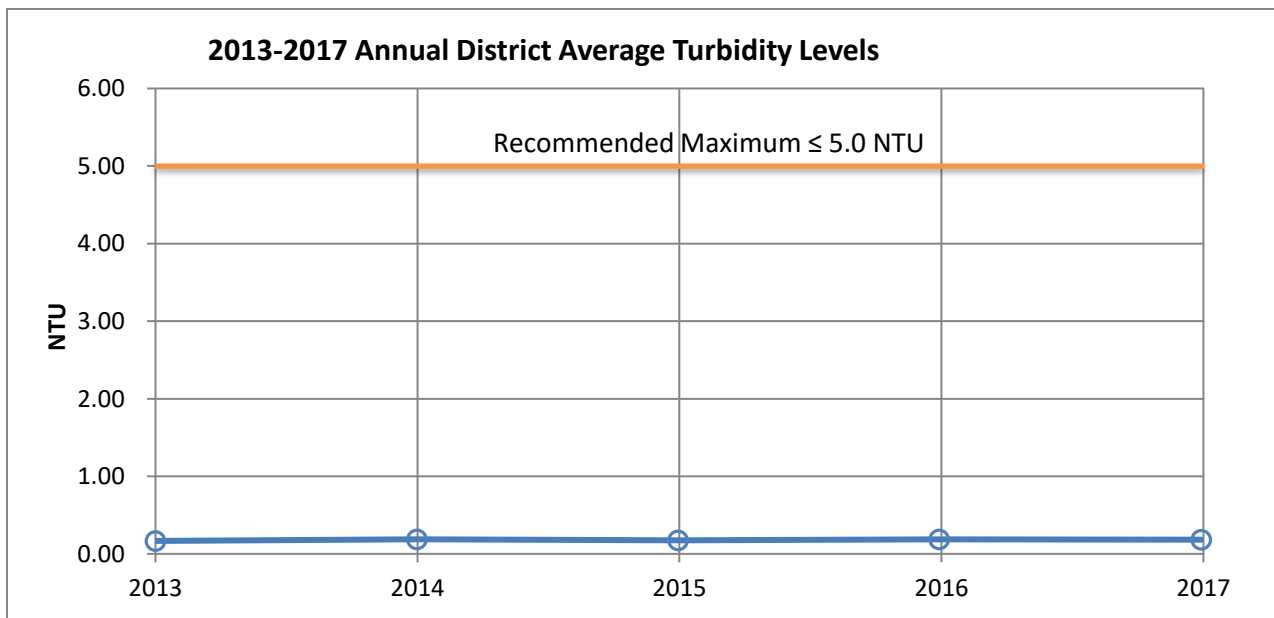
Figure 3. Turbidity Five Year Annual Averages.

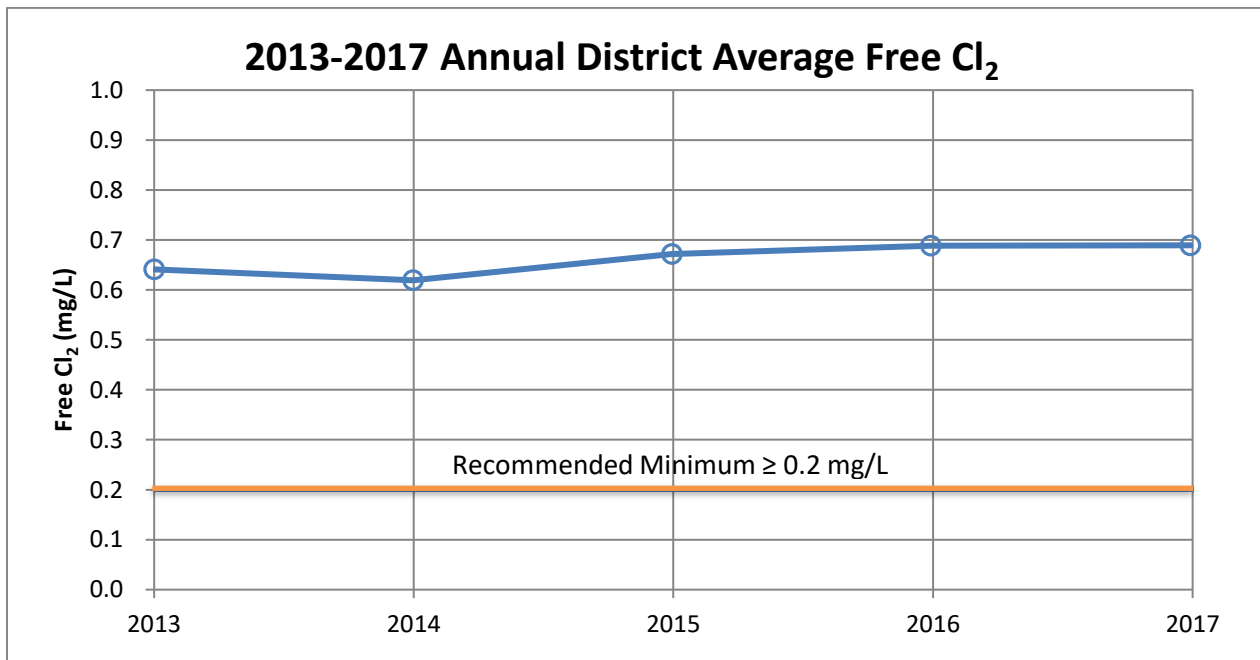
Figure 4. Free Cl₂ Five Year Annual Averages.

- **Chlorine:** Chlorine is used in the disinfection process and a residual amount in the distribution system is desirable to maintain potable water quality. In 2017 all samples were within the OG range for residual chlorine, 0.04-2.0 mg/L and above the OG of 0.2 mg/L. The average system-wide chlorine residual was 0.69 mg/L. The annual DNV average free chlorine for the past 5 years is presented below in figure 4.

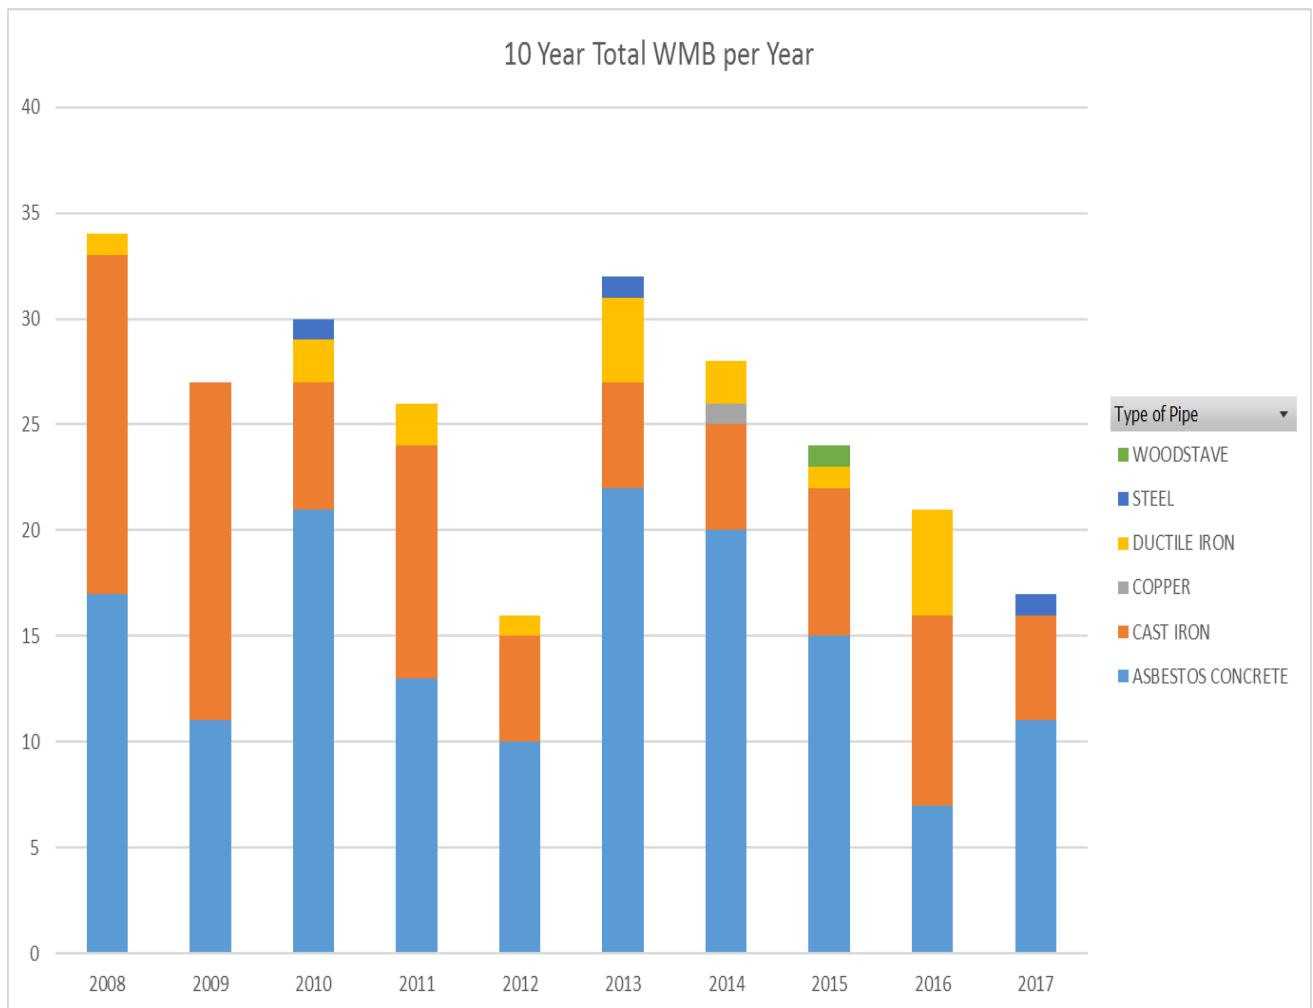
Figure 5. 10-Year Water Main Break Summary

Challenges facing the DNV in 2017 for maintaining good water quality in the distribution system were ensuring that water system maintenance and replacement programs had the greatest possible positive effect on maintaining good water quality, while at the same time achieving target levels for infrastructure repair and replacement. The capital, operating and maintenance budgets along with the staffing and management of related programs continue to be a high priority for the DNV. A 10 year summary of water main break is provided below.

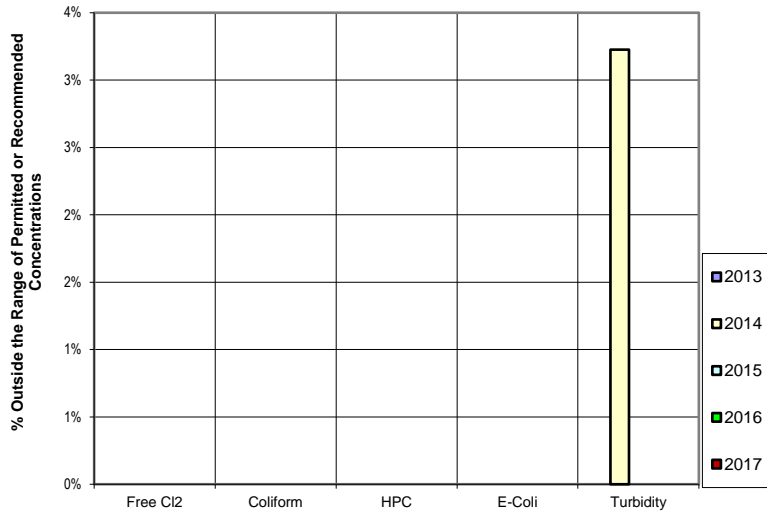
Site 721 - 2838 Panorama Dr
2013 - 2017 Water Quality Results

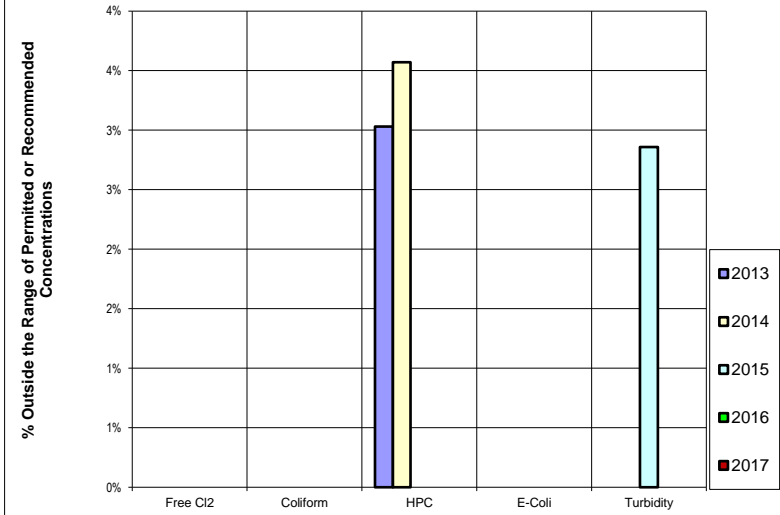
Site 722 - Fairway & Mt Seymour Pkwy
2013 - 2017 Water Quality Results

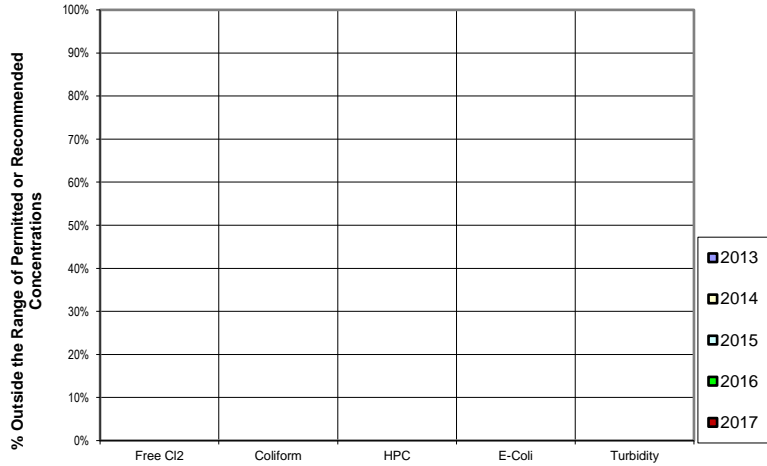
Site 723 - Plymouth Dr & Fairfield Dr
2013 - 2017 Water Quality Results

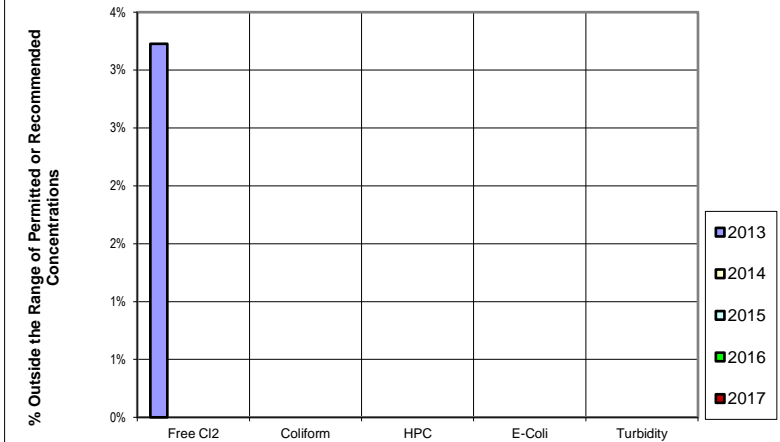
Site 724 - LS #13 Dominion & Mountain Hwy
2013 - 2017 Water Quality Results

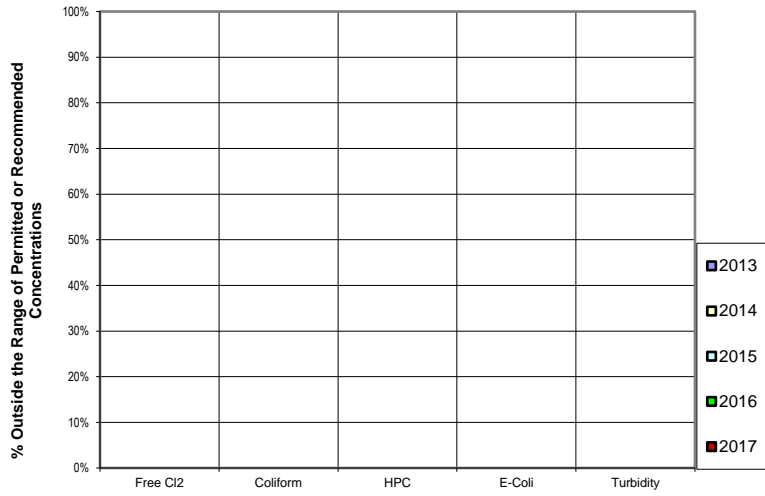
**Site 725 - Marion Pump Station
2013 - 2017 Water Quality Results**

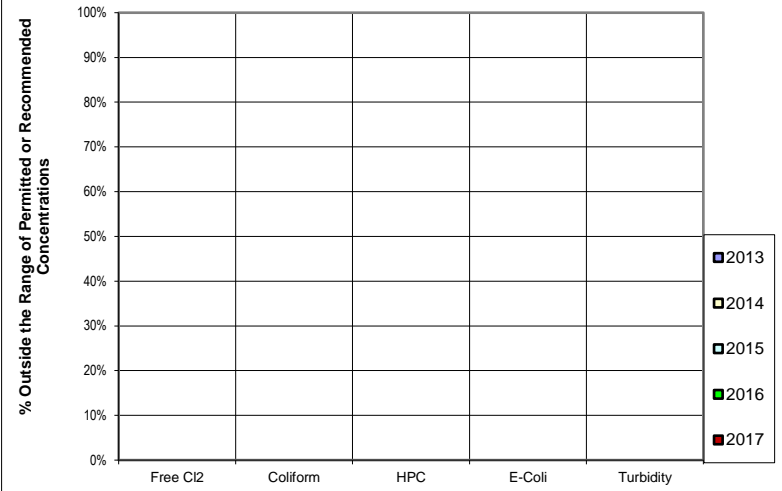
**Site 726 - Hyannis Reservoir
2013 - 2017 Water Quality Results**

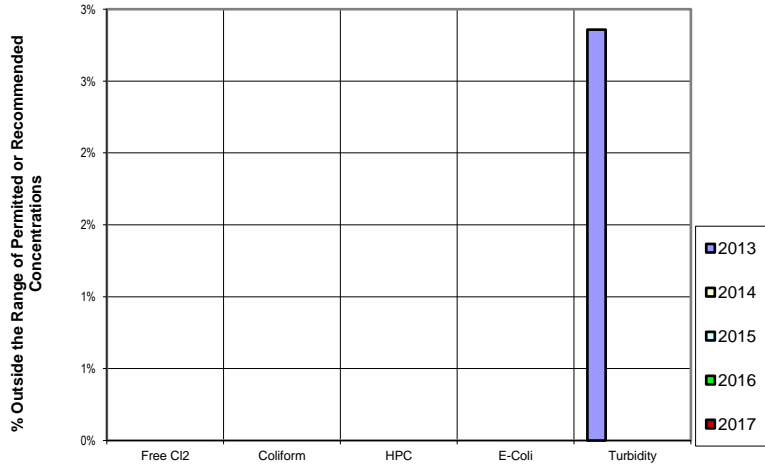
**Site 727 - Hoskins Rd & Kilmarnock Cres
2013 - 2017 Water Quality Results**

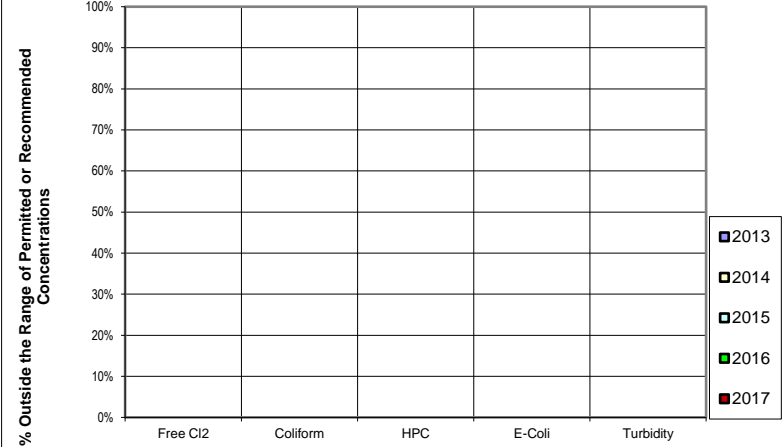
**Site 728 - Lilloet Road
2013 - 2017 Water Quality Results**

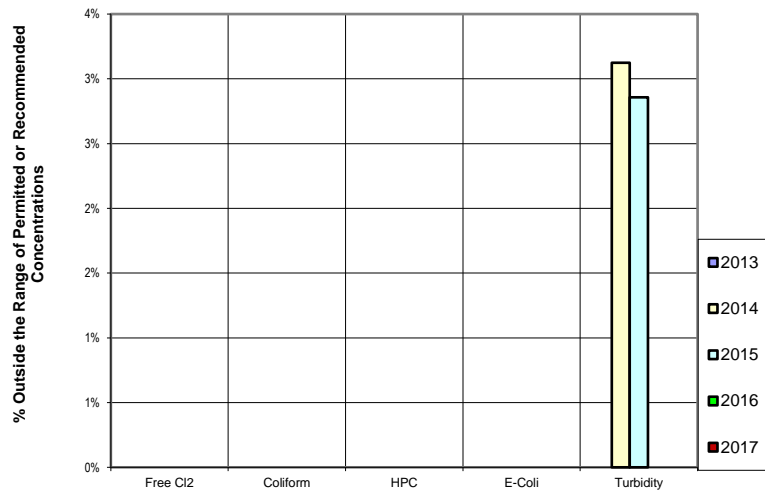
**Site 729 - Ramsay Pump Station
2013 - 2017 Water Quality Results**

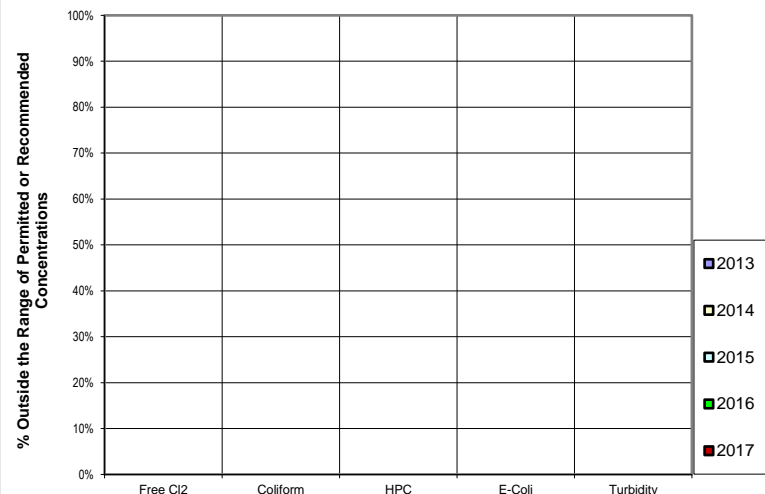
**Site 730 - Braemar Reservoir
2013 - 2017 Water Quality Results**

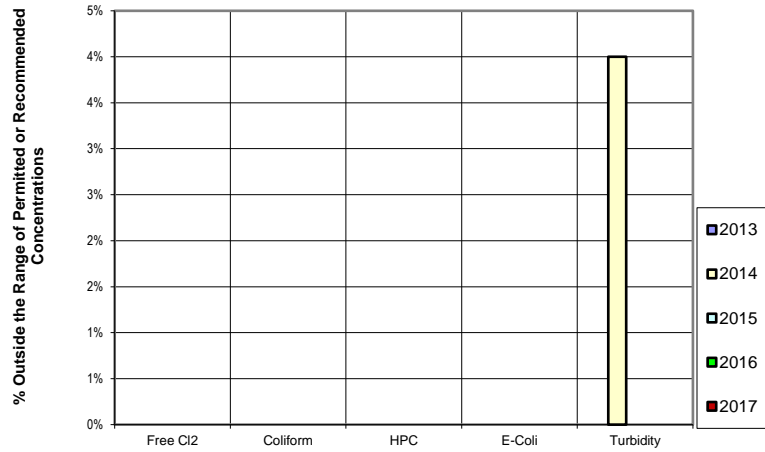
**Site 731 - Skyline Pump Station
2013 - 2017 Water Quality Results**

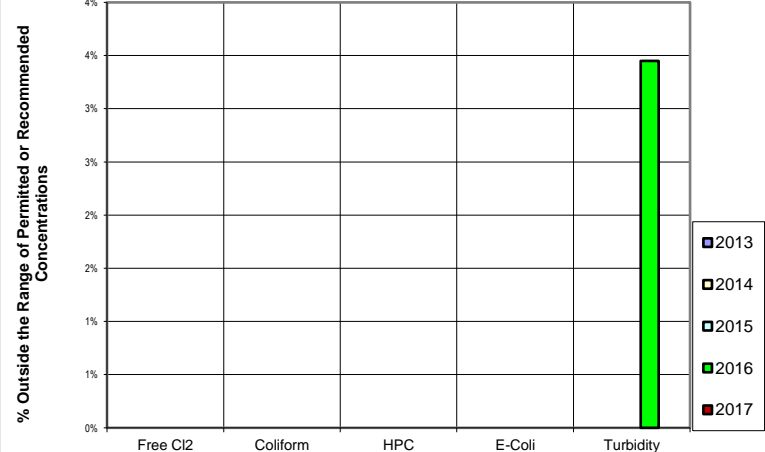
**Site 732 - Sarita Pump Station
2013 - 2017 Water Quality Results**

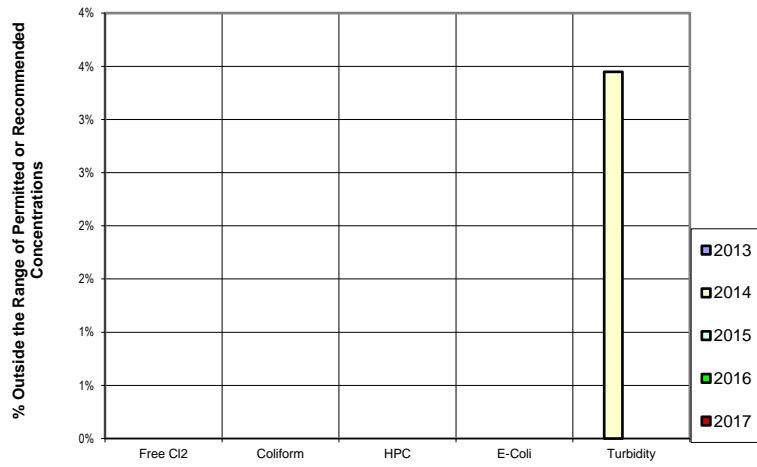
**Site 733 - McKeen Ave & Phillip Ave
2013 - 2017 Water Quality Results**

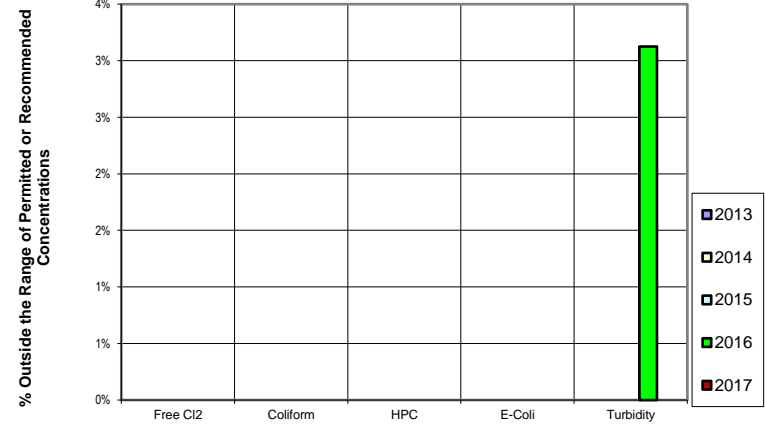
**Site 734 - Pemberton Heights
2013 - 2017 Water Quality Results**

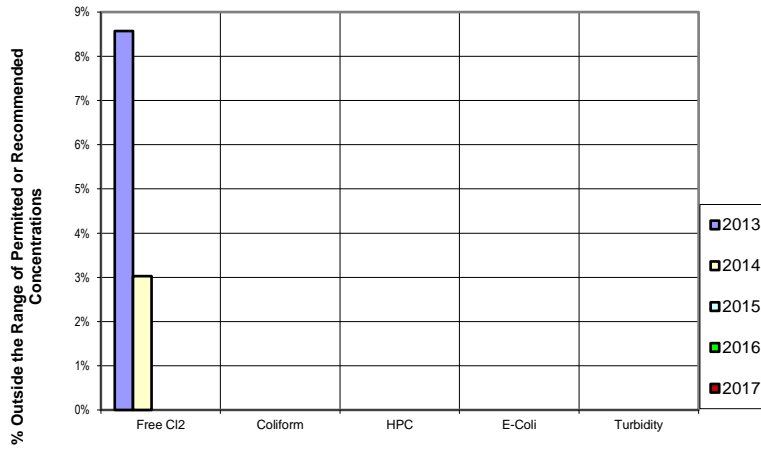
**Site 735 - Prospect Reservoir
2013 - 2017 Water Quality Results**

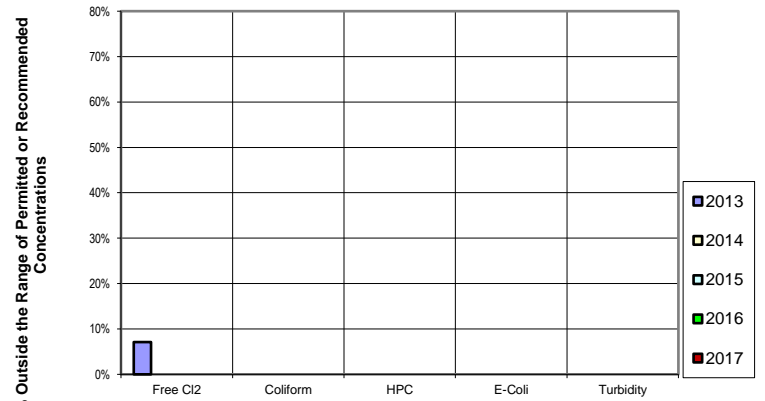
**Site 736 - W Queens Rd & Lonsdale Ave
2013 - 2017 Water Quality Results**

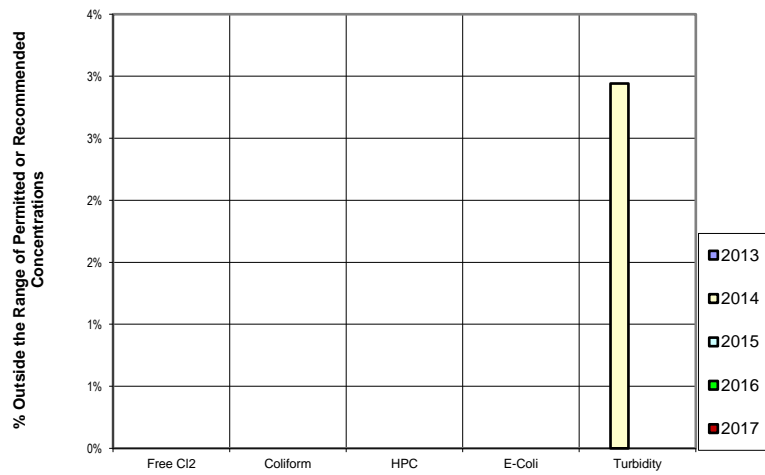
**Site 737 - N. of BC Rail Tracks on Lower Cap. Rd
2013 - 2017 Water Quality Results**

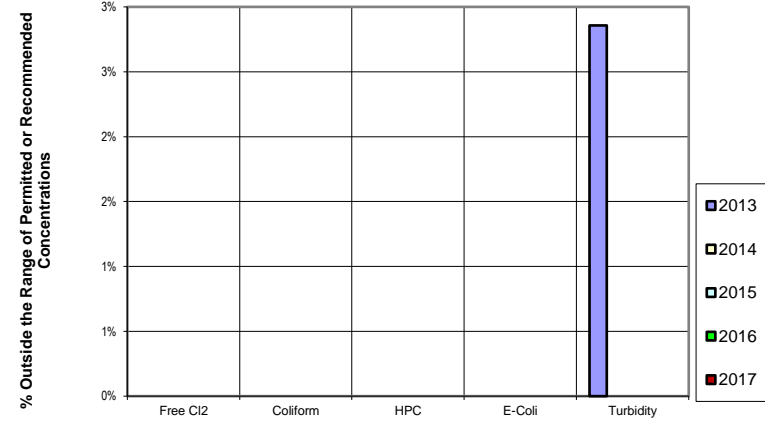
**Site 738 - 3906 Sunnycrest Dr
2013 - 2017 Water Quality Results**

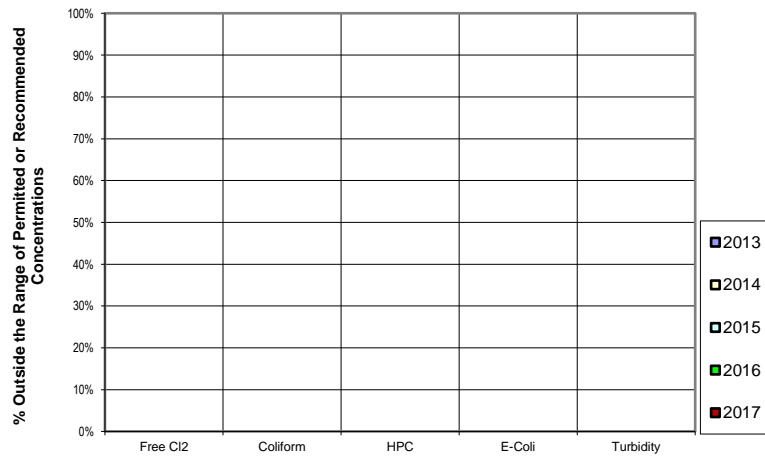
**Site 739 - 376 Cartelier Rd.
2013 - 2017 Water Quality Results**

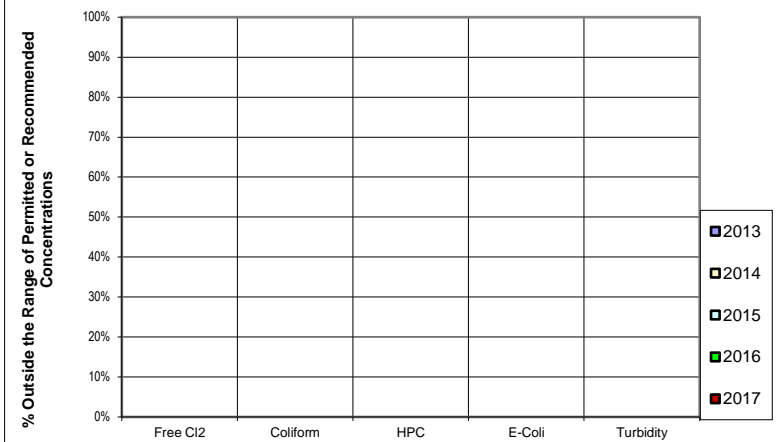
**Site 740 - PRV #5 (190 E. Braemar Rd.)
2013 - 2017 Water Quality Results**

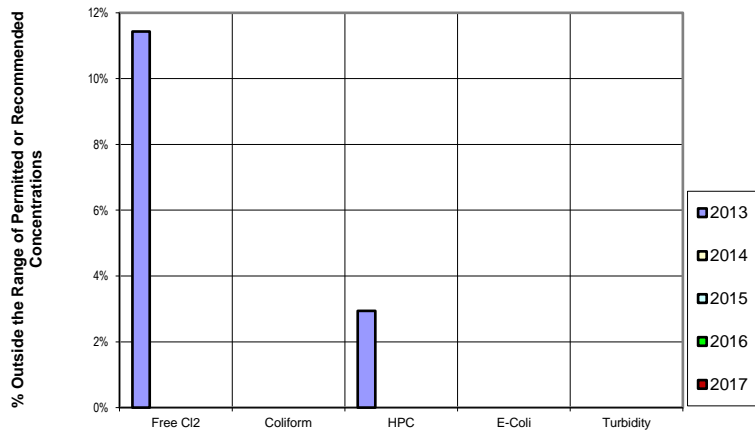
Site 741 - Mountain Hwy Reservoir, North of Mountain Hwy
2013 - 2017 Water Quality Results

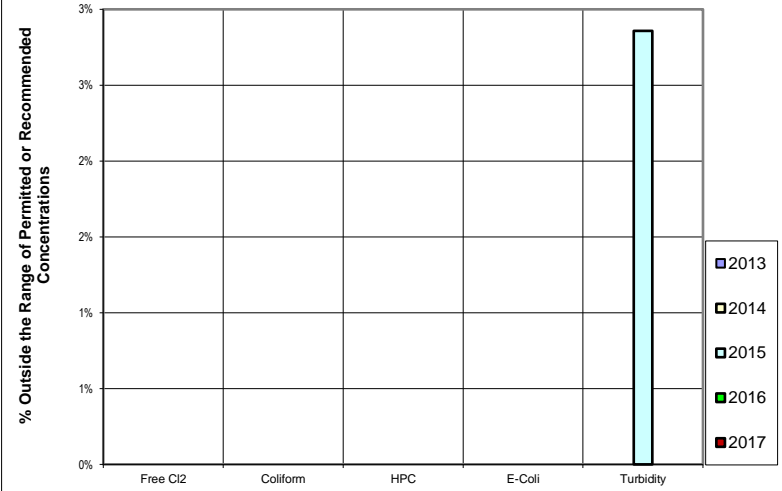
Site 742 - PRV # 11 (Across from 1086 Cloverly St.)
2013 - 2017 Water Quality Results

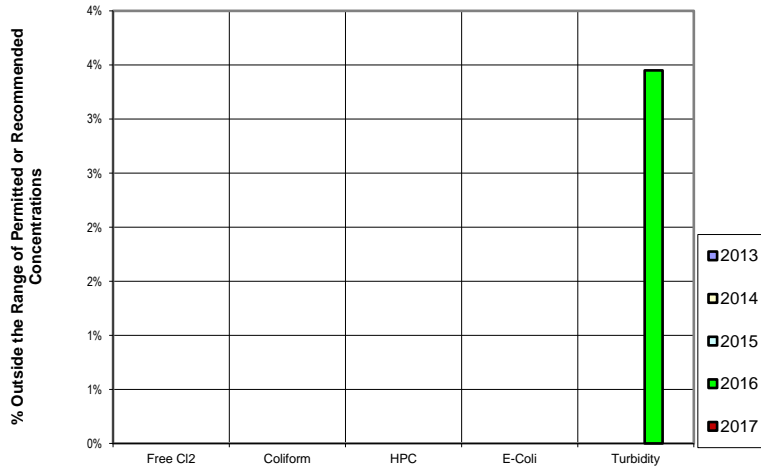
Site 743 - PRV #7 (N across from 481 Mountain Highway)
2013 - 2017 Water Quality Results

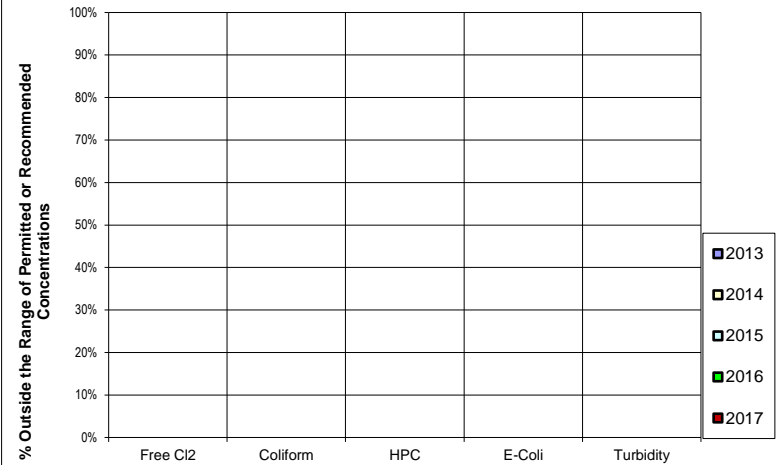
Site 745 - PRV # 13 (N. of 1388 Monashee Dr, Cap College)
2013 - 2017 Water Quality Results

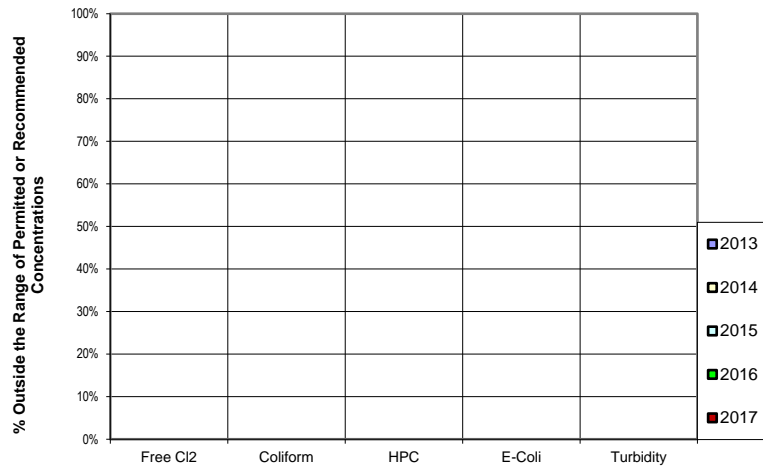
**Site 746 - PRV #17 (60 Riverside Dr.)
2013 - 2017 Water Quality Results**

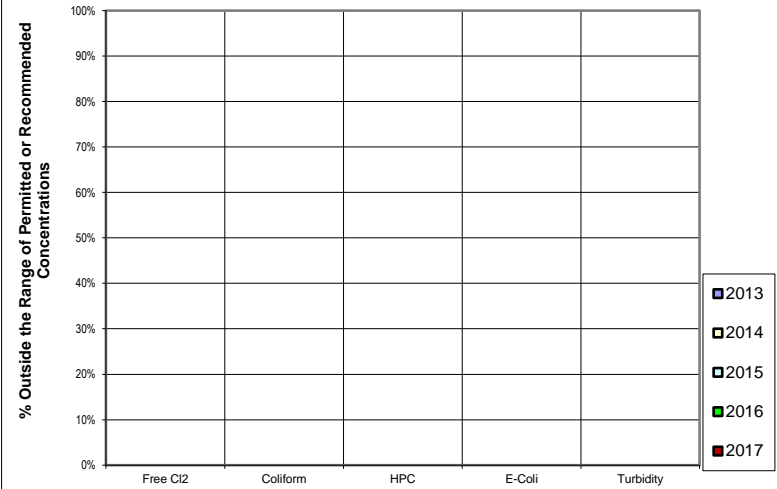
**Site 747 - PRV # 19 (1231 Lennox St.)
2013 - 2017 Water Quality Results**

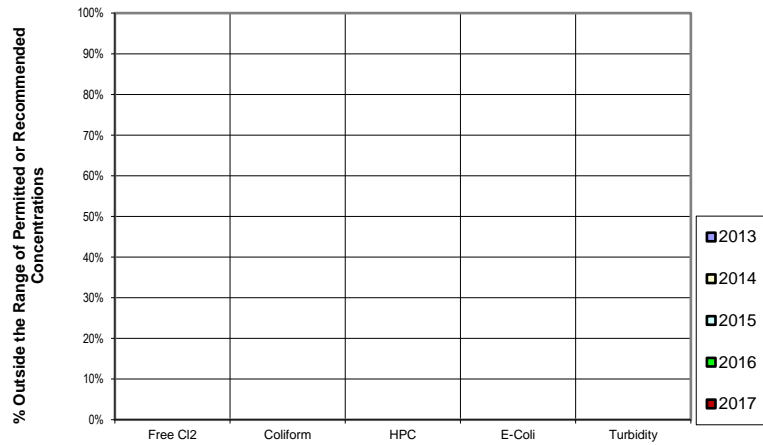
**Site 748 - PRV # 16 (2592 Bendale Rd)
2013 - 2017 Water Quality Results**

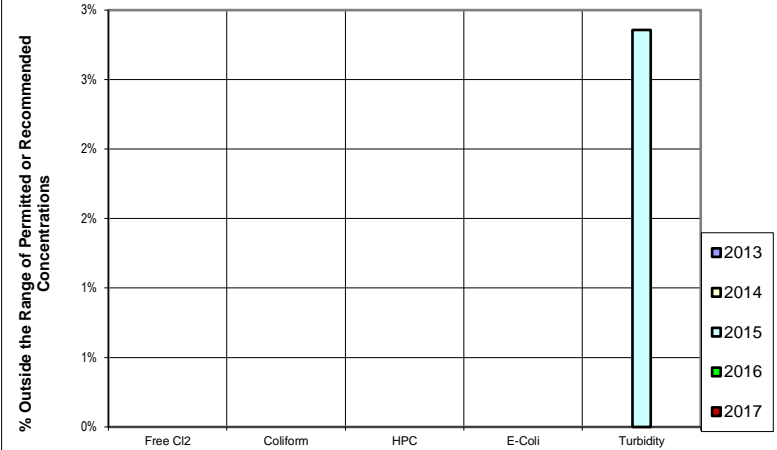
**Site 749 - PRV # 18 (3728 Mt. Seymour Parkway)
2013 - 2017 Water Quality Results**

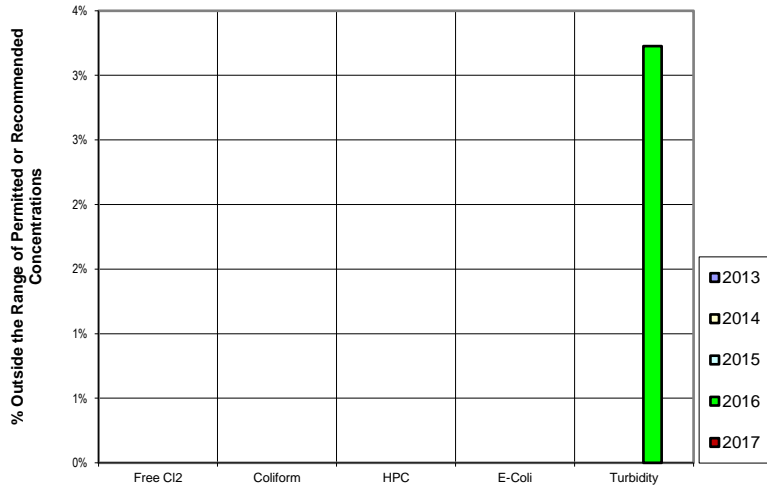
Site 750 - up path behind 1610 Mt. Seymour Rd
2013 - 2017 Water Quality Results

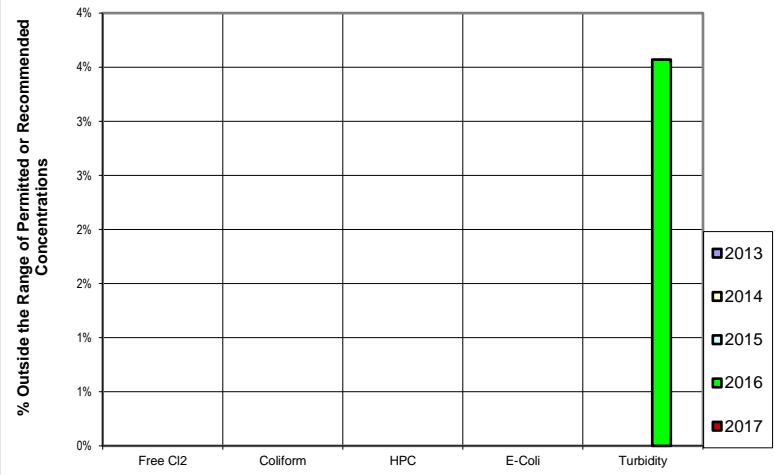
Site 751 - Access Rd, N. end of Cascade Ct.
2013 - 2017 Water Quality Results

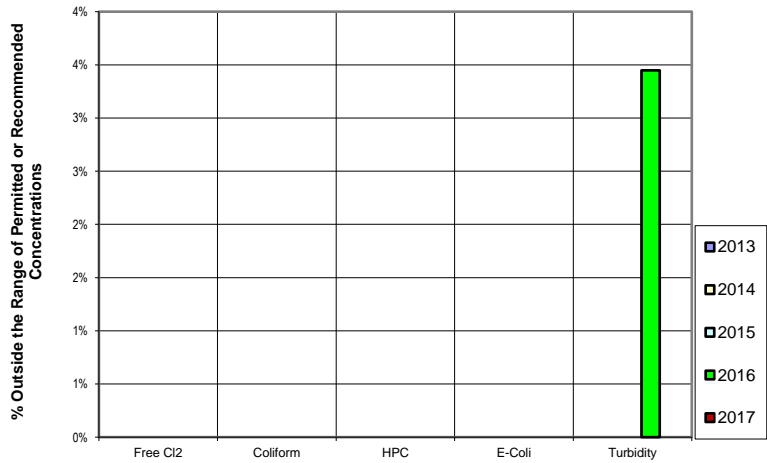
Site 752 - PRV # 25 (4068 Deane Pl.)
2013 - 2017 Water Quality Results

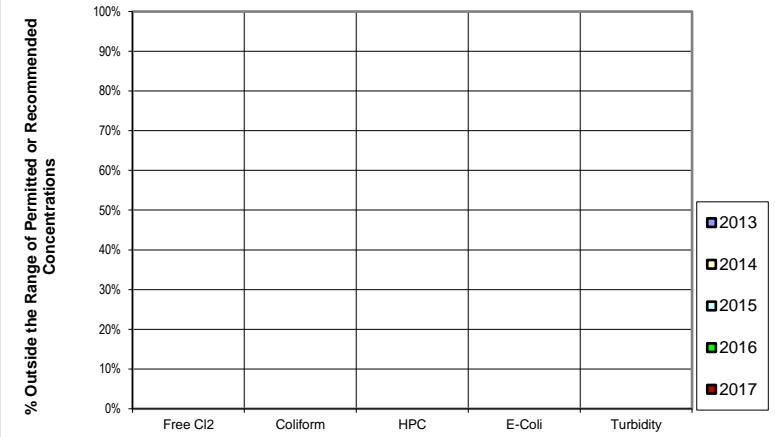
Site 753 - PRV # 20 (1501 Theta Ct.)
2013 - 2017 Water Quality Results

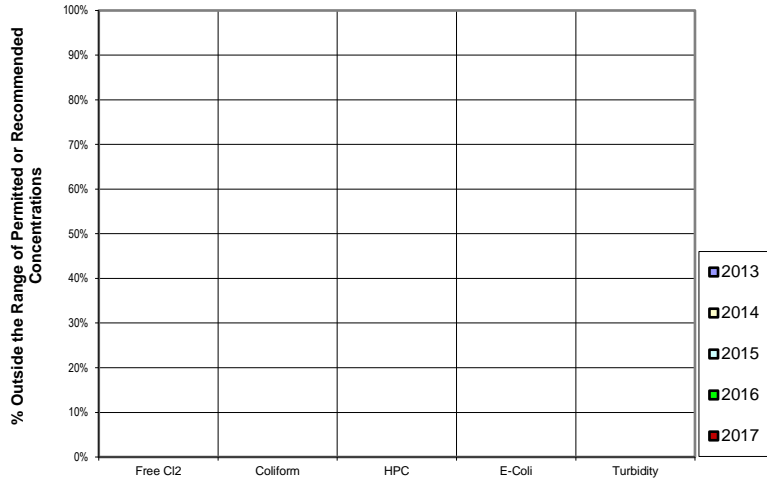
**Site 754 - Woodlands Res, 2.1 km N. of Hixon Rd on Indian River Dr
2013 - 2017 Water Quality Results**

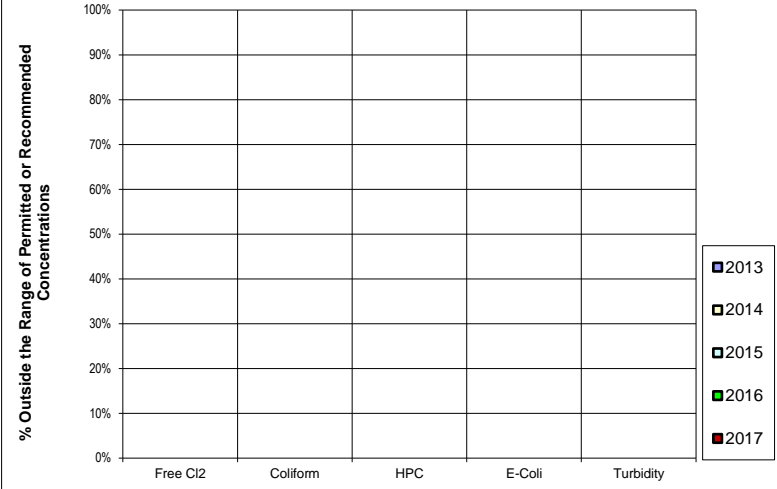
**Site 755 - PRV # 26 3.7 km NE of Hixon Rd. on Indian River Dr.
2013 - 2017 Water Quality Results**

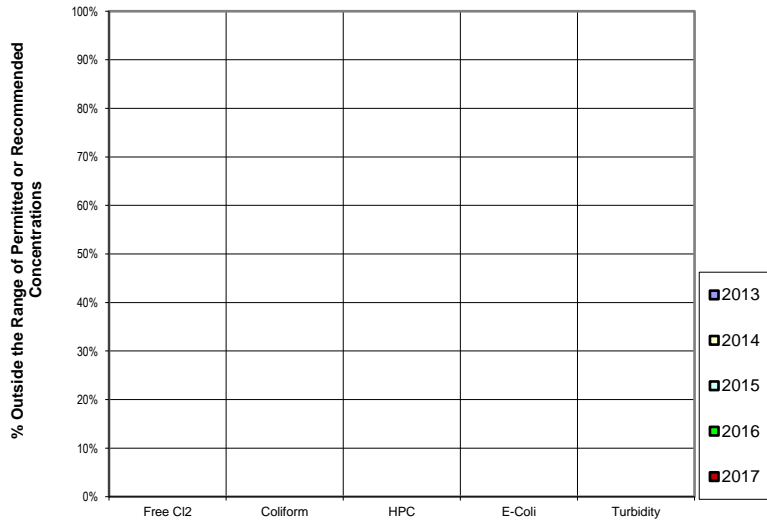
**Site 756 - End of Fire Lane # 7, Firelane #7 is 3.6 km from Hixon Rd.
2013 - 2017 Water Quality Results**

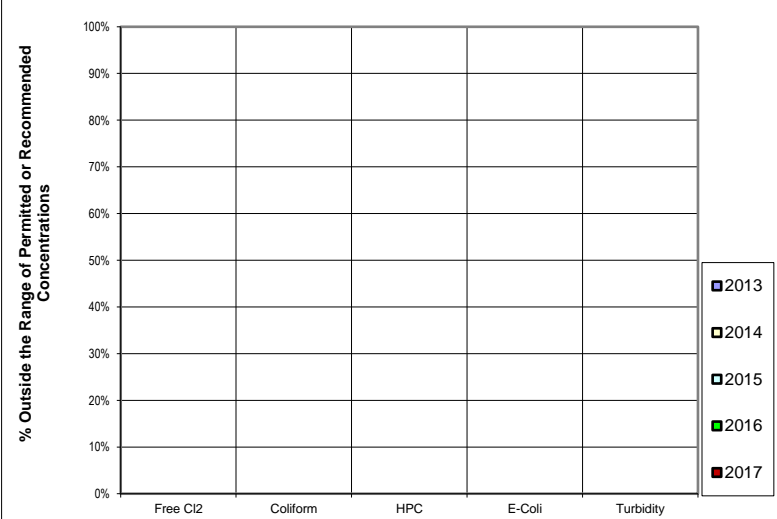
**Site 757 - PRV 200 m south of 879 Roche Point Dr
2013 - 2017 Water Quality Results**

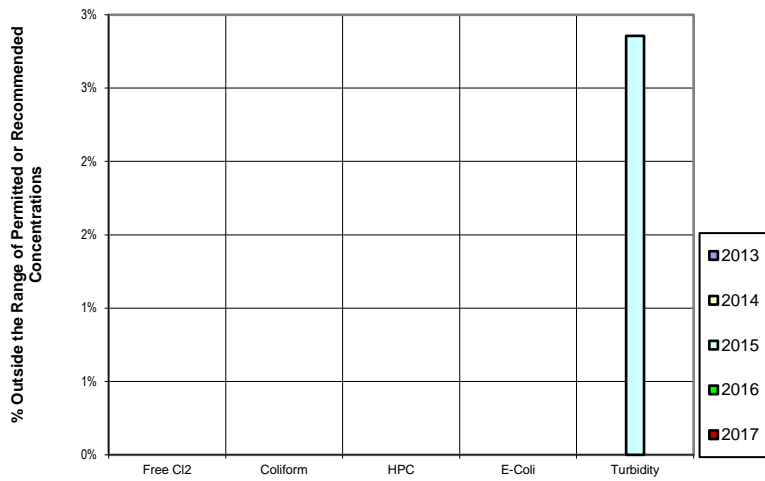
**Site 758 - 3860 Dollarton Hwy
2013 - 2017 Water Quality Results**

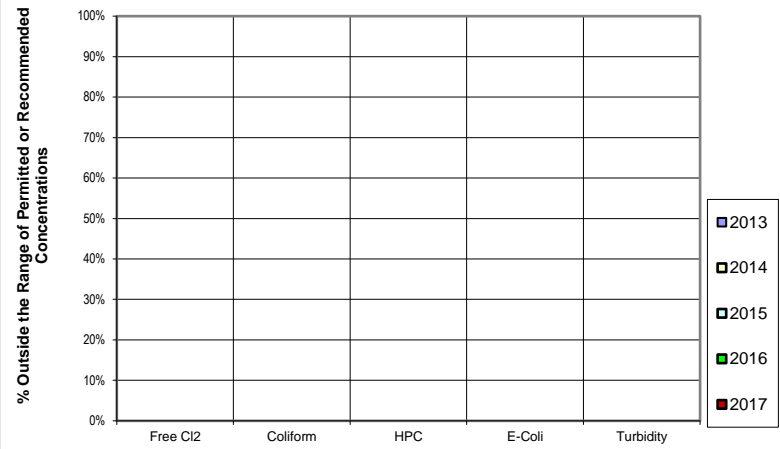
**Site 759 - 1919 Hyannis Drive
2013 - 2017 Water Quality Results**

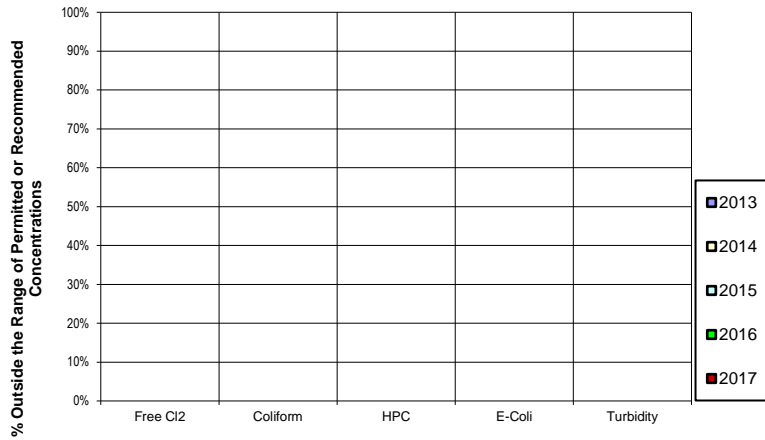
**Site 760 - 3000 Block Dollarton Hwy (Burrard Reserve)
2013 - 2017 Water Quality Results**
