DISTRICT OF NORTH VANCOUVER ROAD SAFETY PLAN

FINAL REPORT

Opus International Consultants (Canada) Limited

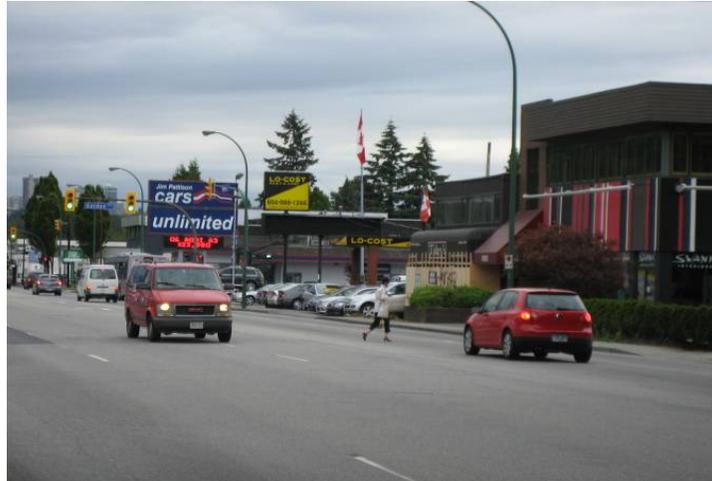
FIGURE 4.1 PEDESTRIAN JAYWALKING ACROSS MARINE DRIVE

- Some pedestrian jaywalking midblock was also observed, as shown in FIGURE 4.1. These occurred along the corridor near commercial accesses and transit stops to avoid delays at the traffic signals. Although pedestrians may feel that the platooning of vehicles by frequent traffic signals creates adequate gaps, they may be unaware that driver workload and distraction along Marine Drive may increase their risk of being involved in a collision.

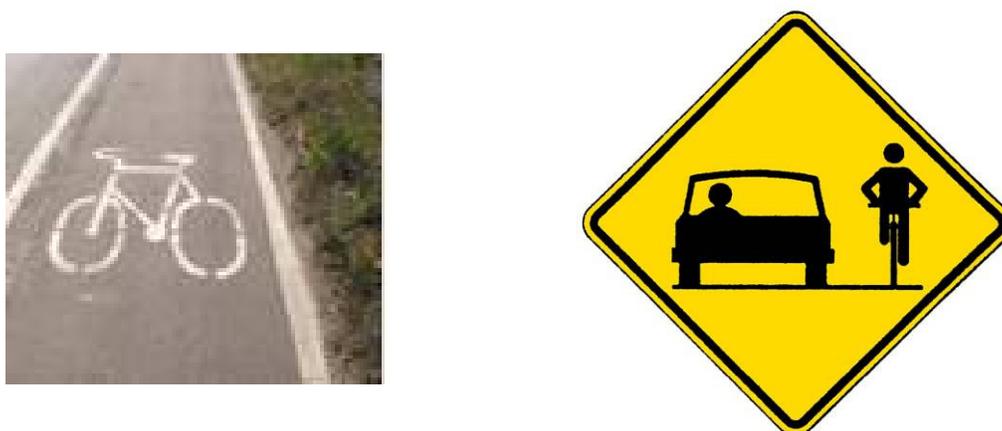
FIGURE 5.2 SIGNAGE AND PAVEMENT MARKINGS FOR BICYCLE FACILITIES

Signs and pavement markings can provide crucial guidance and information to all road users. Based on the responses received from stakeholders, it is felt that additional signage and pavement markings on designated bicycle routes would improve the safety for cyclists. As such, it is recommended that the District ensure that designated bicycle routes are marked with the appropriate pavement markings. As well, signs similar to common “Share the Road” signs could be provided along all designated bicycle routes. The appropriate lane markings and signage are shown in FIGURE 5.2.

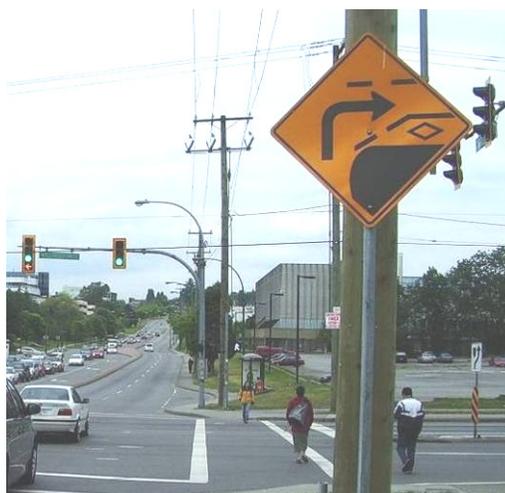
FIGURE 5.3 RESTRICTED LANE USE WARNING SIGN FOR RIGHT TURN

Potential conflicts between right-turning vehicles and transit vehicles exiting a bus stop can be reduced by providing signage warning right-turning drivers of buses after the turn. In the future, as a long-term improvement, the District can also consider providing bus bulges or exclusive bus lanes. With the provision of a bus lane, warning signs such as that shown in FIGURE 5.3 should be provided for the minor street right-turn movement.

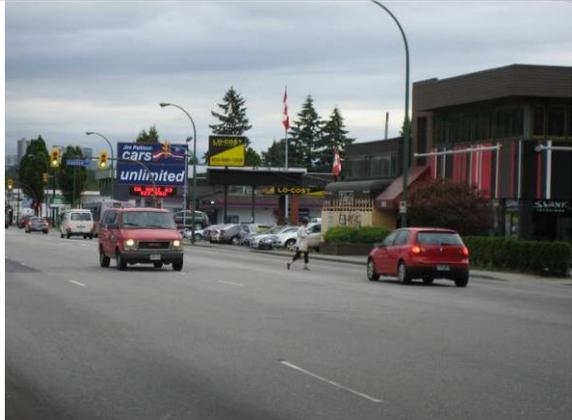
<ul style="list-style-type: none">▪ Crosswalks at intersection were as narrow as 2.1 metres wide, which is less than the 2.5 metres suggested by TAC.▪ Crosswalks were generally faded at intersections.▪ Sidewalks were as narrow 1.4 metres wide, which is considered narrow for urban commercial areas.▪ Letdowns were sometimes located where a pedestrian using them would require them to enter the roadway off the crosswalk.▪ All of the above makes pedestrians less conspicuous and decreases pedestrian comfort.▪ Pedestrian jaywalking was observed.

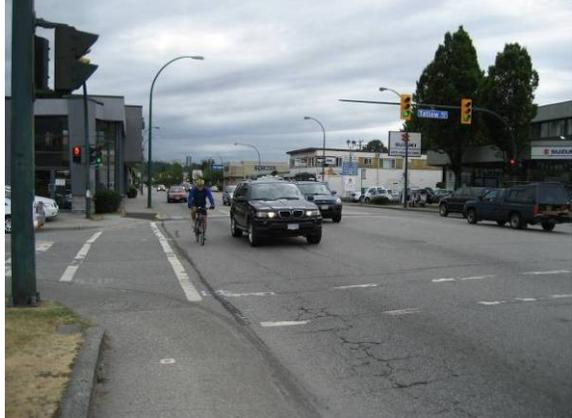
<ul style="list-style-type: none">▪ A high number of cyclists were observed along Marine Drive. With travel lanes of about 3.5 metres, motorists typically try to pass the cyclists without changing lanes. However, the lane width is too narrow for shared lane use.

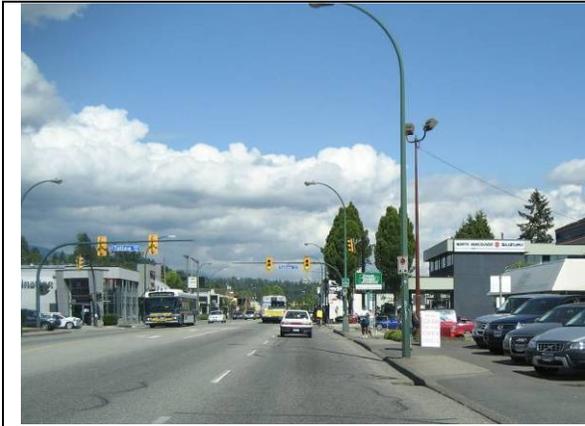
- There are numerous driveways along Marine Drive and close to the intersection. The driveways, in conjunction with heavy turning movement volumes can result in unexpected manoeuvres.

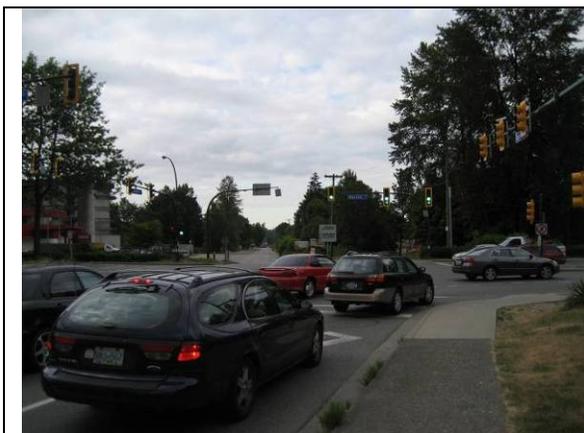
- Southbound right-turn lanes appear to be too narrow, with passenger vehicles observed to encroach into the adjacent lanes. The issue is worse when larger heavy vehicles make the turn, and is exacerbated with the relatively heavy right-turn volumes. Further review of the lane layout indicates that vehicles larger than a passenger vehicle would need to encroach into the adjacent lane to complete the turn.

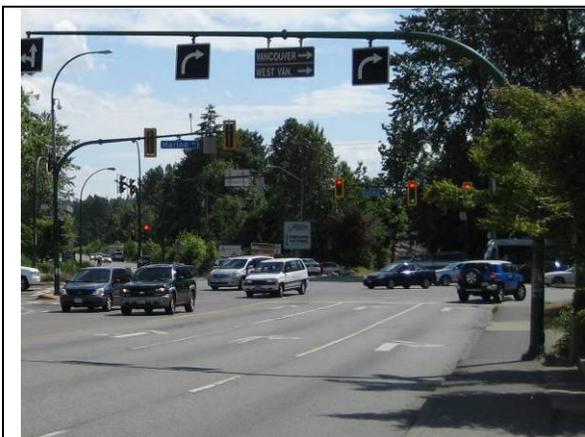
- Eastbound left-turn lanes appear to be tight, with passenger vehicles observed to encroach into the adjacent lanes. Vehicles were also observed to follow each other closely. When a vehicle slows unexpectedly (such as when entering the gas station on the northeast quadrant), heavy braking and rear-end conflicts were observed. The issue is exacerbated with the relatively heavy left-turn volumes.

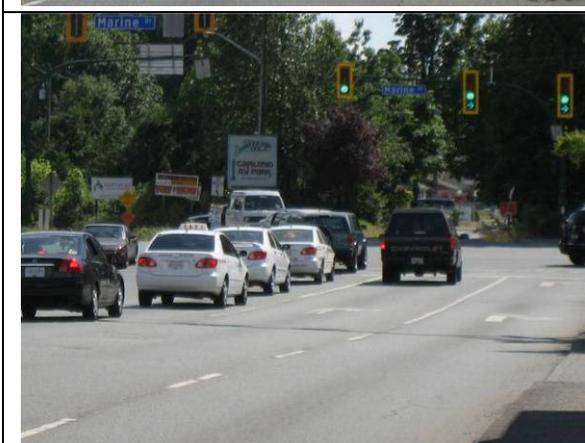
- The southbound left-turn and through lane can encounter long delays due to lack of a designated left-turning lane, heavy northbound through volumes, and lack of a southbound protected left-turn phase. Southbound through vehicles were observed to use the right-turn lane to circumvent the queues. The delays may result in impatient motorists and risk-taking manoeuvres.
- The skew of the north/south legs decrease visibility of opposing through vehicles for northbound left-turning vehicles when southbound through vehicles use the right-turn lane. This may result in southbound sideswiping and left-turn opposing conflicts.

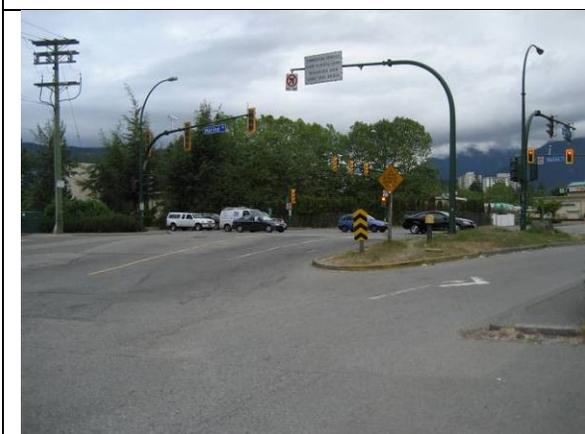
- The northbound approach is wide without pavement markings to guide motorists to where they should manoeuvre their vehicles. This is worsened with angle parking on the southwest quadrant. The lack of guidance can result in sideswipe conflicts.
- The lack of positive guidance may also confuse southbound left-turning motorists as to whether a northbound vehicle is turning left or driving through, and may result in left-turn opposing conflicts.

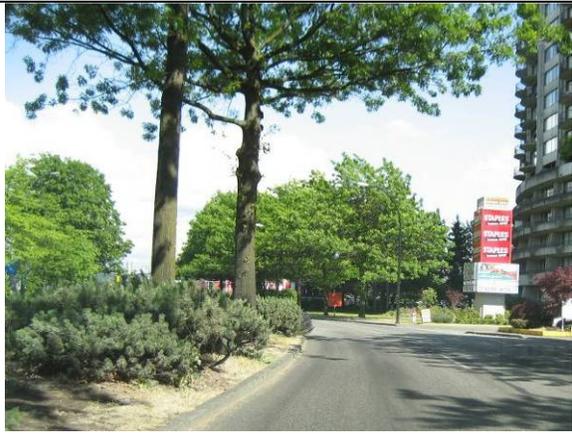
<ul style="list-style-type: none">▪ The heavy landscaping shrubbery on the east leg, in combination with the horizontal curve, may reduce sight distances to queued vehicles or jaywalking pedestrians. This may result in rear-end and pedestrian collisions.

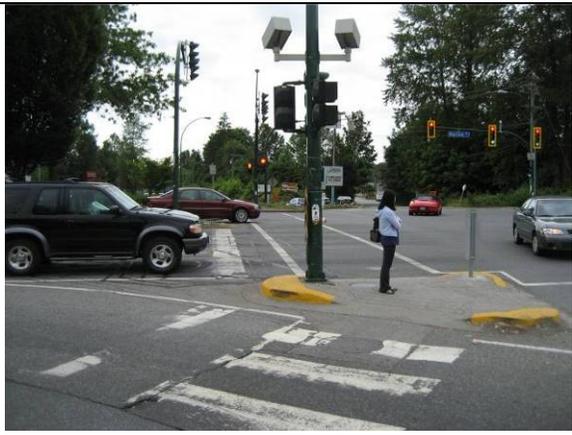
<ul style="list-style-type: none">▪ Crosswalks at intersection were about 2.1 to 2.5 metres wide, which is less than the 2.5 metres suggested by TAC. Crosswalks were generally faded at the intersection.▪ Some sidewalks were about 1.5 metres wide, which is considered narrow for urban commercial areas. TAC suggests a width of 2.0 – 3.5 metres for urban commercial areas.▪ The eastbound right-turn channelized lane with YIELD control typically results in drivers looking for gaps in the northbound through or eastbound left-turn traffic to the left while needing to be wary of stopped vehicles on the right-turn lane in front. The divergent directions of attention results in rear-end conflicts on the right-turn lane.

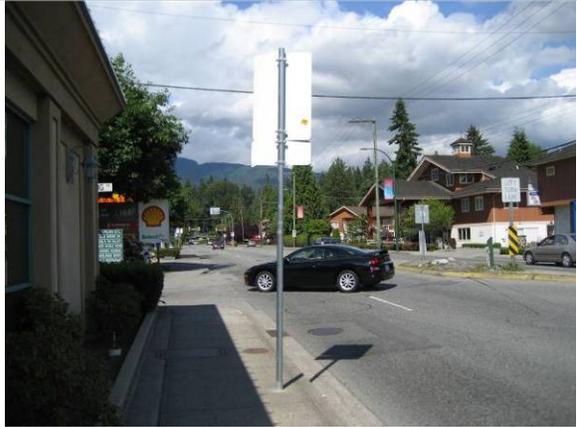
<ul style="list-style-type: none">▪ Sidewalks were about 1.5 metres wide, which is considered narrow for urban commercial areas. Shrubbery was encroaching onto sidewalks, further narrowing the available walking space.▪ Pedestrians were observed to jaywalk across Capilano Road.▪ Some pedestrian-related signal hardware was out-of-date at the Fullerton Avenue intersection.

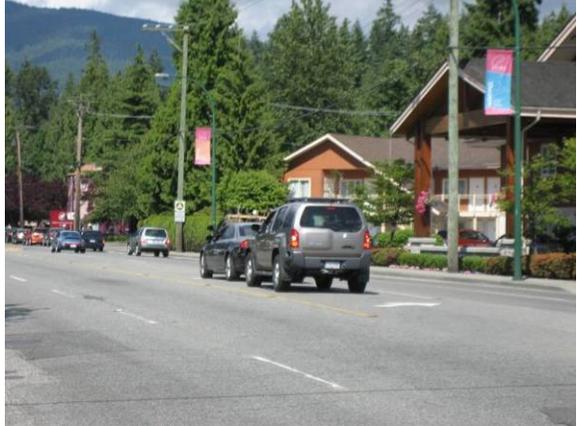
<ul style="list-style-type: none">▪ The northbound left-turn lane at the Curling Road intersection is short and located close to the Marine Drive intersection. When queuing spills onto the through lane, heavy braking was observed especially with the eastbound left-turn movements from Marine Drive.

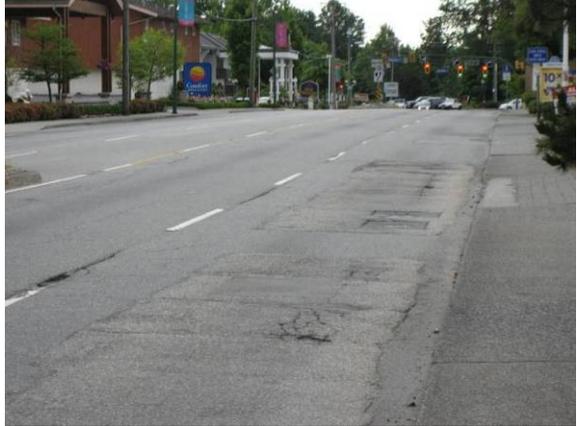
<ul style="list-style-type: none">▪ Capilano Road lanes are generally narrow, with widths measured to be as narrow as 3.2 metres. When combined with high volumes and heavy vehicles, there is potential for sideswipe conflicts.▪ The condition of the pavement was generally poor, and pavement markings were generally faded.

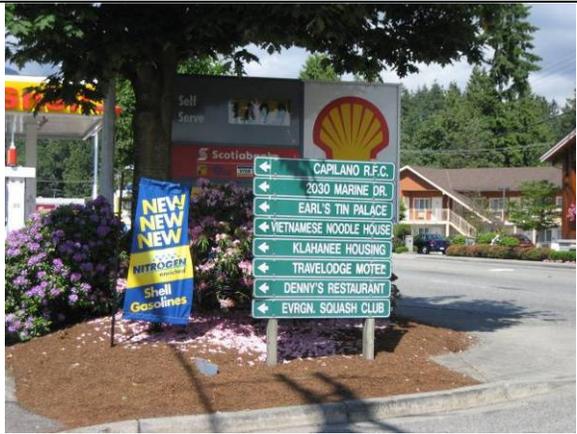
<ul style="list-style-type: none">▪ The sight distance for the eastbound left-turn movement out of Curling Road is poor due to roadside signs and geometry. This may result in conflicts involving eastbound and southbound vehicles at this intersection.

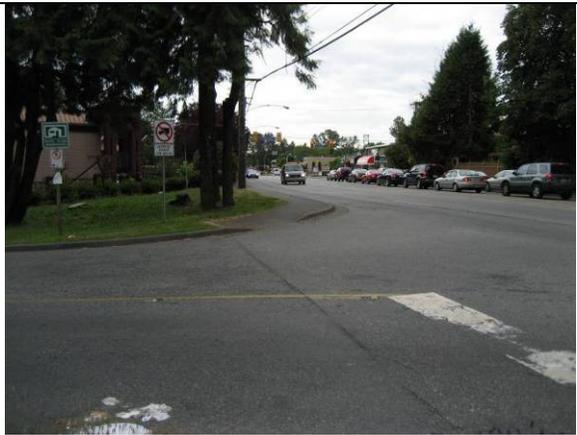
<ul style="list-style-type: none">▪ At the Garden Avenue intersection, the visibility of approaching northbound vehicles for the westbound approach is poor due to the skew of the intersection and the horizontal curve. This may result in conflicts involving westbound and northbound vehicles at this intersection.

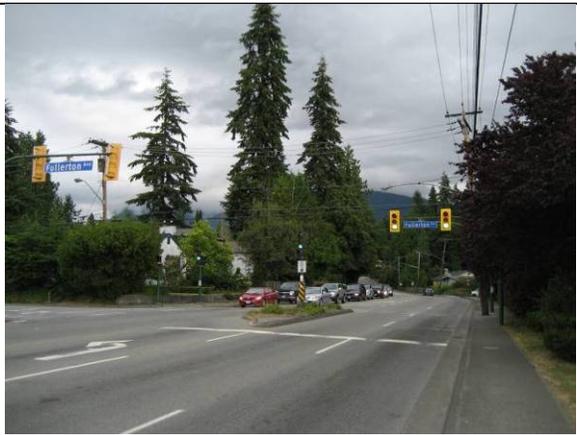
<ul style="list-style-type: none">▪ At the Fullerton Avenue and Curling Road intersections, confusion of how to use the acceleration lane for the eastbound left-turn was observed.

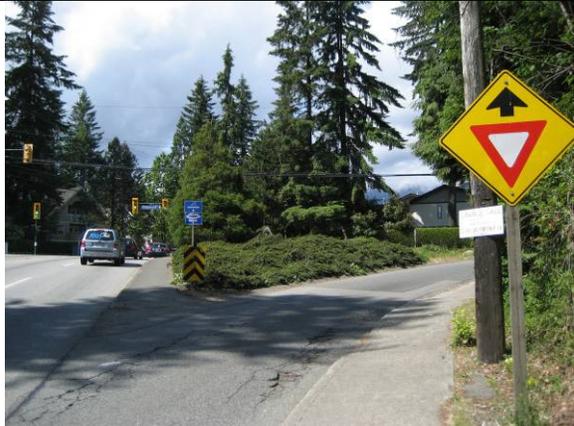
<ul style="list-style-type: none">▪ The northbound right-turn channelized lane at the Riverside Drive intersection has limited sight distance around the shrubbery and rockface should there be any queuing at the YIELD sign. These conditions may result in rear-end conflicts.▪ There is a bus stop at the end of the right-turn lane. When combined with the high volumes and visibility issues, there is a potential for a rear-end collision with a bus that has stopped at the bus stop.

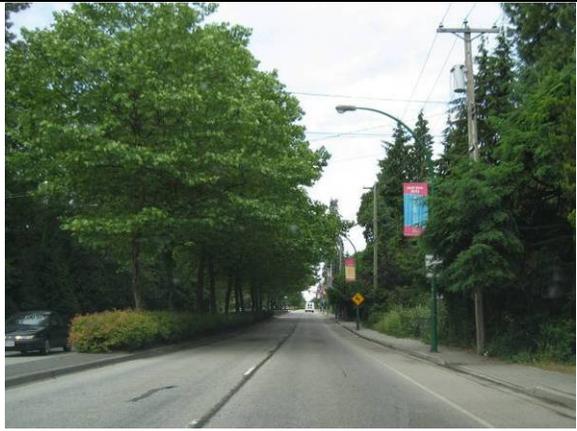
<ul style="list-style-type: none">▪ Much of the corridor has trees on both the median and roadside. Due to the foliage, lighting from the streetlights may be obscured. This may result in lower visibility during dark conditions and a higher nighttime collision risk for all road users.▪ The landscaping can restrict sight distances at locations with horizontal curves.

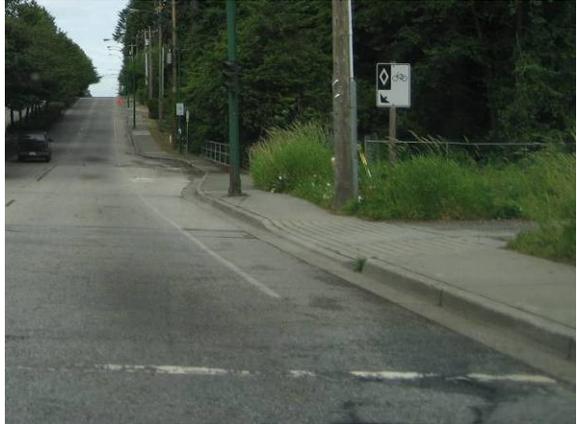
<ul style="list-style-type: none">▪ Bicycle lanes of about 1.3 metres wide are provided in both eastbound and westbound directions. The bicycle lane is less than the 1.8 metre standard for the GVRD and may result in cyclists travelling closer to adjacent vehicular traffic than suggested.

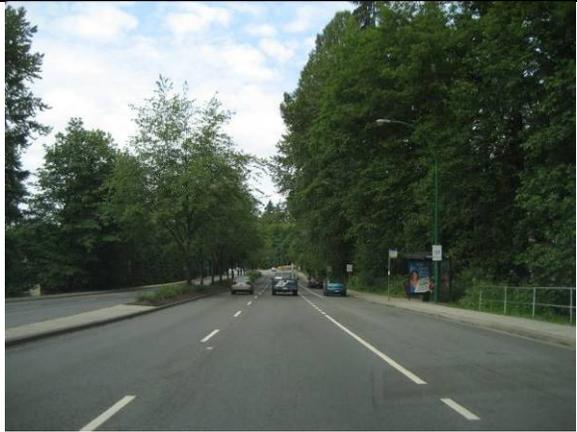
<ul style="list-style-type: none">▪ Prevailing vehicle speeds were typically about 70 kilometres per hour or higher. This is higher than the posted speed limit of 60 kilometres per hour. A high-quality road with relatively wide lanes of 3.3 to 3.4 metres, few intersections and accesses, and high design speed result in this discrepancy.

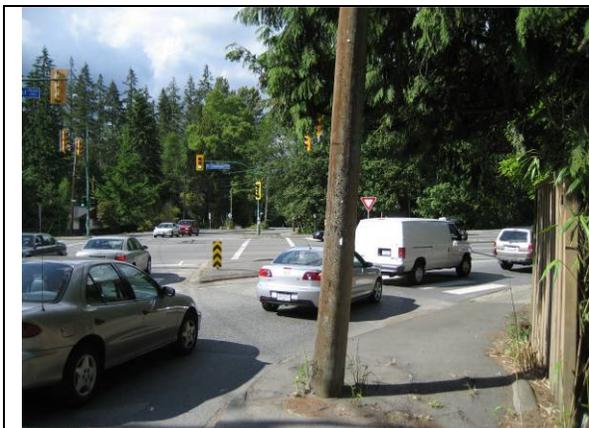
- The northbound right-turn channelized lane has limited sight distance both around the lane and to the west to see eastbound through vehicles. These conditions may result in rear-end and right-turn conflicts.
- The design of right-turn channelized lanes with YIELD control typically results in drivers looking for gaps in the through traffic to the left while needing to be wary of stopped vehicles on the right-turn lane in front. This higher driver workload in opposing directions, combined with observed high volumes and limited sight distance can result in rear-end conflicts on the right-turn lane.
