District of North Vancouver Fromme Mountain Trails Environmental Assessment

February 21, 2015

DIAMOND HEAD
CONSULTING LTD.

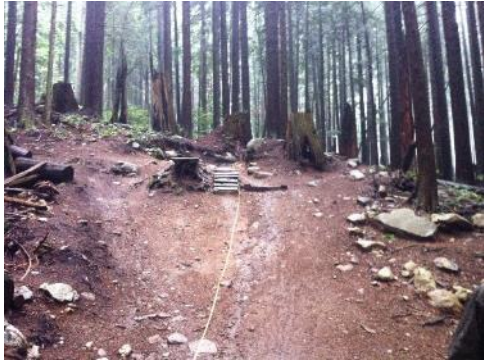
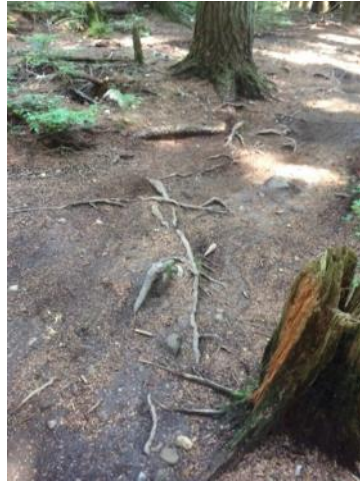
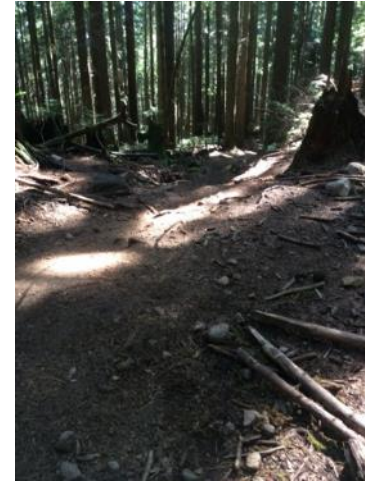
Users leaving the trail accounts for a large part of off-trail impacts as well. Users are leaving the trail to ride around sections they find too difficult, to ride around wet areas, to follow old trails, to take breaks and wait for other riders. These off trail impacts are greatest on trails that experience high use such as Bobsled.

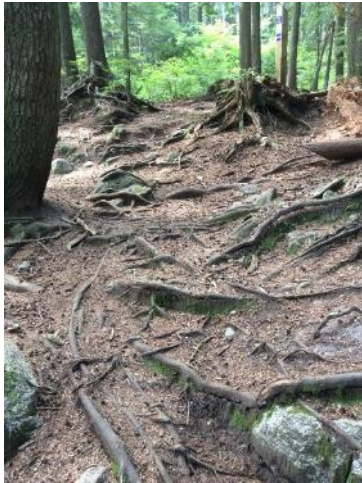
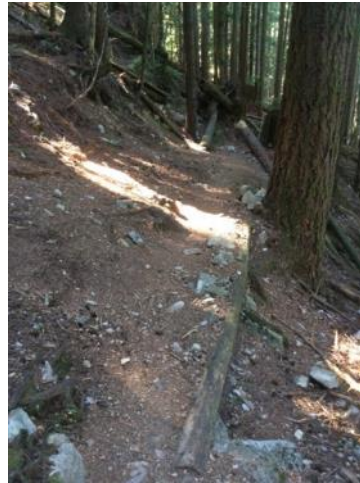
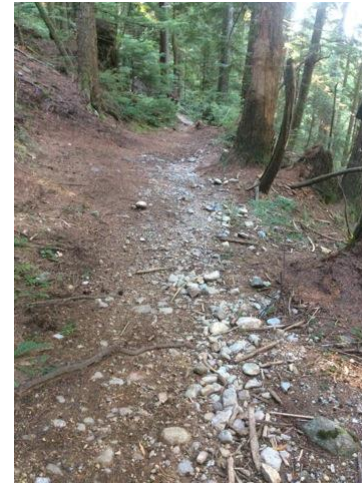
On hiking trails, off trail impacts include primarily expansion of the trail surface. This occurs where the main trail surface is steep and rocky. Hikers will walk up the sides of the trails in these areas. In these areas, forest floor is eroded and tree roots are often exposed.

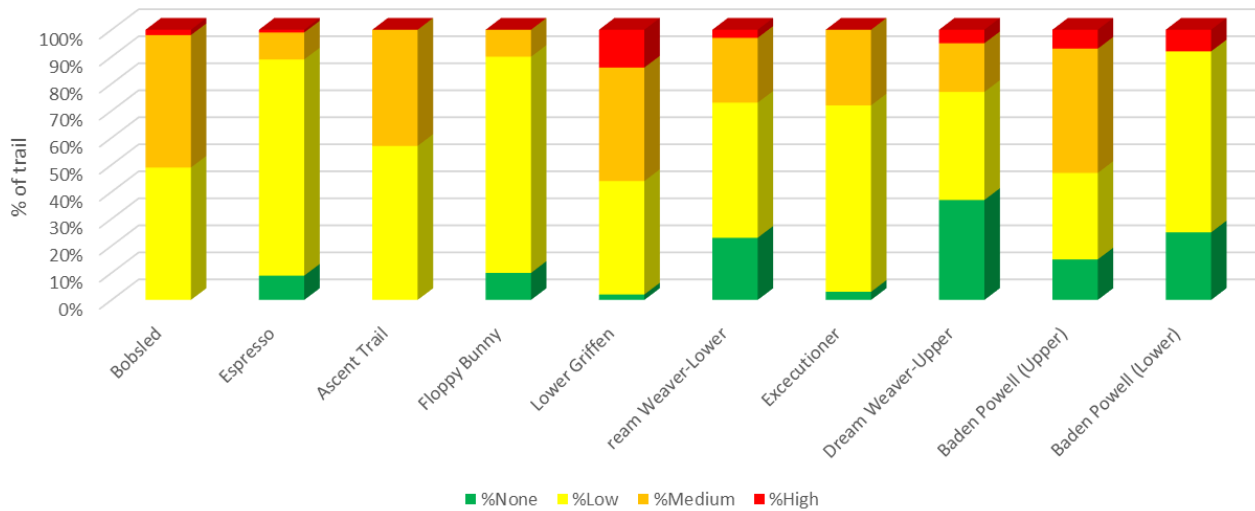
Figure 8. Off trail impacts (See Appendix B for methodology)

Figures 8 and 9 illustrates the causes of off trail impacts from three representative trails. Griffin represents a trail that existed prior to 2007 but has been upgraded and worked on extensively. Espresso have been realigned and significantly upgraded since the Trails Study was adopted. It is a good example of a trail that has been managed following the BMPs in the Trails Study. Executioner is an older trails that was inherited as part of the trail network. It tends to follow fall lines, is steep and has the least amount of upgrading compared to other trails in this study. These are used as representative trails in the subsequent discussions of BMP.

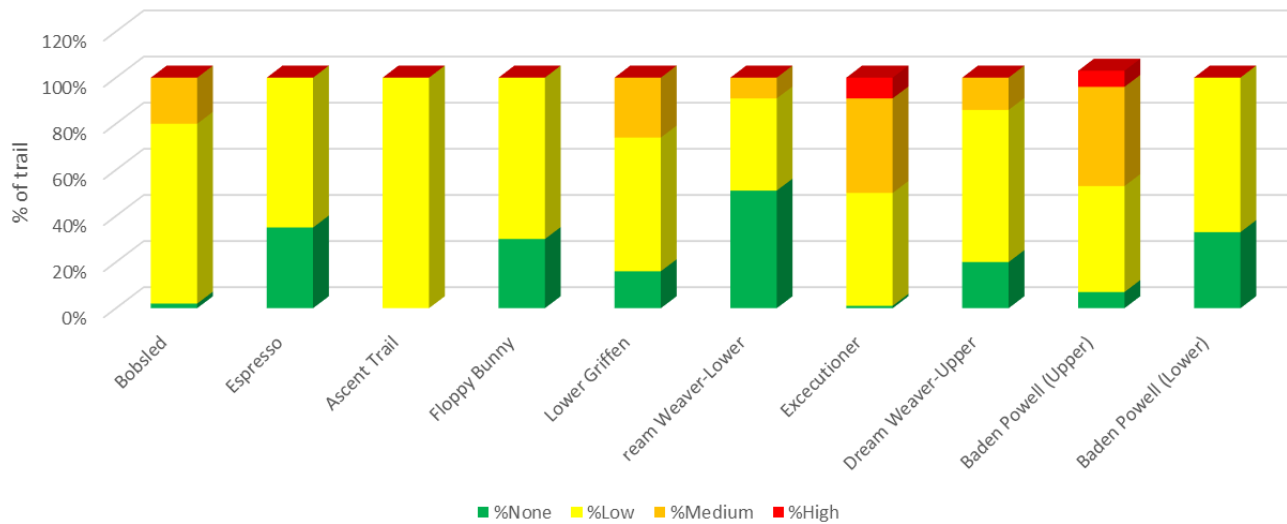
Figure 10. Surface Water Flow Impacts (See Appendix B for methodology)

Impacts from surface water flow increases significantly with the grade of a trail. This is a result of accumulating water flowing faster and having more energy to erode soils. Older trails that follow fall lines for long stretches experience high tread wear from bikes skidding. This erodes soil from the trail creating ruts down the trail surface. During high rain fall, water runs down these sections eroding mineral soil and exposing roots and rocks. Where water eventually leaves the trail, there is often evidence of off trail impacts from water scour.

As previously discussed, newer and upgraded trails have gentler grades and are constructed to manage water flow. Surface water flow was greater on trails with a deep cut slope. This intercepts surface water flows increasing the amount of water flowing onto the trail. Construction of trails above grade allows for more natural ground flows to continue below the trails surface.

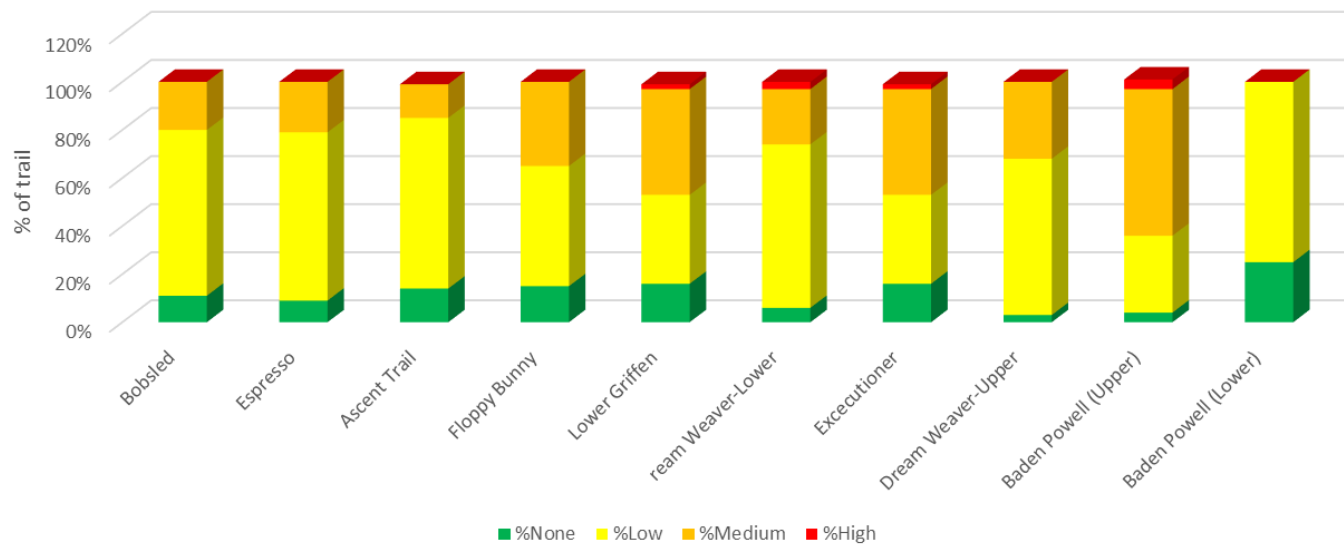
Figure 12. Tread Wear (See Appendix B for methodology)

Where tread wear is high, surface roots or trees are often exposed and impacted. Armoring has been used as a method of preventing tread wear on highly impacted trails. There was not a lot of armouring used on the eight trails assessed with the exception of steeper sections of Executioner and the Baden Powell trail.

Newer trails tend to have a gentler grade and subsequently bikes do not skid as frequently and the tread wear was lower. The areas that do show signs of tread wear on newer trails include the sections before TTFs and steep corners. Placing obstacles strategically before these areas has been effective at slowing riders to prevent them from skidding.

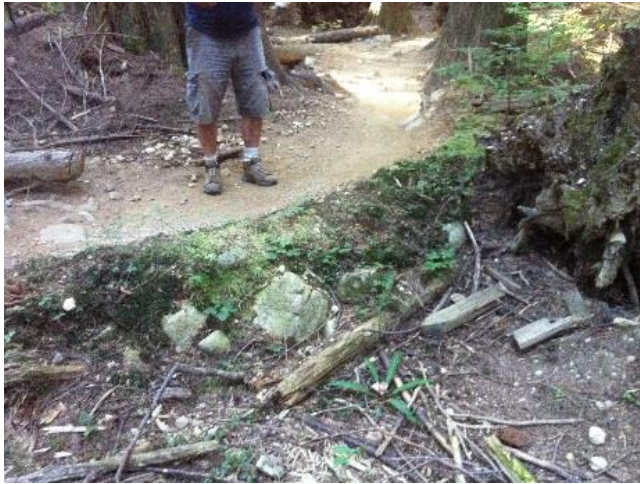
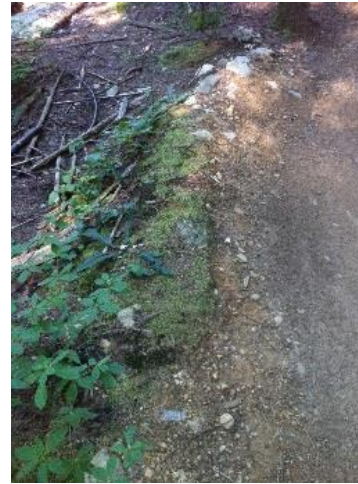
Trails impact vegetation in a number of ways. The trail surface itself amounts to a permanent loss of growing sites for the duration that the trail is active. The soil that is deposited on the trail fill slope can be replanted or will revegetate naturally over time if left undisturbed. BMPs for trail construction include the replanting of disturbed trail edges and this is evident in many places where mosses and ferns have been planted. Revegetation is difficult where off trail use has caused compaction of these soils.

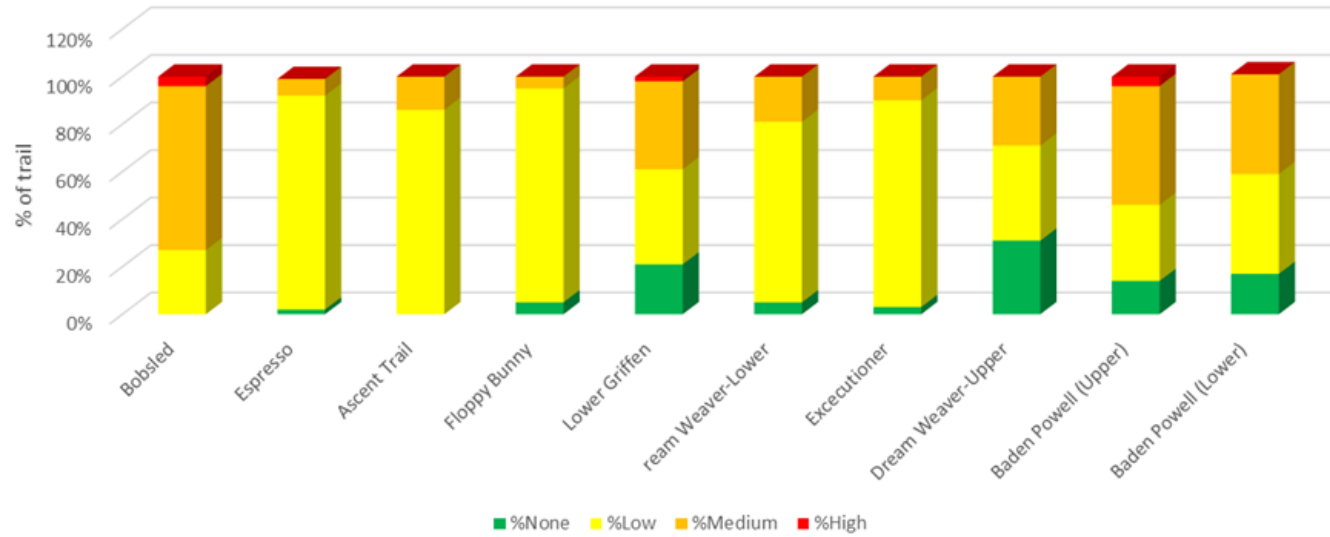
Figure 14. Vegetation Impacts (See Appendix B for methodology)

Borrow pits for new trail construction causes the loss of ground vegetation and can impact roots of adjacent trees. Each borrow pit is a small, isolated disturbance area; however in large numbers the collective impact on ground vegetation could become significant.

Invasive species are distributed into the Fromme mountain areas primarily through seed dispersal. This is caused by wildlife eating berries, feces of dogs and seeds dispersing on the vehicles up mountain highway or people and bikes traveling on the trails. Overall invasive species are found mainly along the Mountain highway road. Invasive plant observed along the trail edges include English Holly and a very small amount of laurel. These are found throughout the forest and are distributed mostly by birds.

- Continue to promote building methods that minimize cut slopes and build up over existing grades to protect tree roots.
- Only remove hazard trees that pose an extreme risk. The cutting of any live trees for trail construction materials should not be permitted. Post signage that trails should not be used during high wind storm events.
- The Trails Study requires that trails be aligned out of the dripline of trees. Due to the density of the forest this is not possible. Amend the BMP to require that trails be located as far as possible away from mature healthy trees and so that trails are constructed above grade without severing or suffocating roots.

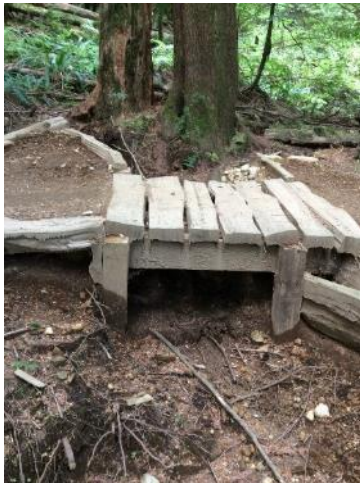
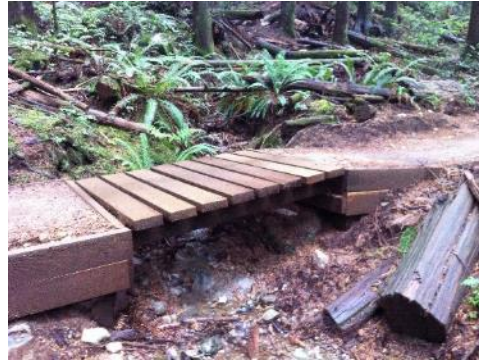
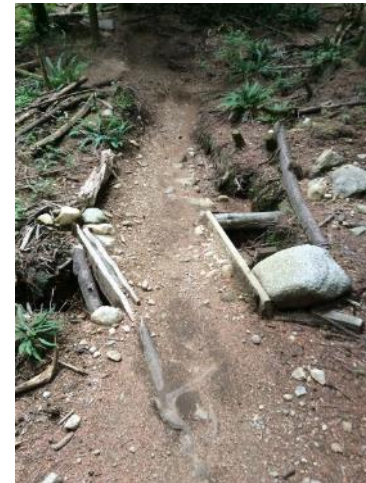
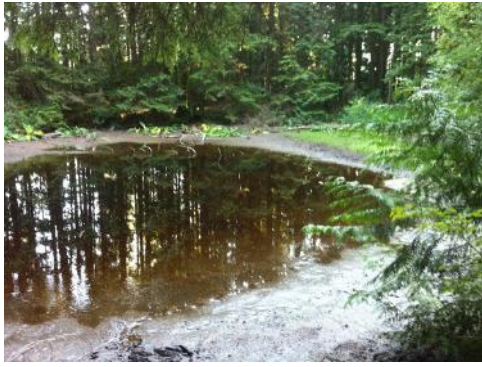
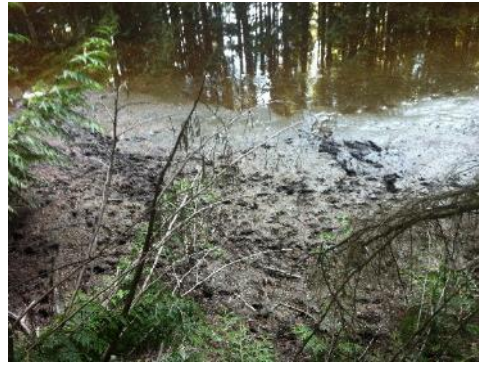
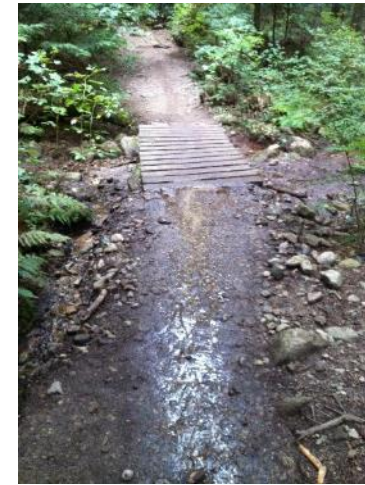
One of the highest environmental impacts identified in this study was to creeks and water quality (ie sedimentation from soil erosion). Areas of greatest concern included trails with steep grades extending down to a creek crossing. Skidding and surface water flow carry sediment to the crossing and often around its banks and into the creek. This problem is compounded were dogs and people walk down to the creek edges.

The BMPs for creek crossings should be amended to enhance the protection of creeks, wetlands and their riparian areas. The requirements for a 15m wide protection zone of both sides of every creek is difficult to achieve for the numerous small creeks on Fromme Mountain. Also submitting a RAR assessment for every creek encountered along the trails would be onerous. It is recommended that a creek crossing standard be adopted for the Fromme Mountain area. Applications to construct or upgrade creek crossings should be submitted to and approved by the District. Recommended standards to be adopted include the following:

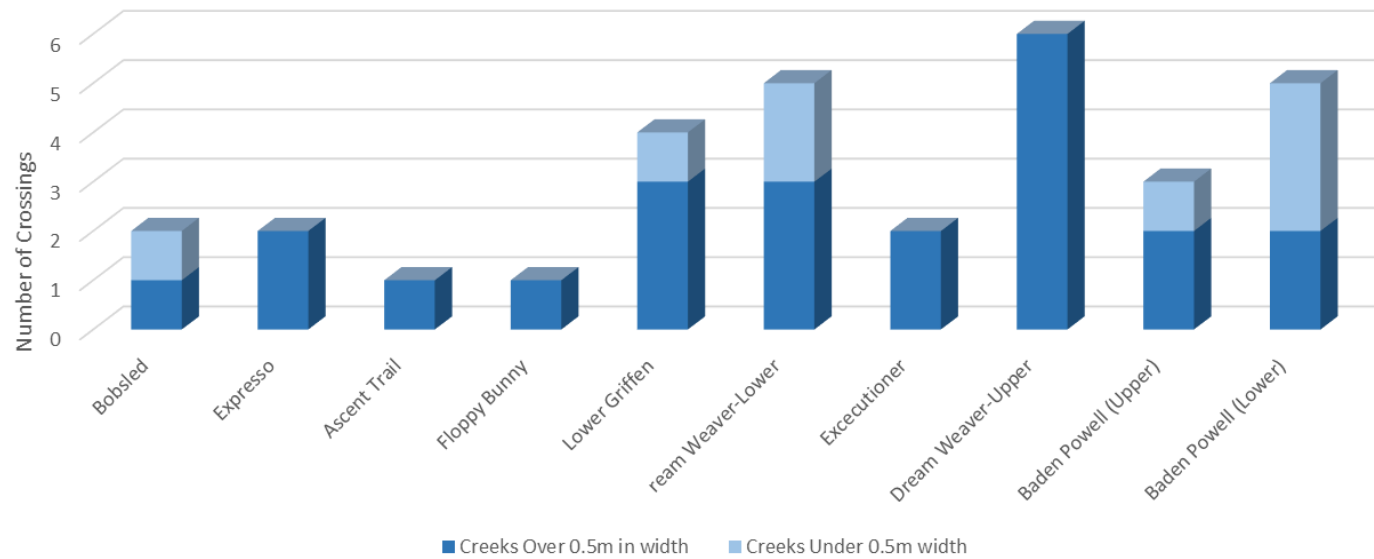
Figure 16. Number of creek crossings

BMPs for creek crossings include the installation of safe crossings and protection of their riparian zones. Recommended widths of these protection areas follow the methods of the Provincial Riparian Areas Regulation. None of the creek crossings assessed in this study were in compliance with these standards. The required crossings for creeks would be 15m on both sides. Most crossings are constructed across the creek and to either of its banks. They rarely extended further than 2m beyond the creek’s banks.

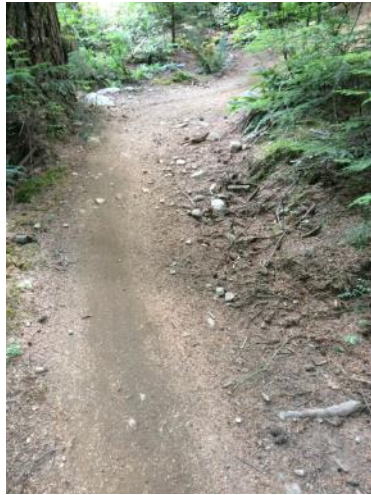
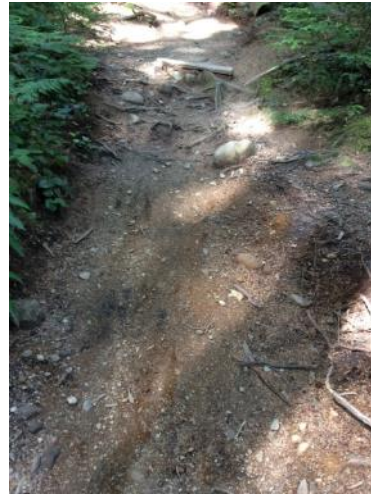
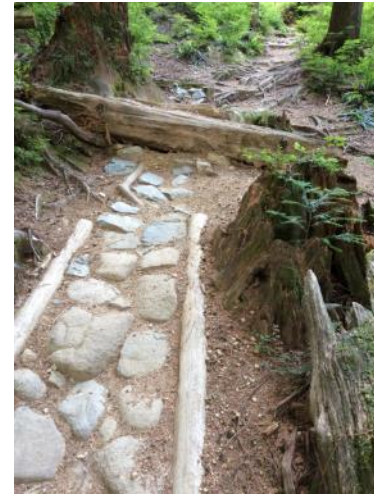
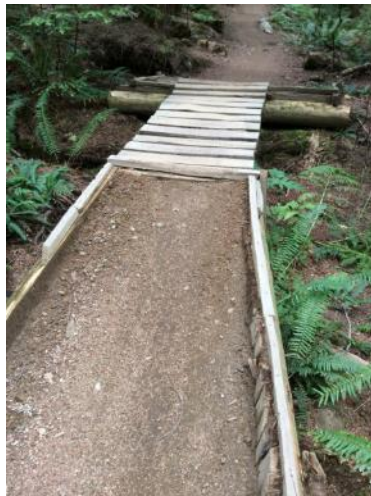
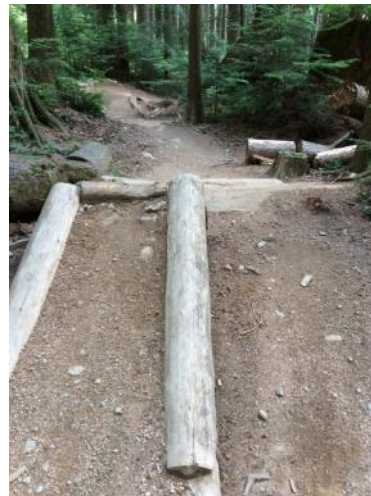
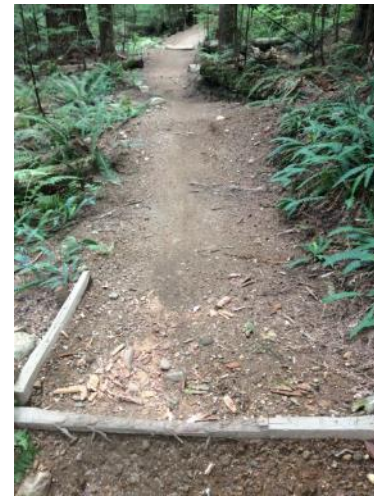
Figure 27. Representative Photos of Floppy Bunny

- Well used trail by the widest range of riders
- Numerous borrow pits were identified along the trail
- Steeper sections and areas just before turns or technical features experience high tread wear due to high use and level of riders
- Allows for fast riding
- New TTFs are well constructed and safe
- Surface water is managed effectively

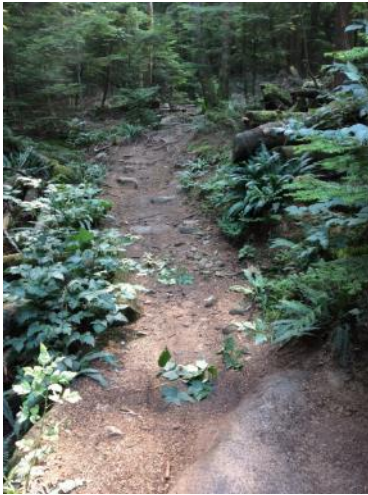
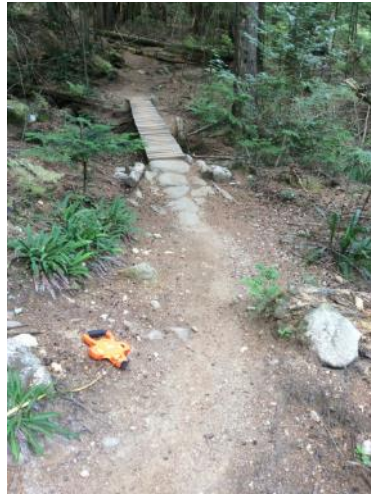
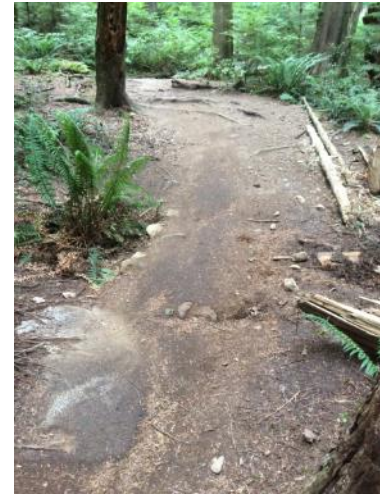
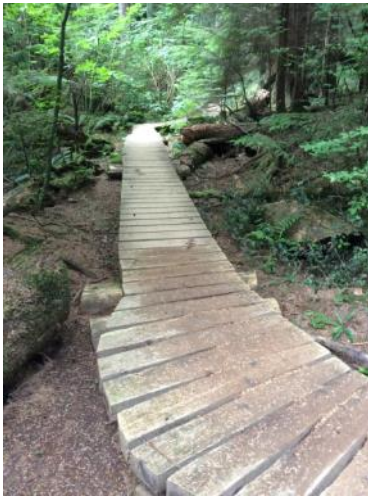
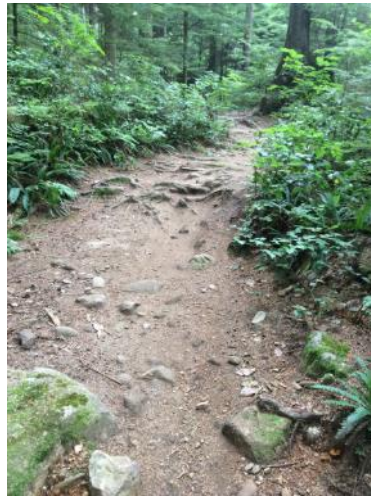
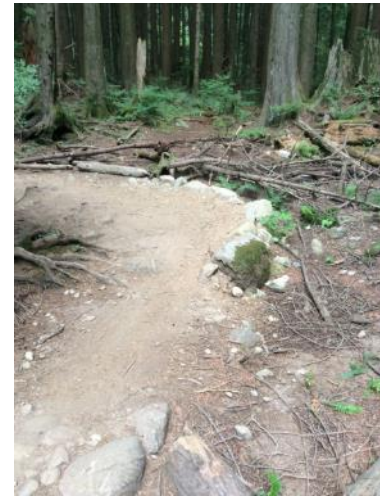
Figure 30. Representative Photos of Lower Griffen

- This is a long trail that exists with a range of conditions
- Section of this trail that have not been upgraded have moderate impacts due to tread wear and poor surface water control
- Some older TTFs exists that are in poor condition
- Some boardwalks are still narrow and causing ride around
- Middle section follows an old logging road
- Riparian crossings of significant creeks are not protecting water quality adequately

- Recommendation: Manage and upgrade. Install signs for dogs-on-leash in Mountain View Park Area.
- MTB XC/decent (some TTFs)
- Single-track
- High level of use
- Multi-use trail (Youth/beginner MTB trail for study area), hikers and dog walkers
- Rated intermediate
- Moderate level of volunteer stewardship (rock armouring and drainage)
- Poor condition (erosion and worn TTFs)
- Sustainable alignment
- Bridges required for creek crossing(s)
- Moderate harmony

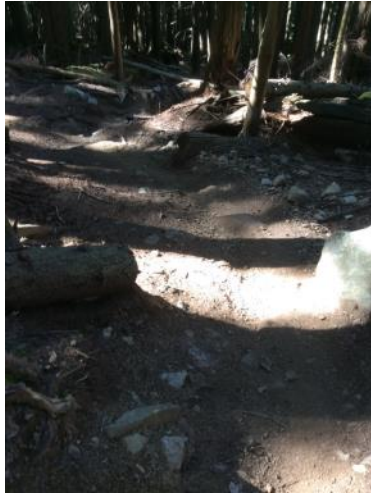
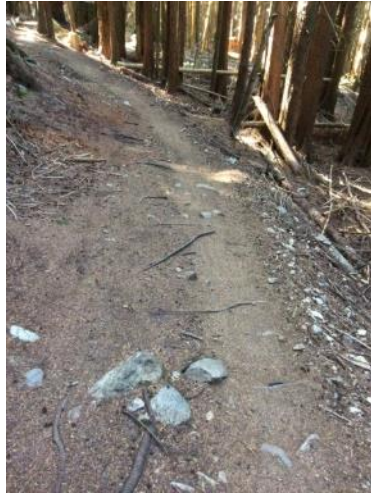
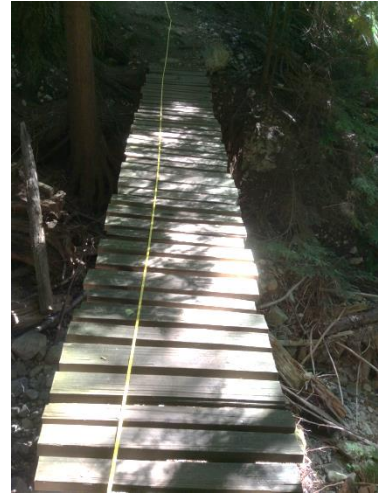
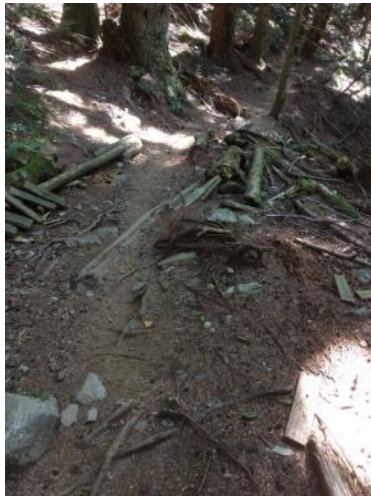
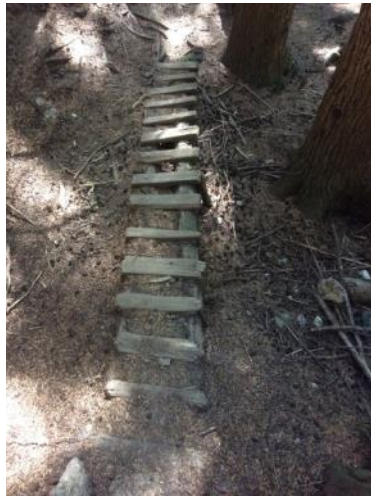
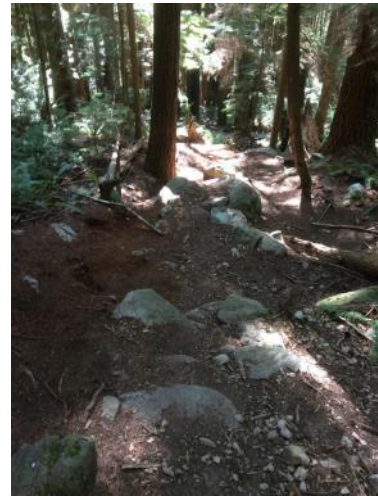
Figure 35. Representative Photos of Executioner

- This is a steep fall line trail that was inherited from prior to 2007
- The lower section has high riparian zone impacts
- There is high tread wear on both sections due to steep slopes and skidding
- There is extensive surface water flow
- Recent cutting of hazard trees has taken place next to the trail
- Many TTFs have poor ride arounds causing increased trail widths

- Recommendation: Manage and upgrade. Re-route onto sustainable alignment for multi-use.
- MTB descent (some TTFs).
- Single-track.
- Low level of use.
- Lots of recent windthrow.
- MTB trail.
- Rated expert.
- Low level of volunteer stewardship.
- Poor condition (erosion and worn TTFs).
- Partially situated on private property (Grouse Mountain).
- Low harmony.

- Recommendation: Consolidate into one sustainable hiking only route. Actively decommission 35C.
- MTB descent (some TTFs). Braided into multiple routes.
- Single-track (with linking skid-roads).
- Low level of use.
- Multi-use trail.
- Rated expert.
- Low level of volunteer stewardship.
- Very poor condition (erosion and worn TTFs).
- Partially situated on private property (Grouse Mountain).
- Very low harmony.

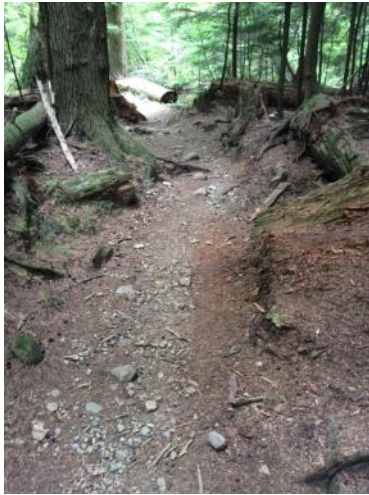
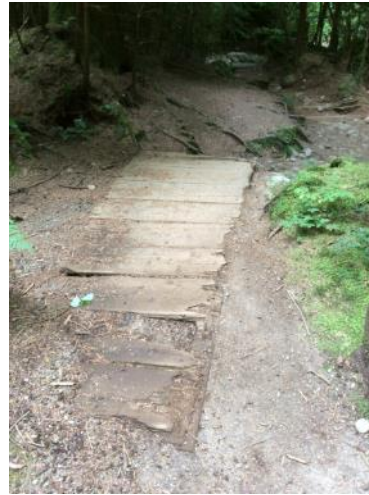
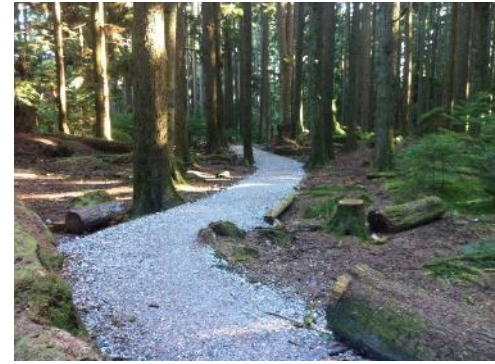
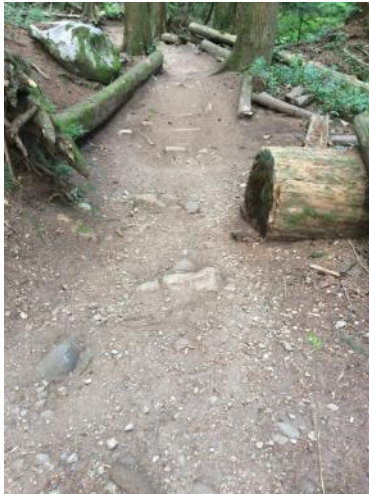
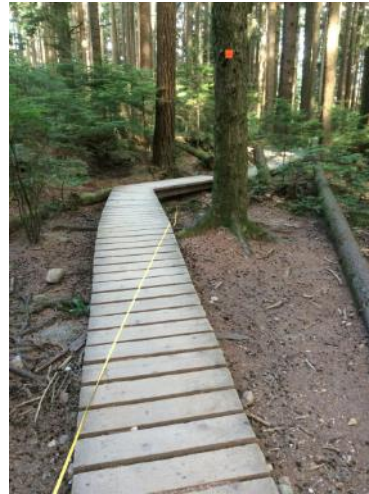
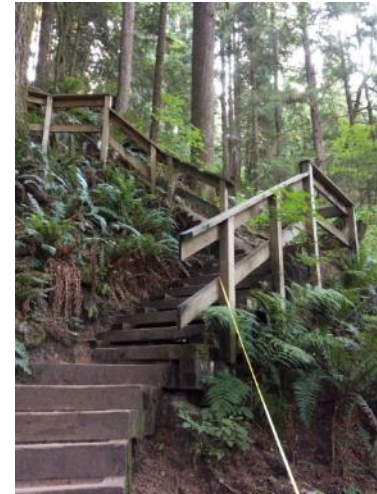
Figure 38. Representative Photos of Baden Powell

- Where trails surface is rocky, walkers expanding trail edges
- Steeper with long sections with poor water control
- Graded trails beside this trail
- Moderate tread wear due to long time use
- Moderate impacts from water flow due to steep grades
- Scattered holly growing beside trail
- High number of hazard trees removed adjacent to trails
- Dog tracks evident in all wet areas adjacent to trail

- As BP extends down to the flatter sections of the park, most of trail has been restored with new gravel and hand rails to prevent access to the wetland area
- This section of trail is wide with low grades.
- There is little tread wear or surface water flow
- The two creek crossings should be widened beyond the top of banks
- High number of hazard trees removed adjacent to trails
- Two creek crossings
- Dog tracks evident in all wet areas including wetland
