District of North Vancouver Fromme Mountain Trails Environmental Assessment

February 21, 2015

DIAMOND HEAD
CONSULTING LTD.

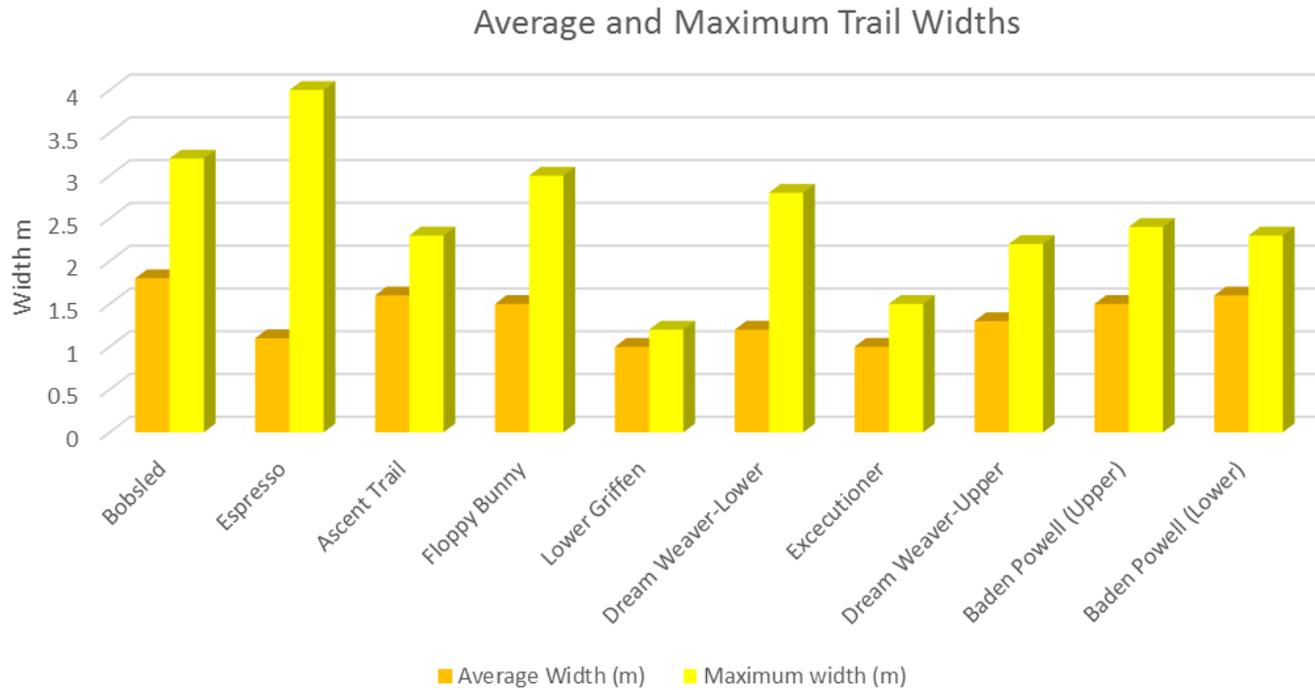
Figure 6. Average and maximum trail widths

The trial plots provide an assessment of the general trail characteristics. Trail width was similar between trails; however maximum width on newer trails was higher. These trails experience higher use and wider sections are found on some turns and above and below TTFs where riders will stop for viewing. Trail grades are generally lower on new trails and steepest on older trails. Older trails tended to follow fall lines and were not constructed cross slope.

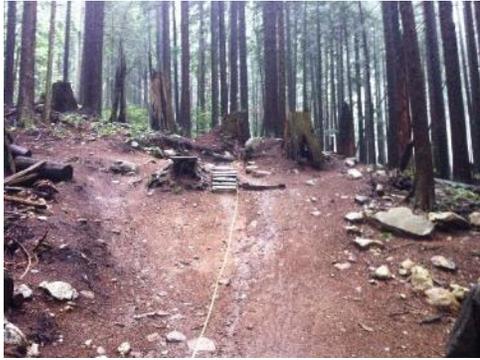
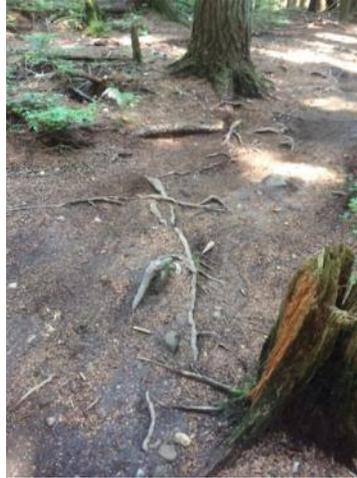
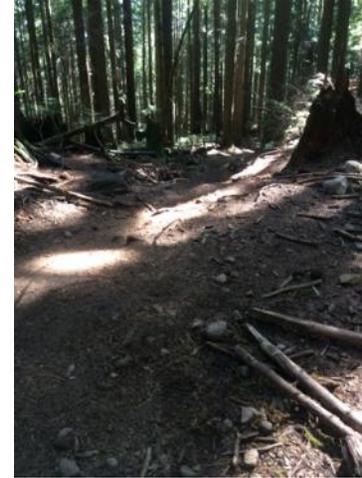
Users leaving the trail accounts for a large part of off-trail impacts as well. Users are leaving the trail to ride around sections they find too difficult, to ride around wet areas, to follow old trails, to take breaks and wait for other riders. These off trail impacts are greatest on trails that experience high use such as Bobsled.

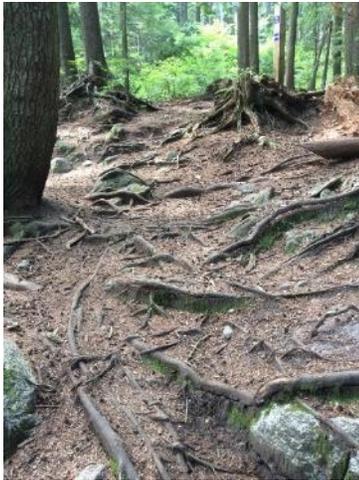
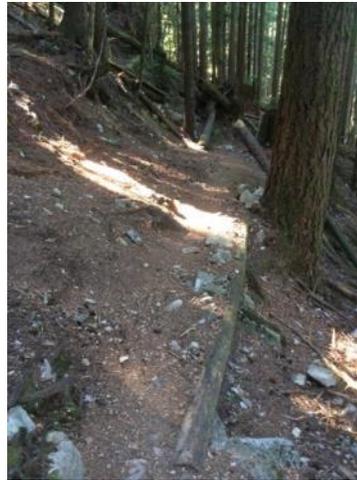
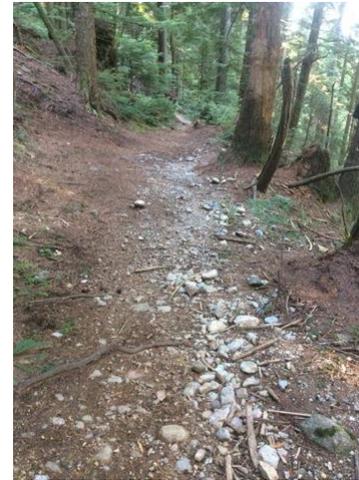
On hiking trails, off trail impacts include primarily expansion of the trail surface. This occurs where the main trail surface is steep and rocky. Hikers will walk up the sides of the trails in these areas. In these areas, forest floor is eroded and tree roots are often exposed.

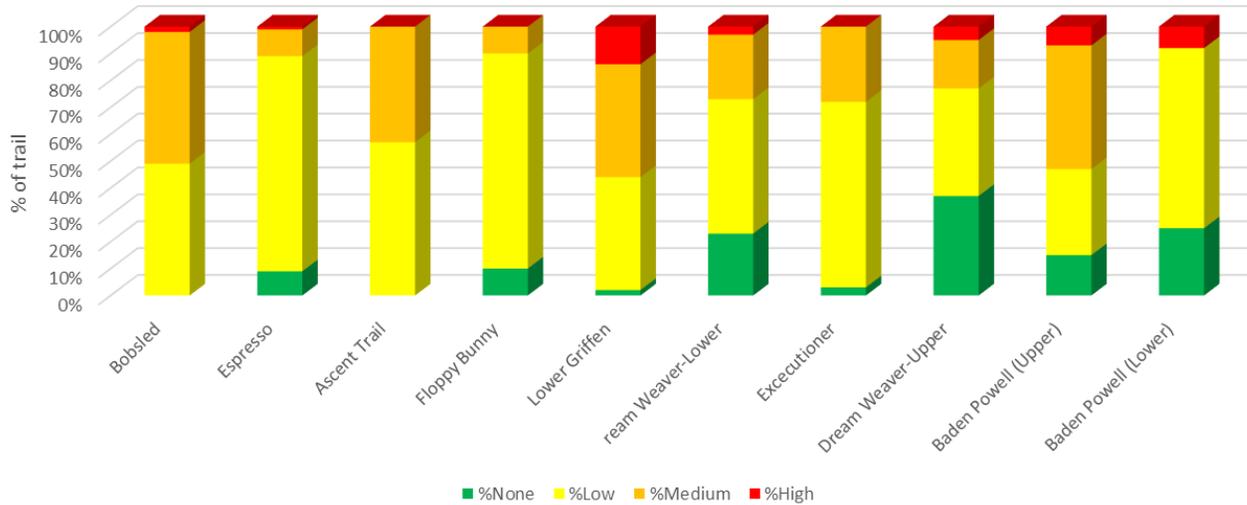
Figure 8. Off trail impacts (See Appendix B for methodology)

Figures 8 and 9 illustrates the causes of off trail impacts from three representative trails. Griffin represents a trail that existed prior to 2007 but has been upgraded and worked on extensively. Espresso have been realigned and significantly upgraded since the Trails Study was adopted. It is a good example of a trail that has been managed following the BMPs in the Trails Study. Executioner is an older trails that was inherited as part of the trail network. It tends to follow fall lines, is steep and has the least amount of upgrading compared to other trails in this study. These are used as representative trails in the subsequent discussions of BMP.

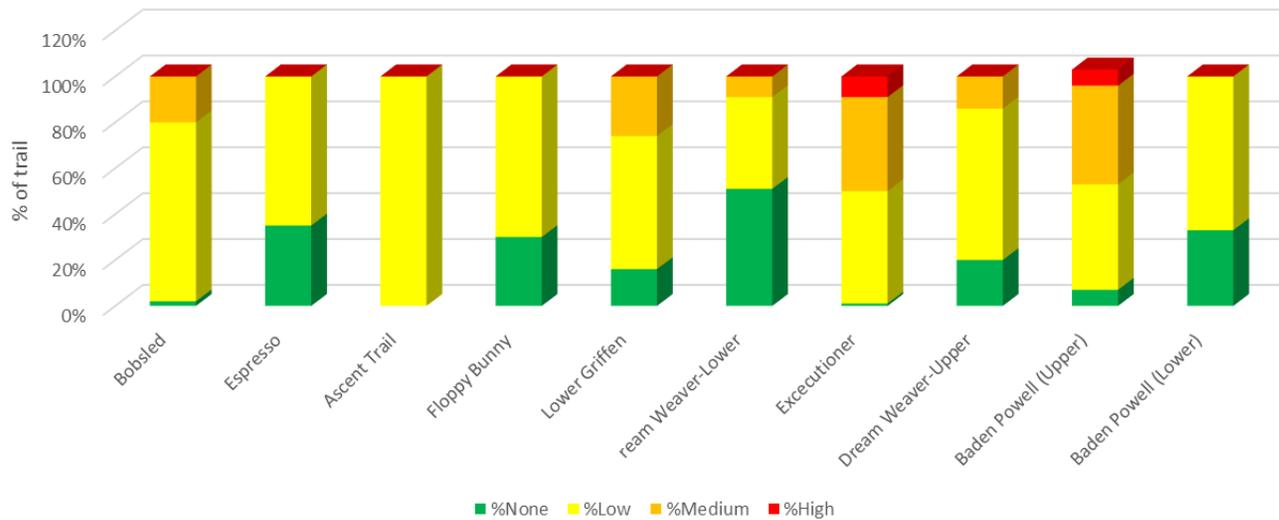
Figure 10. Surface Water Flow Impacts (See Appendix B for methodology)

Impacts from surface water flow increases significantly with the grade of a trail. This is a result of accumulating water flowing faster and having more energy to erode soils. Older trails that follow fall lines for long stretches experience high tread wear from bikes skidding. This erodes soil from the trail creating ruts down the trail surface. During high rain fall, water runs down these sections eroding mineral soil and exposing roots and rocks. Where water eventually leaves the trail, there is often evidence of off trail impacts from water scour.

As previously discussed, newer and upgraded trails have gentler grades and are constructed to manage water flow. Surface water flow was greater on trails with a deep cut slope. This intercepts surface water flows increasing the amount of water flowing onto the trail. Construction of trails above grade allows for more natural ground flows to continue below the trails surface.

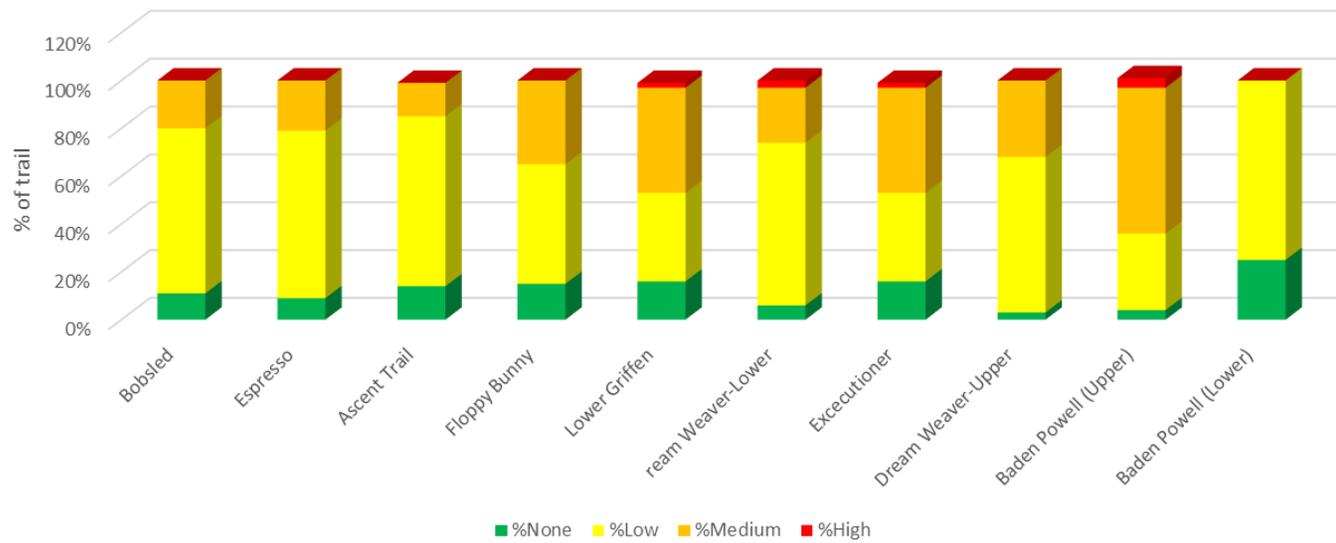
Figure 12. Tread Wear (See Appendix B for methodology)

Where tread wear is high, surface roots or trees are often exposed and impacted. Armoring has been used as a method of preventing tread wear on highly impacted trails. There was not a lot of armouring used on the eight trails assessed with the exception of steeper sections of Executioner and the Baden Powell trail.

Newer trails tend to have a gentler grade and subsequently bikes do not skid as frequently and the tread wear was lower. The areas that do show signs of tread wear on newer trails include the sections before TTFs and steep corners. Placing obstacles strategically before these areas has been effective at slowing riders to prevent them from skidding.

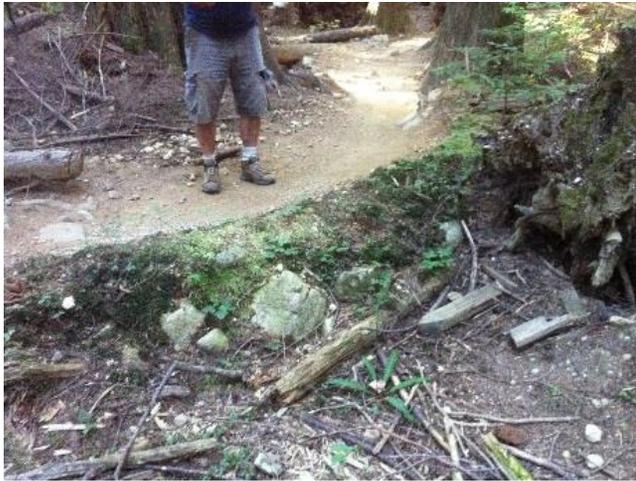
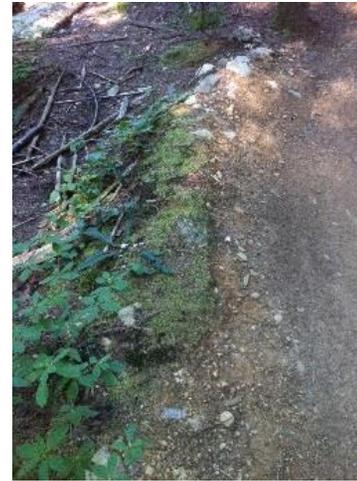
Trails impact vegetation in a number of ways. The trail surface itself amounts to a permanent loss of growing sites for the duration that the trail is active. The soil that is deposited on the trail fill slope can be replanted or will revegetate naturally over time if left undisturbed. BMPs for trail construction include the replanting of disturbed trail edges and this is evident in many places where mosses and ferns have been planted. Revegetation is difficult where off trail use has caused compaction of these soils.

The most frequent impact to vegetation was related to mature trees. It is difficult to avoid impacts to trees on the Fromme Mountain area as the forest is dense with continuous tree cover. Old and steeper trails have high tread wear and loss of mineral soil from surface water flow. This exposes the roots of trees adjacent to the trail. In many areas large structural roots are exposed and are damaged. This includes the wear of root bark at the trail surface. From observations in the field, mature trees appear to be able to recover when less than about 1/3 of their roots are impacted. The greatest impacts to trees include smaller intermediate and suppressed trees that tend to have a smaller root system and are struggling to survive in the understory. Some tree mortality was observed when trails cut roots within 1m of these smaller trees.

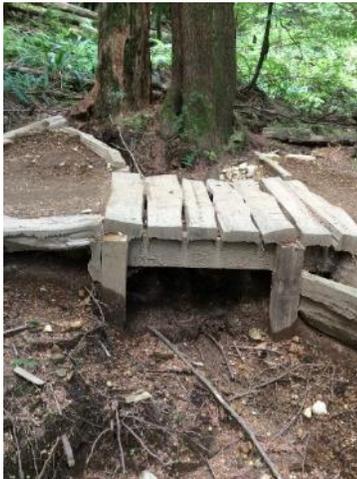
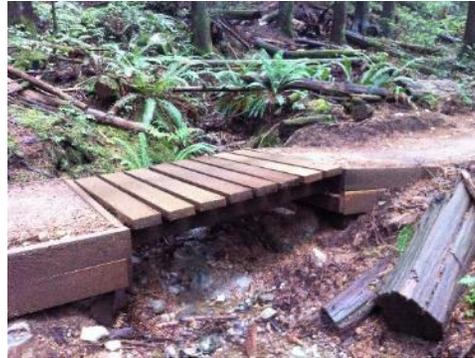
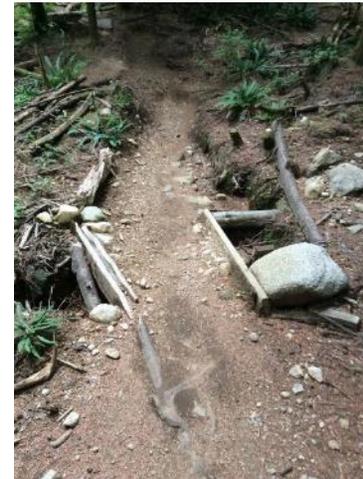
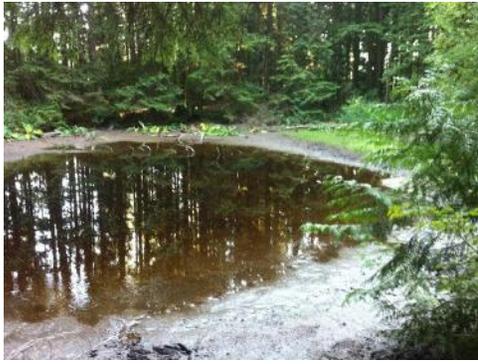
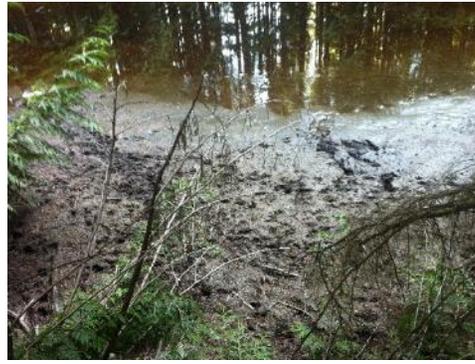
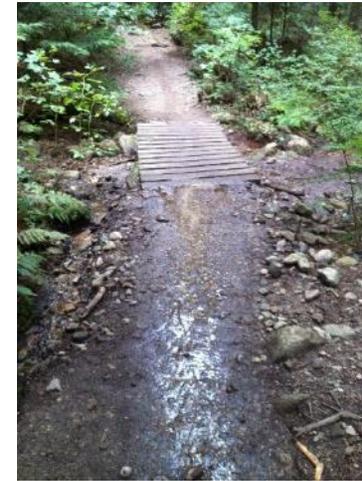
One of the highest environmental impacts identified in this study was to creeks and water quality (ie sedimentation from soil erosion). Areas of greatest concern included trails with steep grades extending down to a creek crossing. Skidding and surface water flow carry sediment to the crossing and often around its banks and into the creek. This problem is compounded were dogs and people walk down to the creek edges.

The BMPs for creek crossings should be amended to enhance the protection of creeks, wetlands and their riparian areas. The requirements for a 15m wide protection zone of both sides of every creek is difficult to achieve for the numerous small creeks on Fromme Mountain. Also submitting a RAR assessment for every creek encountered along the trails would be onerous. It is recommended that a creek crossing standard be adopted for the Fromme Mountain area. Applications to construct or upgrade creek crossings should be submitted to and approved by the District. Recommended standards to be adopted include the following:

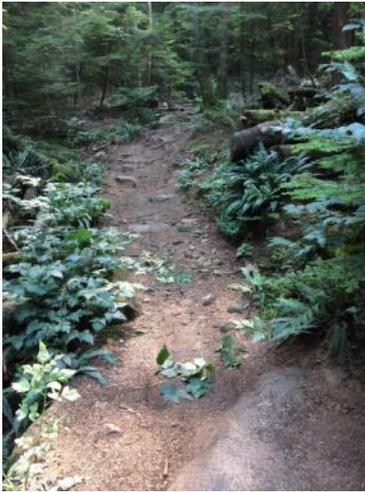
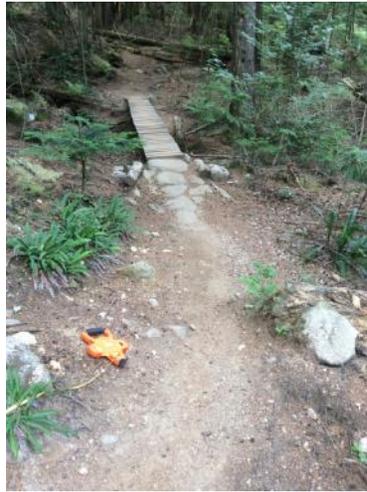
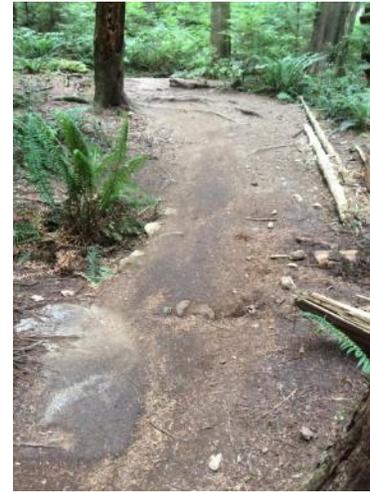
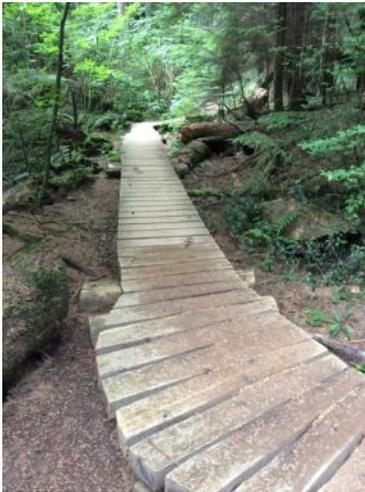
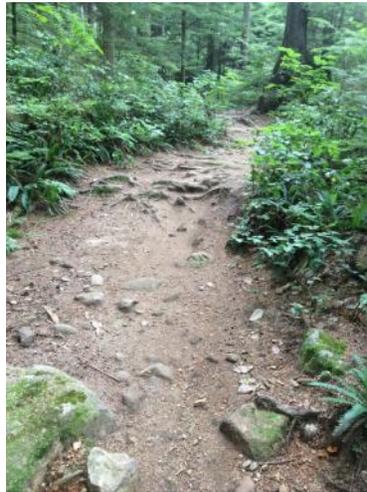
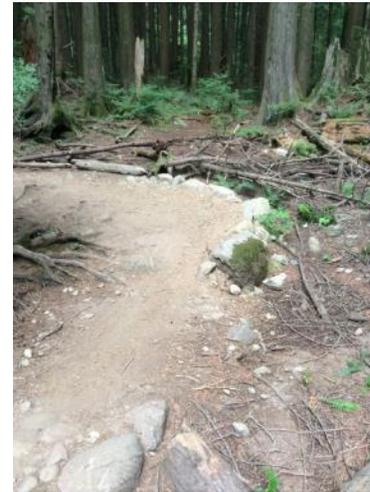
Figure 30. Representative Photos of Lower Griffen

- This is a long trail that exists with a range of conditions
- Section of this trail that have not been upgraded have moderate impacts due to tread wear and poor surface water control
- Some older TTFs exists that are in poor condition
- Some boardwalks are still narrow and causing ride around
- Middle section follows an old logging road
- Riparian crossings of significant creeks are not protecting water quality adequately

- Recommendation: Manage and upgrade. Install signs for dogs-on-leash in Mountain View Park Area.
- MTB XC/decent (some TTFs)
- Single-track
- High level of use
- Multi-use trail (Youth/beginner MTB trail for study area), hikers and dog walkers
- Rated intermediate
- Moderate level of volunteer stewardship (rock armouring and drainage)
- Poor condition (erosion and worn TTFs)
- Sustainable alignment
- Bridges required for creek crossing(s)
- Moderate harmony

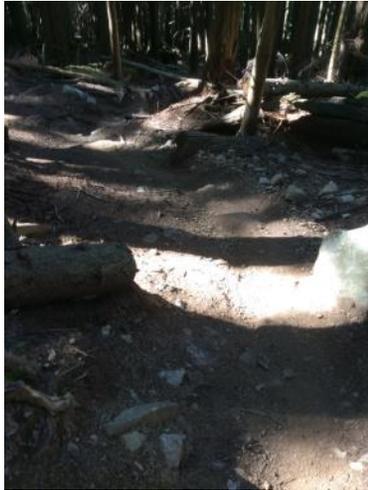
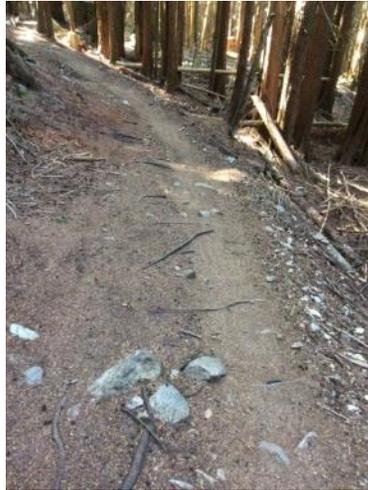
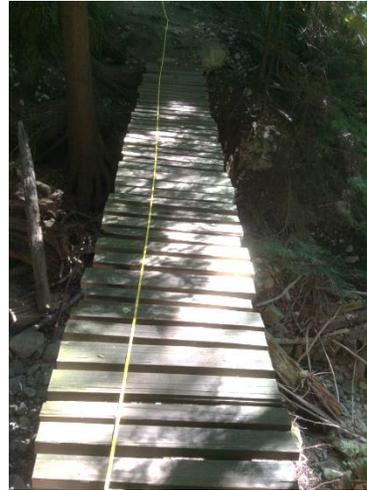
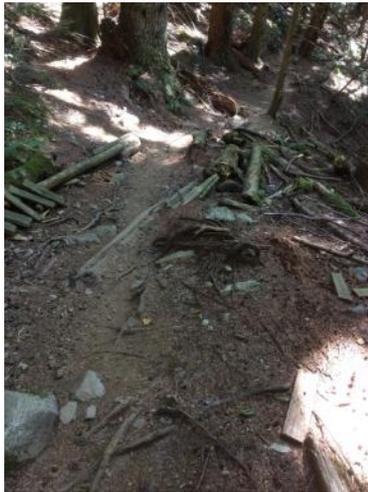
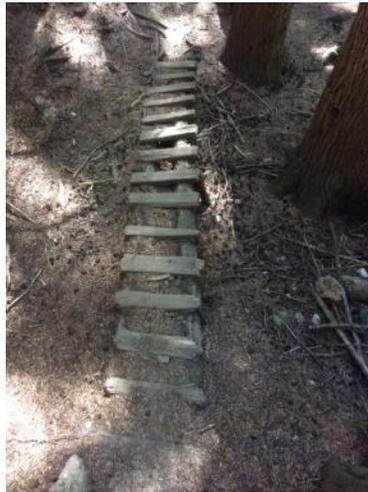
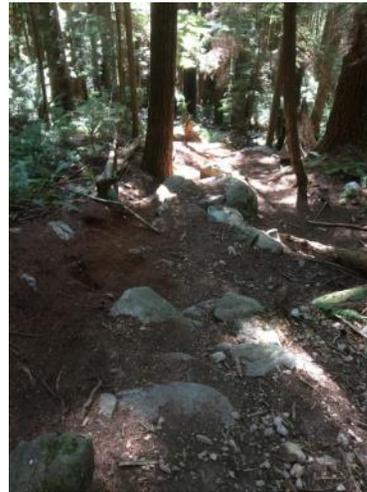
Figure 35. Representative Photos of Executioner

- This is a steep fall line trail that was inherited from prior to 2007
- The lower section has high riparian zone impacts
- There is high tread wear on both sections due to steep slopes and skidding
- There is extensive surface water flow
- Recent cutting of hazard trees has taken place next to the trail
- Many TTFs have poor ride arounds causing increased trail widths

- Recommendation: Manage and upgrade. Re-route onto sustainable alignment for multi-use.
- MTB descent (some TTFs).
- Single-track.
- Low level of use.
- Lots of recent windthrow.
- MTB trail.
- Rated expert.
- Low level of volunteer stewardship.
- Poor condition (erosion and worn TTFs).
- Partially situated on private property (Grouse Mountain).
- Low harmony.

- Recommendation: Consolidate into one sustainable hiking only route. Actively decommission 35C.
- MTB descent (some TTFs). Braided into multiple routes.
- Single-track (with linking skid-roads).
- Low level of use.
- Multi-use trail.
- Rated expert.
- Low level of volunteer stewardship.
- Very poor condition (erosion and worn TTFs).
- Partially situated on private property (Grouse Mountain).
- Very low harmony.

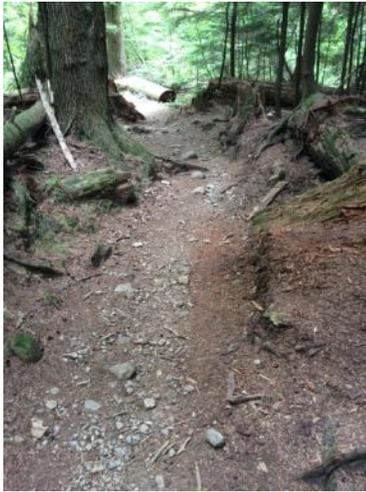
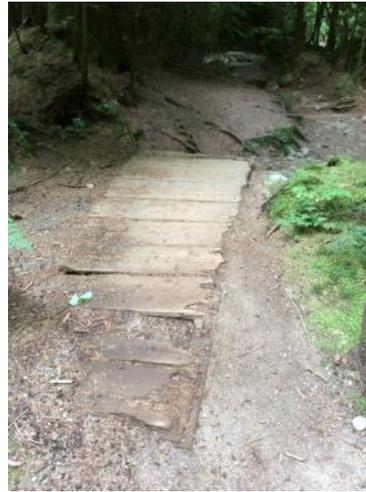
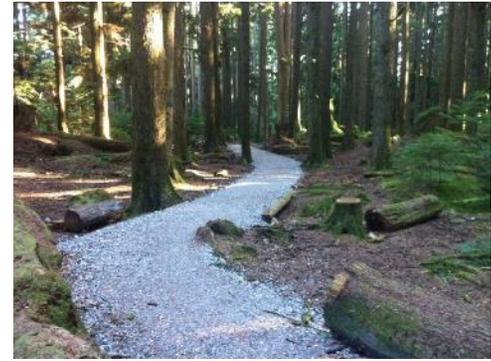
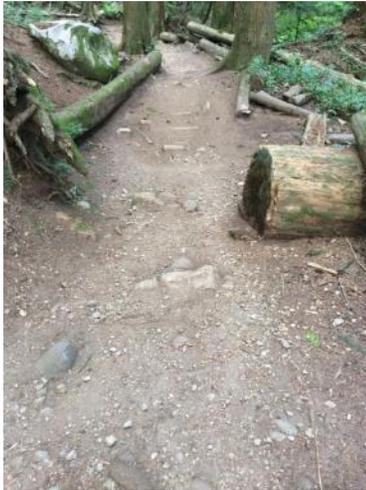
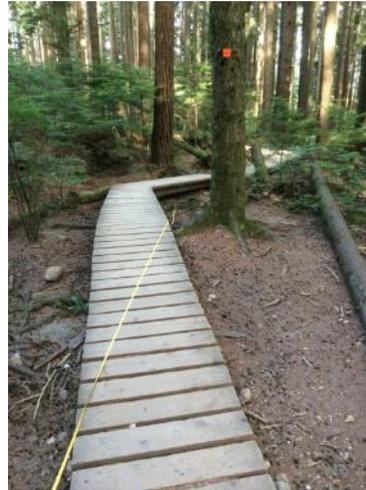
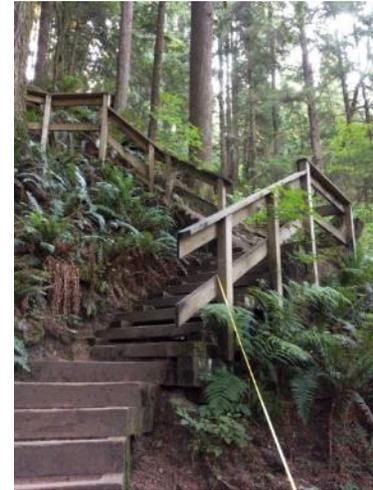
Figure 38. Representative Photos of Baden Powell

- Where trails surface is rocky, walkers expanding trail edges
- Steeper with long sections with poor water control
- Graded trails beside this trail
- Moderate tread wear due to long time use
- Moderate impacts from water flow due to steep grades
- Scattered holly growing beside trail
- High number of hazard trees removed adjacent to trails
- Dog tracks evident in all wet areas adjacent to trail

- As BP extends down to the flatter sections of the park, most of trail has been restored with new gravel and hand rails to prevent access to the wetland area
- This section of trail is wide with low grades.
- There is little tread wear or surface water flow
- The two creek crossings should be widened beyond the top of banks
- High number of hazard trees removed adjacent to trails
- Two creek crossings
- Dog tracks evident in all wet areas including wetland
